June 1, 2018

Version 1

Warranty Extension: Customer Support Program For Front Passenger's Airbag Inflator for 2005-11 RL and 2003-06 MDX (Expires June 30, 2026)

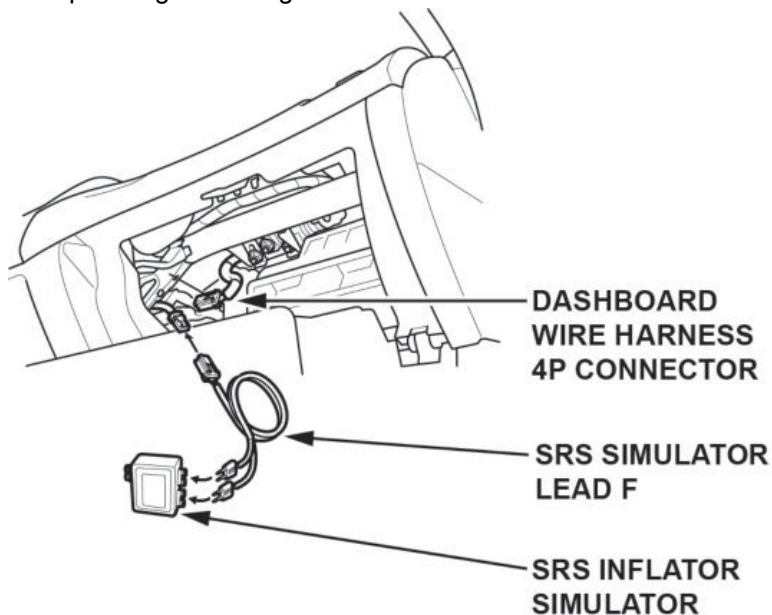
11. Access the front passenger's airbag, and disconnect the dashboard wire harness connector 4P connector from the front passenger's airbag 4P connector.

12. Connect the terminals of SRS simulator lead F to the SRS inflator simulator (2 Ω connectors), then connect SRS simulator lead F to the 4P connector as shown.
13. Reconnect the negative battery cable.
14. Turn the ignition to ON, not ACC, and wait 10 seconds.
15. Check if the SRS DTC listed in step 8 returns.
 - If the same SRS DTC returned, the inflator is OK. The Customer Support Program does not apply. Continue with normal troubleshooting.
 - If the same SRS DTC **did not** return, go to the REPAIR PROCEDURE.

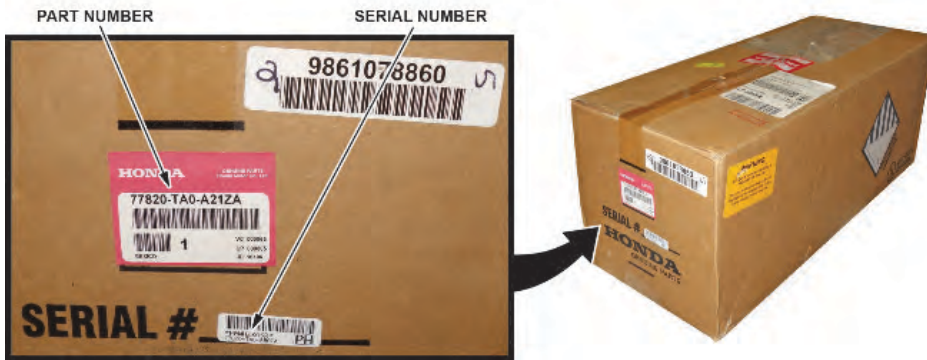
6. Write the serial number and part number from the outside of the airbag module box on the RO.

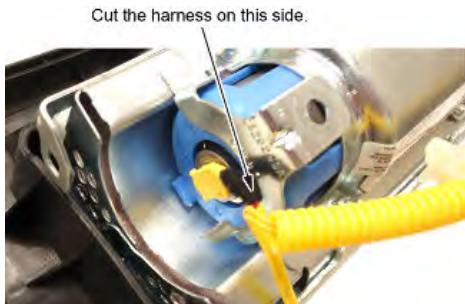
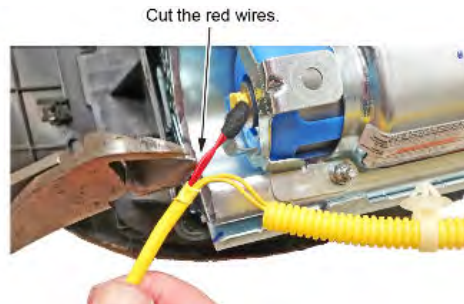
- 3.1. Cut the red wires about 2 inches from the inflator.

There may be some protective tube covering the wires that needs to be cut away to access the wires.

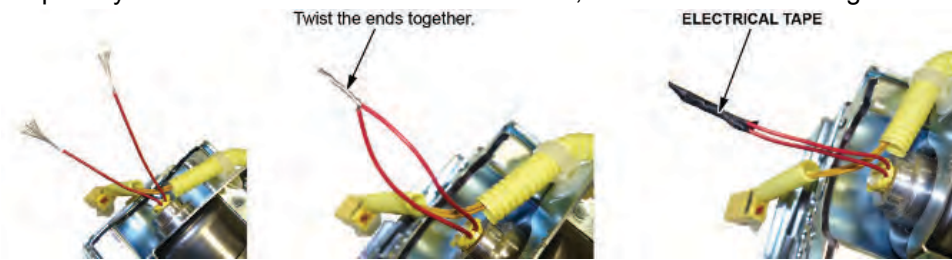
3.2. Strip away about 1 inch of the red wire insulation, then twist the wires together.

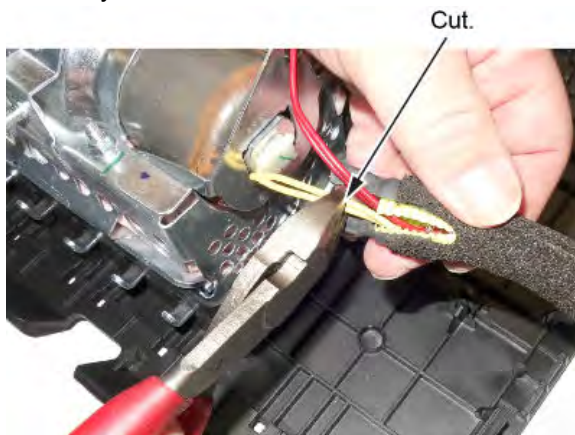
3.4. Cut the yellow wires about 2 inches from the inflator.

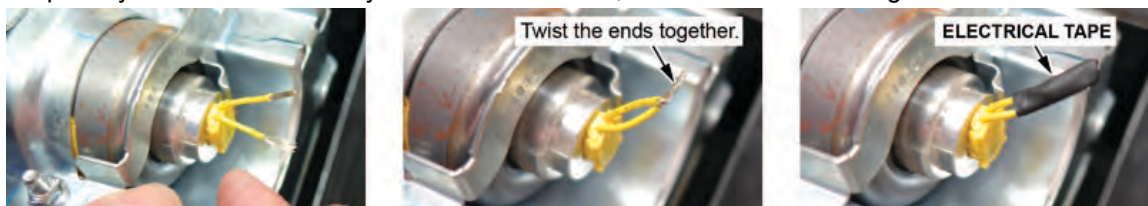
3.5. Strip away about 1 inch of the yellow wire insulation, then twist the wires together.

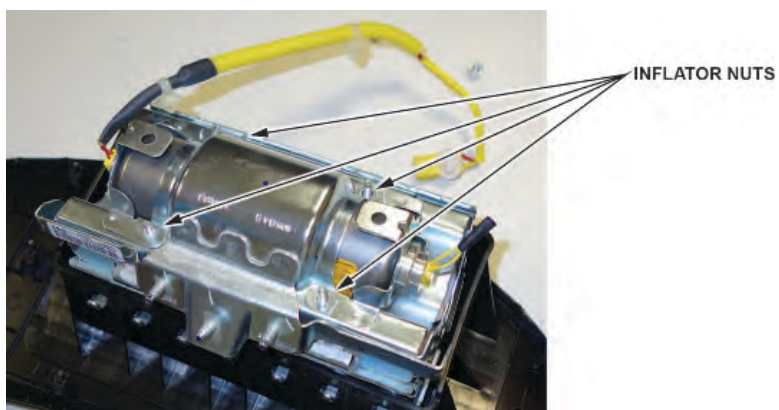
3.7. Remove the four inflator nuts.
