June 7, 2018

Warranty Extension: Customer Support Program For Front Passenger's Airbag Inflator for 2005-06 MDX and 2005-12 RL (Expires January 31, 2027)

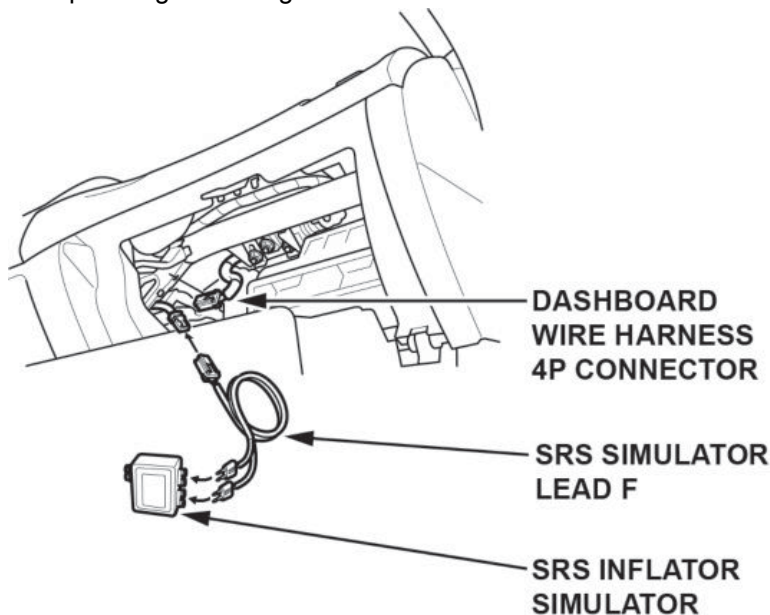
12. Connect the terminals of SRS simulator lead F to the SRS inflator simulator (2 Ω connectors), then connect SRS simulator lead F to the 4P connector as shown.
13. Reconnect the negative battery cable.
14. Turn the ignition to ON, not ACC, and wait 10 seconds.
15. Check if the SRS DTC listed in step 8 returns.
 - If the same SRS DTC returned, the inflator is OK. The Customer Support Program does not apply. Continue with normal troubleshooting.
 - If the same SRS DTC **did not** return, go to the REPAIR PROCEDURE.

11. Access the front passenger's airbag, and disconnect the dashboard wire harness connector 4P connector from the front passenger's airbag 4P connector.

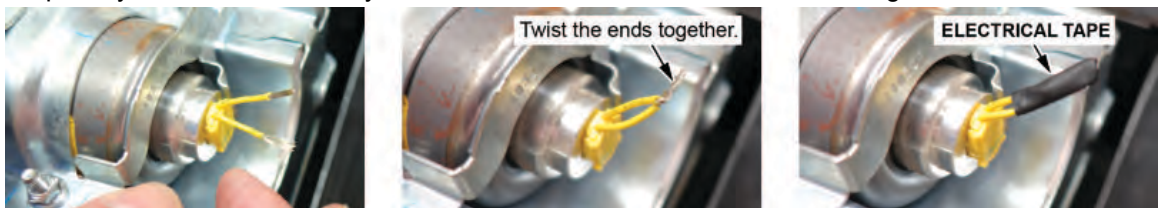
- 3.5. Strip away about 1 inch of the yellow wire insulation, then twist the wires together.
