Volvo Models

Volvo Model VT , VNX , VNL , VNM , VHD , VAH

Title Volvo Chassis - Equipped With An Automated Manual Transmission (AMT, I-Shift)
- Reverse / Back-Up Lights Inoperative, No Diagnostic Trouble Codes (DTC), No Issues With Circuit, Additional Check - **US10 And US13 Emissions, Commonly Model Years 2011 To 2014**

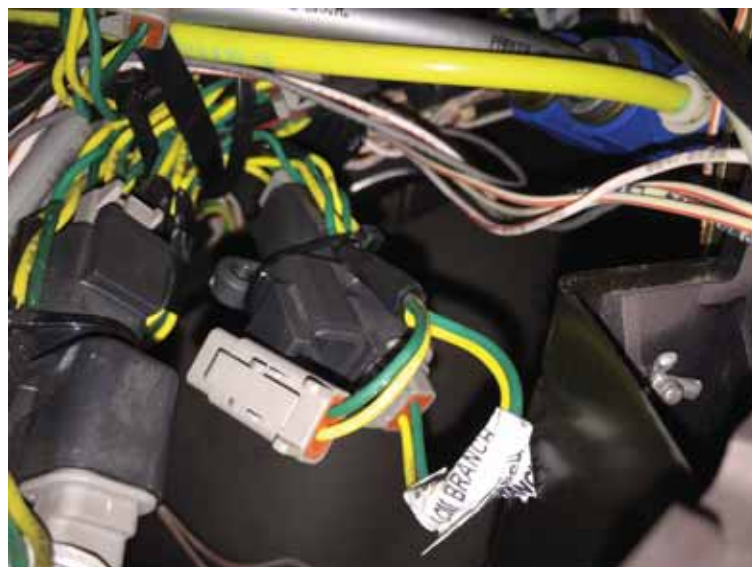
Ensure that all three connections are clean and tight. An example of an unplugged connector is shown below. Note that the example below did not set any fault codes pointing directly to a particular circuit or component and because it was the data link that was unplugged, the reverse light circuit was found free of faults.

Solution If all diagnostic steps for the conditions above lead to No Fault Found (NFF), an additional item to check are the data link connections to the LCM. There are three Tee (3-way) connectors for the J1587 And J1939 data links located in the dash: Two of the connectors supply the LCM and the third leads to another branch.
