09352 Version 10

Warranty Extension: MIL Comes On With DTCs P0301 thru P0304

AFFECTED VEHICLES

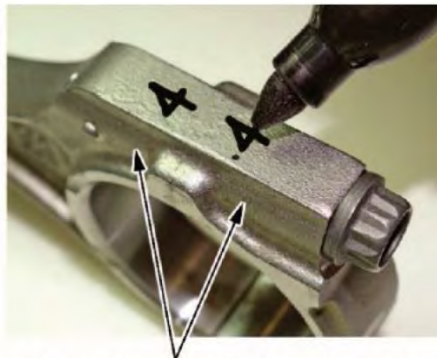
Mark the connecting rod and rod cap with the cylinder number.

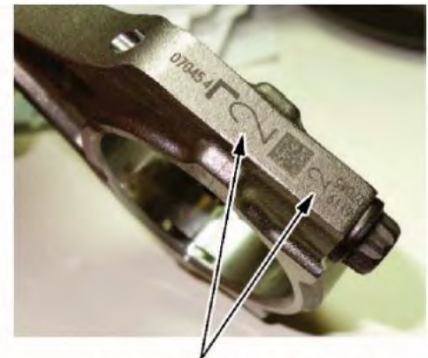
These are manufacturing marks, and do not indicate the cylinder number.

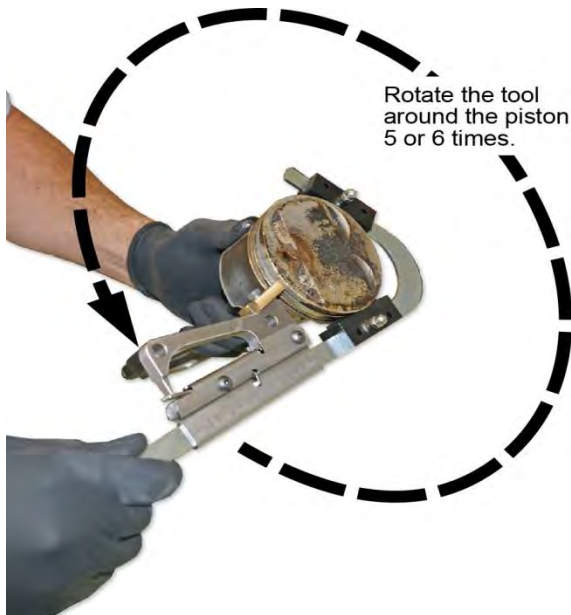
- Hold the piston steady and rotate the tool counter-clockwise five to six times to remove any carbon deposits in the piston ring grooves. **Do not** rotate the tool clockwise.
