**Complaint "Seat Cover Wrinkled" (22/13)**

Revisions: Revision 1 — **This bulletin replaces bulletin dated April 13, 2013.**  
This information is now applicable for all model lines.

Concerns: **Look of the seat cover**

Information: **Work procedure in the event of complaint "Seat cover wrinkled".**

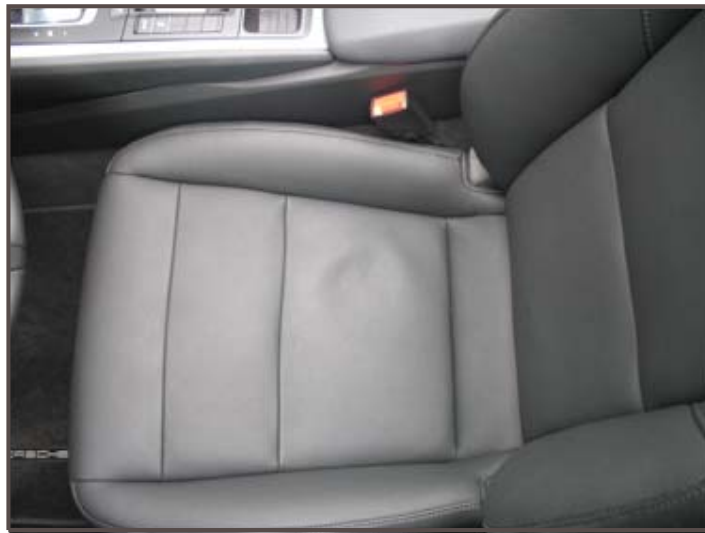
*Figure 1*

If wrinkles or bulges are visible on a seat cover (e.g. ⇒ *Figure 1*), these do not constitute a defect.

**Leather is a natural product** and has so-called "natural characteristics". These characteristics are:

- The larger the upholstered surface, the greater the tendency to crease and bulge.
- **Body heat, perspiration and body weight** cause fabric and leather to **stretch, resulting in "wrinkles"**.

This **visual change is perfectly normal** and does

- **not affect** its use, function or service life
- and **is not a defect**.

⇒ If a visual flaw that is **clearly different** from the "natural characteristics" described here is found, the seat cover must be replaced:

- Sufficient **documentation with corresponding pictures** (clear overview and detailed photos) **must be provided**.
- The **seat cushion is not the cause** of these wrinkles and **must not therefore be replaced**.
