TECHNICAL INSTRUCTIONS
FOR
SPECIAL SERVICE CAMPAIGN JSD
CONTINUOUSLY VARIABLE TRANSAXLE SOFTWARE UPDATE
CERTAIN 2014-2017 TOYOTA Corolla
CERTAIN 2017 TOYOTA Corolla iM
CERTAIN 2016 SCION iM

IV. BACKGROUND

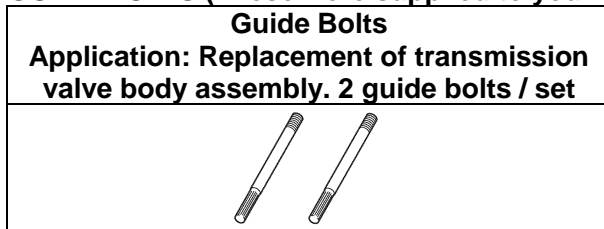
GUIDE BOLTS (These were supplied to your dealership at the launch of JSD)

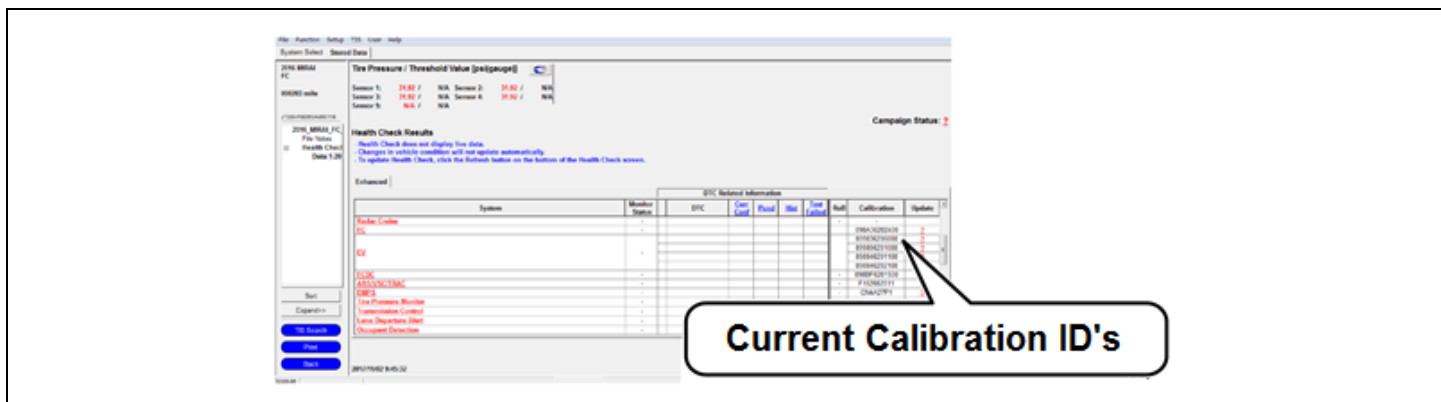
- Identify the Calibration ID for the ECM in the Health Check Results.
- Referencing the table below, verify if the ECM has the updated Calibration.

Vehicle Specification				ECM Calibrations	
Model	MY	Engine	Shift Type	Current CID	New CID
COROLLA	2014	2ZR-FAE	Gate	302Y <u>6000</u>	302Y<u>6500</u>
				302Y <u>6100</u>	
				302Y <u>6200</u>	
				302Y <u>6300</u>	
				302Y <u>6400</u>	
		2ZR-FE	Gate	302W <u>8000</u>	302W<u>8500</u>
				302W <u>8100</u>	
				302W <u>8200</u>	
				302W <u>8300</u>	
				302W <u>8400</u>	
	2015 - 2016	2ZR-FAE	Gate	302Y <u>7000</u>	302Y<u>7500</u>
				302Y <u>7100</u>	
				302Y <u>7200</u>	
				302Y <u>7300</u>	
				302Y <u>7400</u>	
2015 - 2016	2ZR-FAE	Gate	302U <u>1000</u>	302U<u>1300</u>	
			302U <u>1100</u>		
	2ZR-FE	Gate	302U <u>1200</u>		
			30Z5 <u>8000</u>	30Z5<u>8300</u>	
30Z5 <u>8100</u>

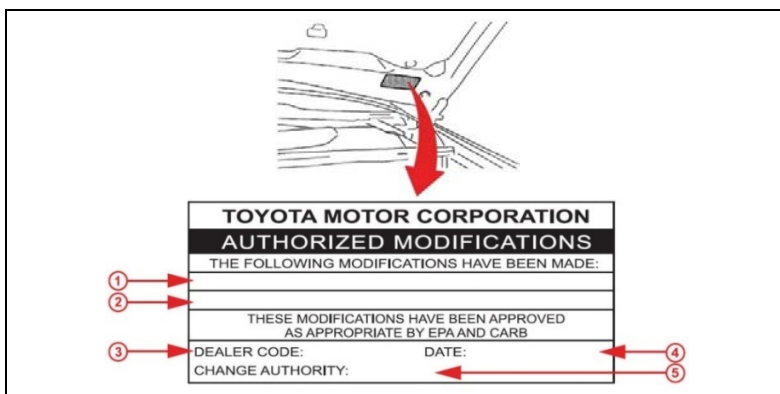
- a. Fill out the label.
- b. Affix the label to the under-side of the hood.

1	ECM P/N
2	New Calibration ID
3	Dealer Code
4	Date Completed
5	Campaign Code (XXX)

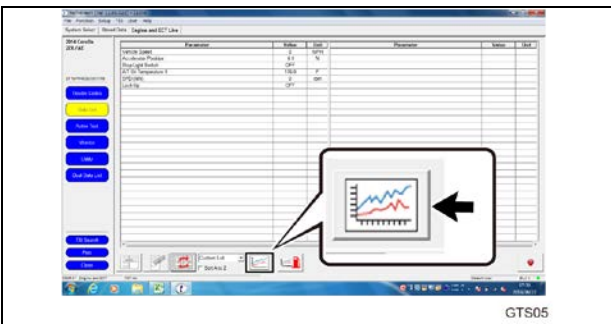
e) Click the "Graph" button to represent the data in charts.

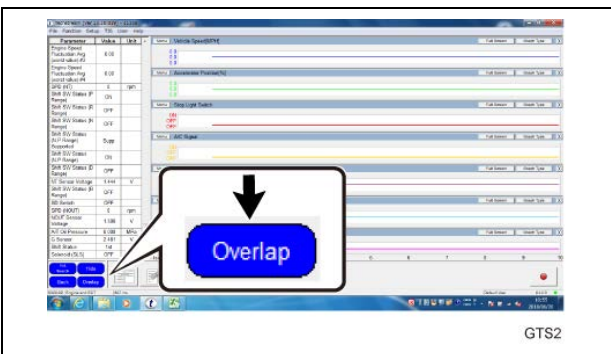
f) Double click on the PID's listed to the left to make the graphs display

g) Click the "Overlap" button.

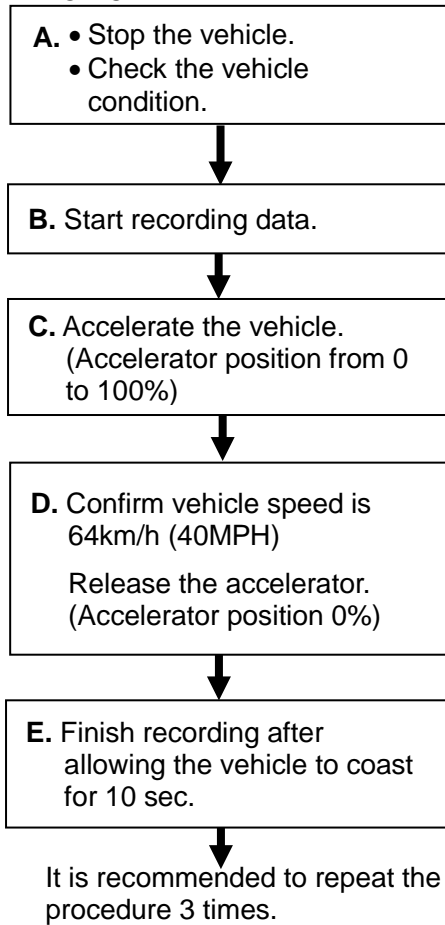
< FLOWCHART >

- Confirm A/C ON.
- Confirm 0km/h (0MPH).
- A/T Oil Temperature is higher than 40°C (104°F).
- Confirm that the Techstream displays the required data items.
 - (1) Vehicle Speed
 - (2) Accelerator Position
 - (3) Stop light Switch
 - (4) A/T Oil Temperature 1
 - (5) SPD (NIN)
 - (6) Lock Up

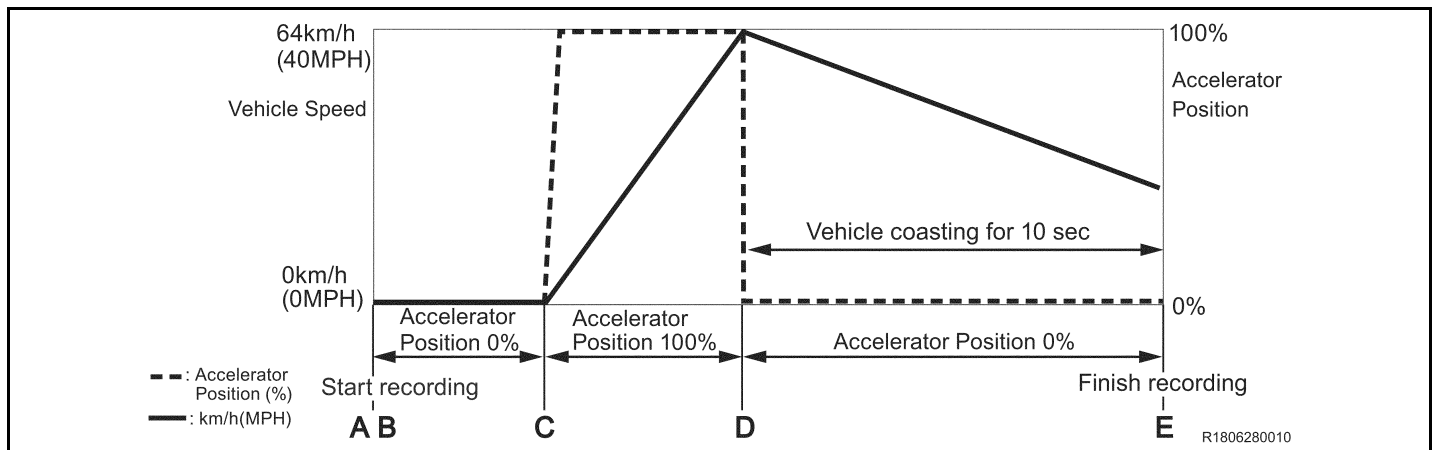
- f) With the vehicle stopped, fully depress the accelerator pedal (wide open throttle) so that the accelerator position becomes 100 % and accelerate the vehicle to 40MPH (64 km/h),
- g) Once you achieve 40MPH fully release the accelerator pedal (foot off gas pedal) and allow the vehicle to coast for more than 10 seconds.

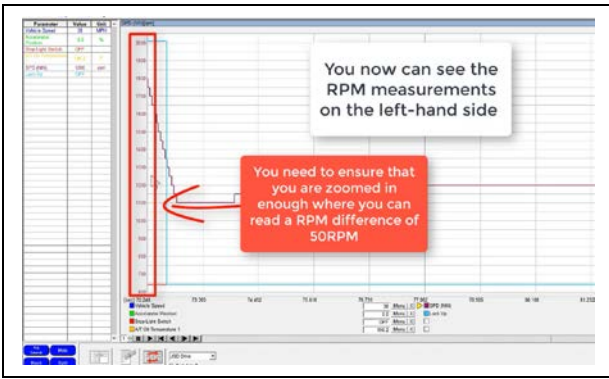
- g) You can now inspect the difference in RPM using the scale to the left.
- h) Check and make sure you have selected the SPD (NIN) PID on the bottom of the screen so the scale on the left is correct

Standard Good Value : The RPM difference is less than 250 rpm in the inspection range.

Judgment	Check Result	To do
OK	<p>RPM difference is less than 250 rpm.</p>	<p>CAMPAIGN COMPLETE Return the vehicle to the customer</p>
NG	<p>RPM difference is greater than or equal to 250 rpm even at one place.</p>	<p>Valve body assembly replacement is required.</p> <p>Go to next page and follow the instructions on how to release the parts for valve body replacement</p>

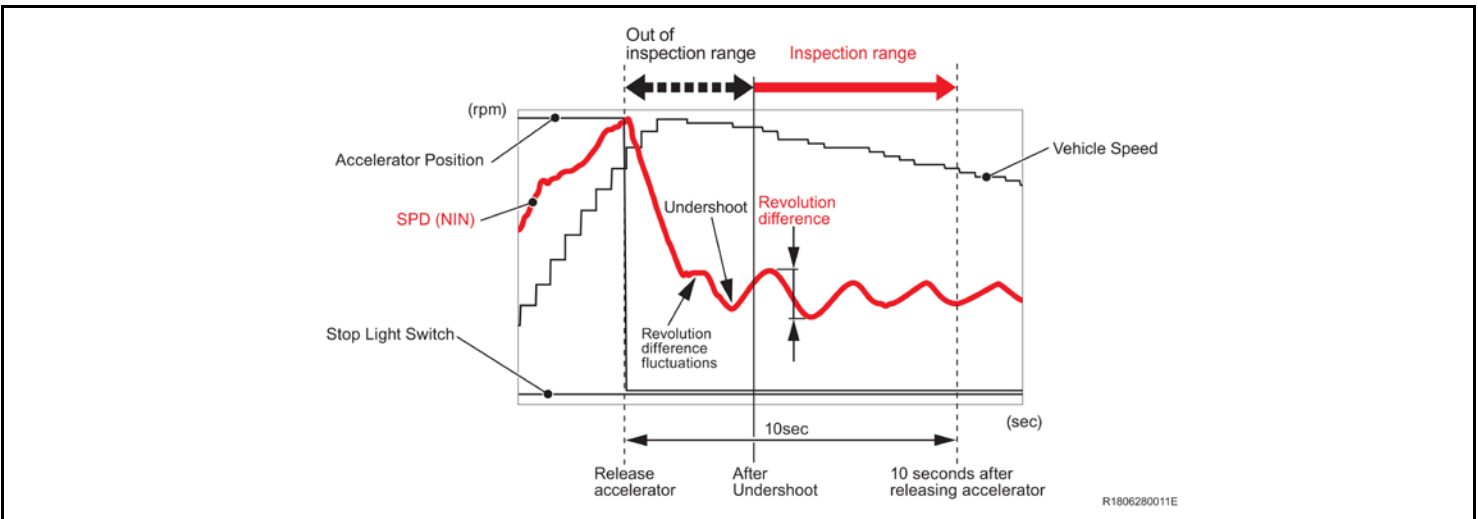
- Confirm that a scale of SPD (NIN) represents 50 rpm.
- The recorded time of the data can be checked at (sec) on the graph.

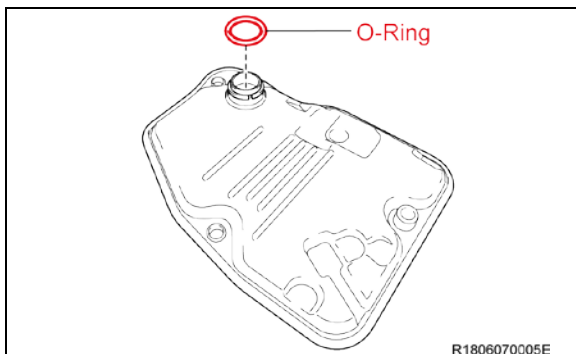
17. REMOVE THE OIL STRAINER

- a) Unscrew 3 bolts and remove the oil strainer from the transmission valve body assembly.

Additional fluid will flow out when removing the oil strainer.

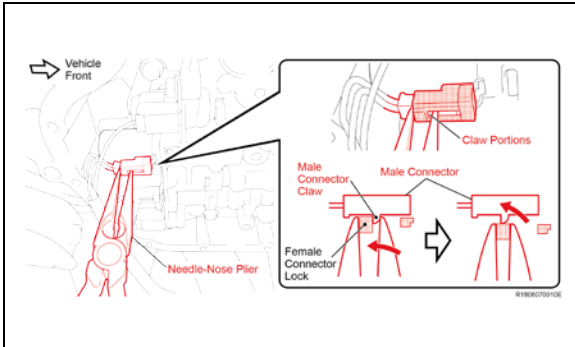
18. REMOVE THE TRANSMISSION HARNESS

- a) Disconnect 5 connectors of transmission harness from the transmission valve body assembly.

- (1) To remove the connector, apply the needle-nose plier end to the male connector tab.
- (2) Gently hold the needle-nose plier and then push the male connector tab out.

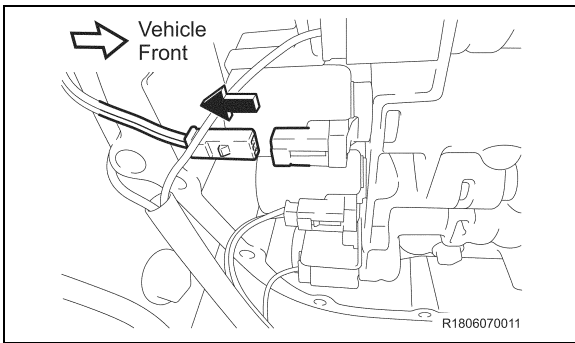
- (3) Pull out the male connector.

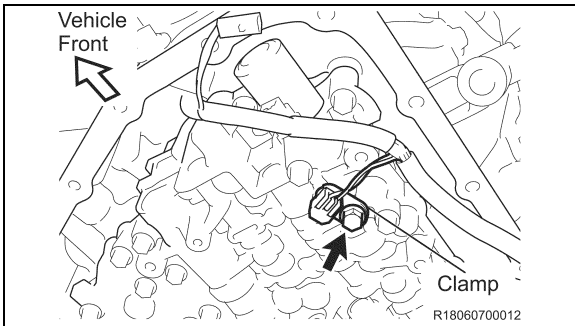
- d) Remove the O-ring from the oil temperature sensor.
- e) Break the removed O-ring and store it in a replacement part box etc.

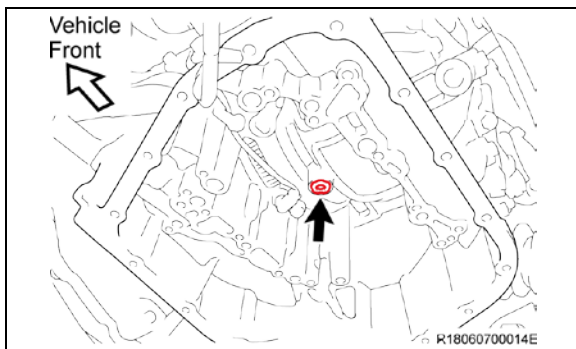
- c) Remove transaxle case gasket from the transmission case.

- d) Break the removed gasket and store it in a replacement part box etc.

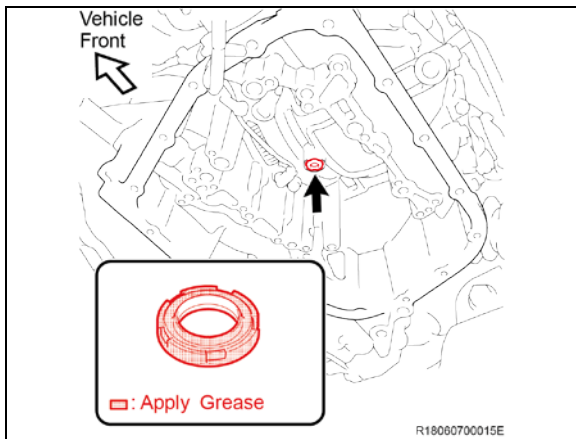
1. INSTALL THE TRANSMISSION VALVE BODY ASSEMBLY
 - a) Apply a small amount of Toyota genuine MP grease No.2 to the **NEW** transaxle case gasket.
 - b) Install the gasket to the transmission case.

NOTE:
Transaxle case gasket is non-directional.

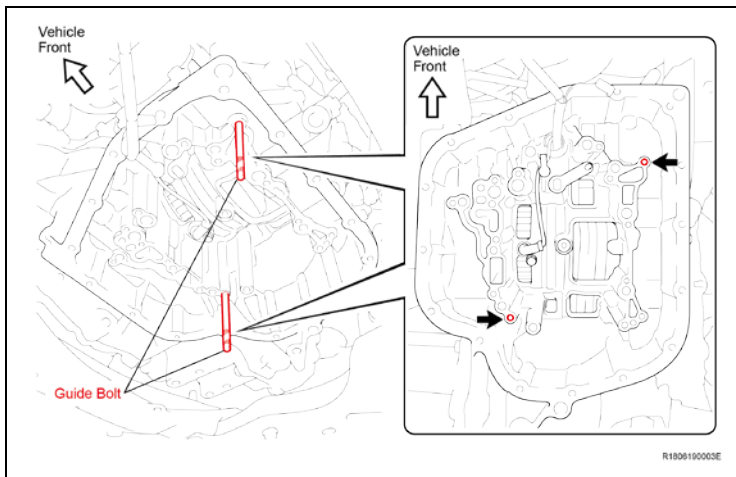
- c) Install the 2 guide bolts at the positions shown in the illustration.

Make sure to use the guide bolts, since the valve body may slide and cause the transaxle case gasket to fall off.

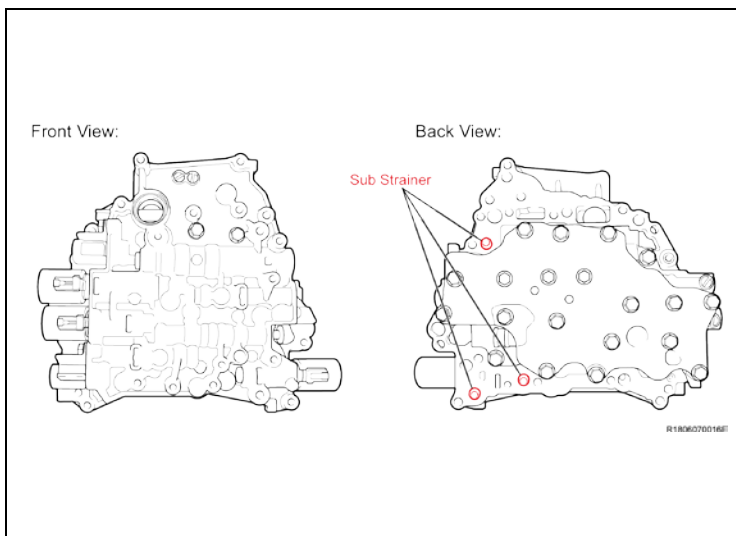
- When installing the **NEW** transmission valve body assembly, fit it into the transmission case carefully as to **NOT** damage the top of the sub strainers that are positioned at the back of the transmission valve body assembly.
- When installing the **NEW** transmission valve body assembly, hold the transmission valve body assembly horizontally to prevent the manual valve from falling off.

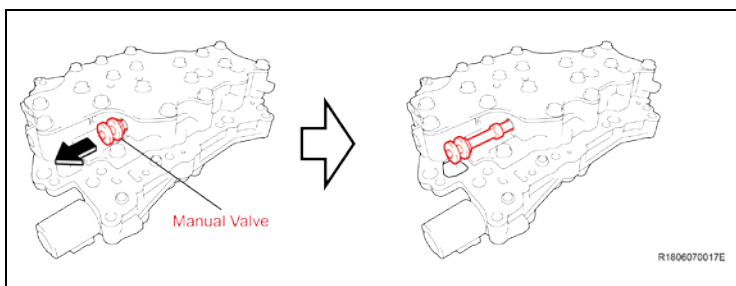
- d) Pull out the manual valve as shown in the illustration.

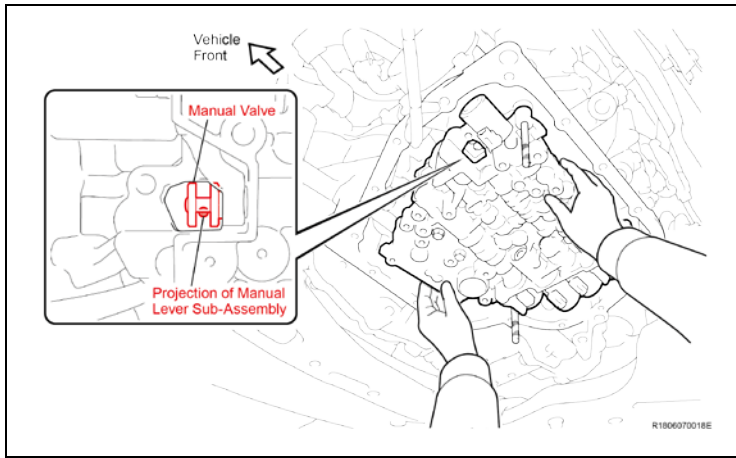
- e) Match the position of the holes of the **NEW** transmission valve body assembly to the guide bolts and hold the valve body assembly in place.
- f) Ensure that the projection of the manual valve lever sub-assembly and the groove of the manual valve are matching as shown.

If the projection is not matching the groove, relocate the manual valve.

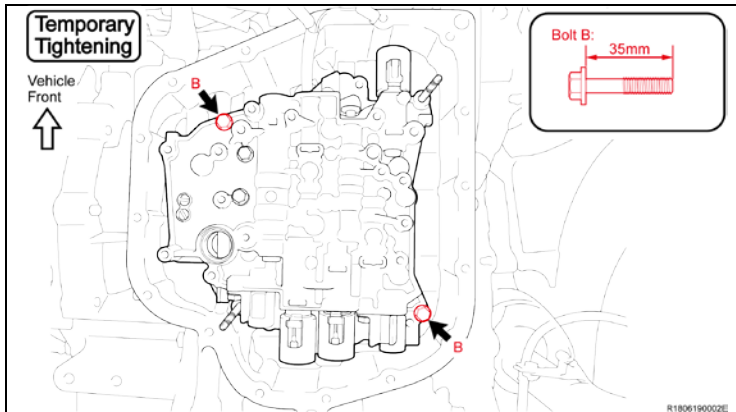
- g) Push to install the **NEW** transmission valve body assembly to the transmission case and hold it in place.
- h) Holding the transmission valve body assembly, install the 2 bolts (35 mm in length) to position B.

STOP Make sure to start torquing from the 2 bolts shown in the illustration, since they will be the installation position standard.

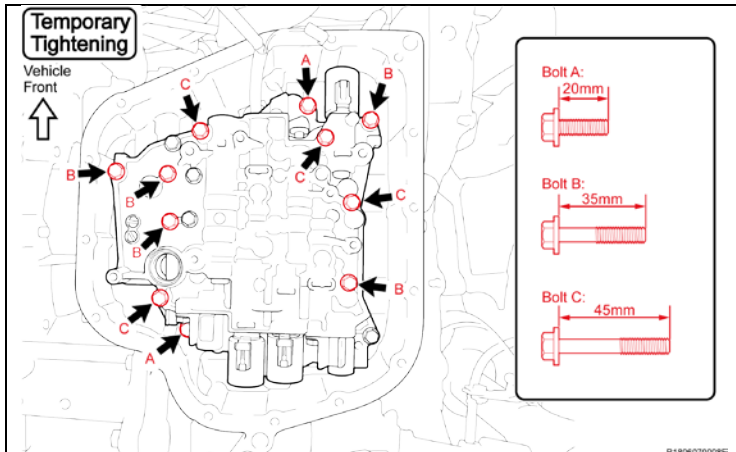
- i) Temporarily tighten the bolts manually until they sit properly on the transmission valve body assembly.
- j) Remove the 2 guide bolts.
- k) Temporarily tighten the remaining 11 bolts manually until they sit properly.

Bolt A: (2) 20mm in length
Bolt B: (5) 35mm in length
Bolt C: (4) 45mm in length

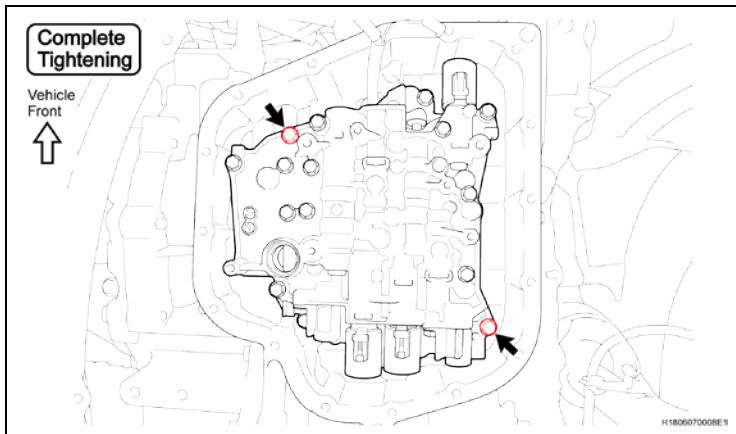
- l) Tighten the 2 bolts.
Torque: 10.8 N*m (110 kgf*cm, 8 ft.*lbf)
- m) Every time one of the bolts is complete-tightened, clean the bolt head and put a yellow paint mark

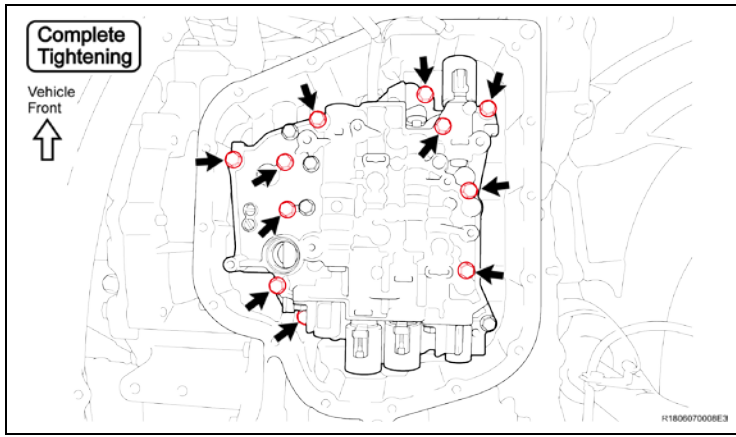
n) Tighten the other 11 bolts evenly.
Torque: 10.8 N*m (110 kgf*cm, 8 ft.*lbf)

o) Every time one of the bolts is completely tightened, clean the bolt head and put a yellow paint mark.

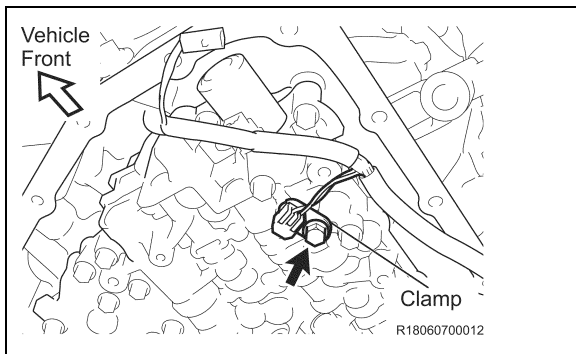
20. REINSTALL THE TRANSMISSION HARNESS

a) Apply Toyota genuine CVT fluid to **NEW** O-ring and fit it to the oil temperature sensor.

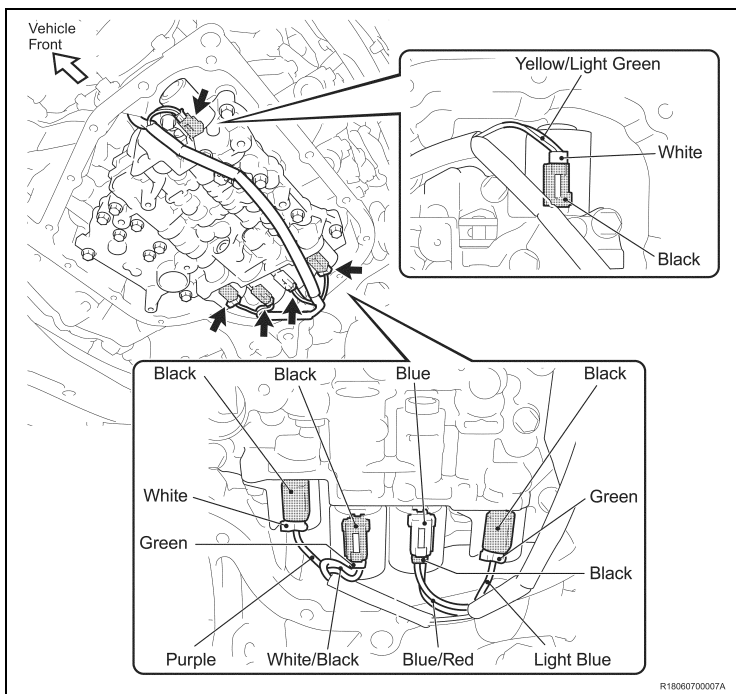
d) Reconnect the 5 connectors and install the transmission harness to the transmission valve.

Make sure to install the connector to the position shown in the illustration. If the installation position is mistaken, the CVT assembly may malfunction or need to be replaced.

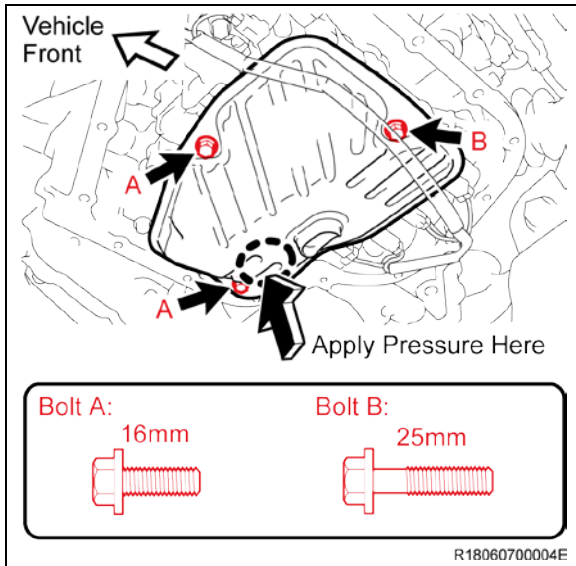
22. REINSTALL THE OIL STRAINER

- a) Apply Toyota genuine CVT fluid to the **NEW** O-ring and then fit it into the oil strainer.

- b) Tighten the 3 bolts evenly, temporarily reinstall the oil strainer to the transmission valve body assembly.

Bolt A: (2) 16mm in length

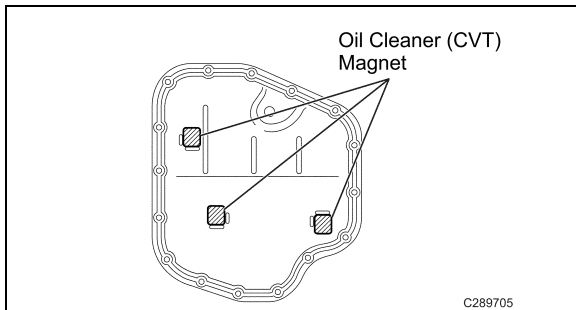
23. REINSTALL THE TRANSAXLE OIL (CVT) PAN SUB-ASSEMBLY

- a) Remove the 3 oil cleaner (CVT) magnets from the transaxle oil (CVT) pan sub-assembly.
- b) Clean off any metal particles adhered to the 3 oil cleaner (CVT) magnets.
- c) Clean the transaxle oil (CVT) pan sub-assembly and remove any metal particles, sludge, etc.

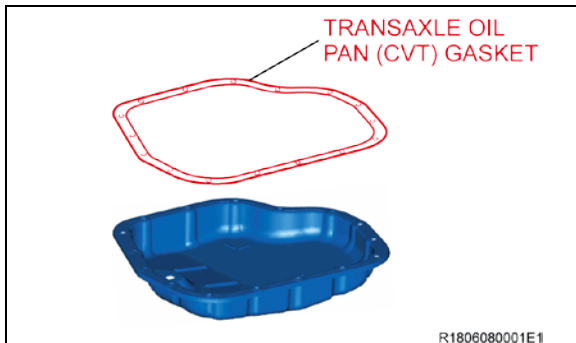
- d) Install the **NEW** transaxle oil pan (CVT) gasket.

Clean the mating surfaces of the transaxle oil (CVT) pan sub-assembly and the transmission case with wipes to remove grease, moisture and/or dirt (DO NOT use brake cleaner).

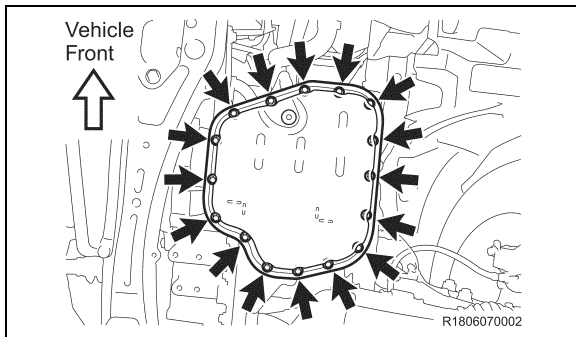
- f) Tighten the 16 bolts.

Torque: 7.8 N*m (80 kgf*cm, 69 in.*lbf)
