TECHNICAL INFORMATION

Bulletin #	Date	Page
MAS001643	05/09/2018	1/2

MODEL: Maserati Levante MY17

SUBJECT: Note on the hydraulic steering rack replacement

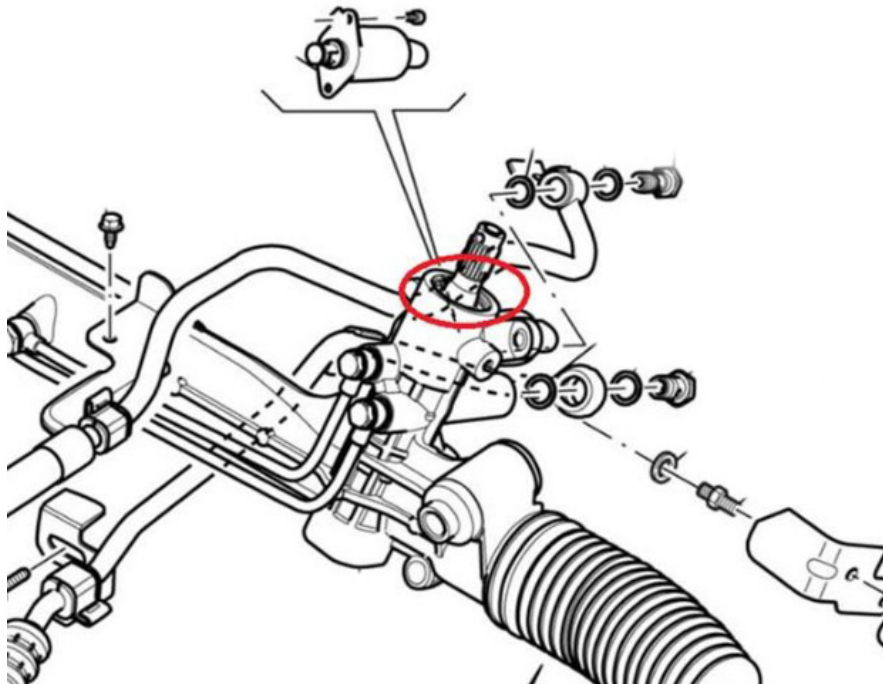
In case of hydraulic steering rack replacement on Maserati Levante MY17 vehicles, in order to avoid future noise phenomenon, it is mandatory to follow the steps hereby reported (see Technical Documentation for the complete replacement procedure):

- Blow the highlighted area with compressed air
- Clean it with specific products such as heptane (or other similar products, for use permitted by current environmental protection regulations)
- Apply a protective waxy such as “Tectyl 4D750” or “Efcoat 964” (About thicknesses and times, follow what indicated from the supplier's data sheet)
