N20, N26, N55, N63TU, S63TU and S55 Engines: Bosch Injector ETK Part Number Error

This Service Information bulletin replaces **SI B13 03 15 dated February 2016**

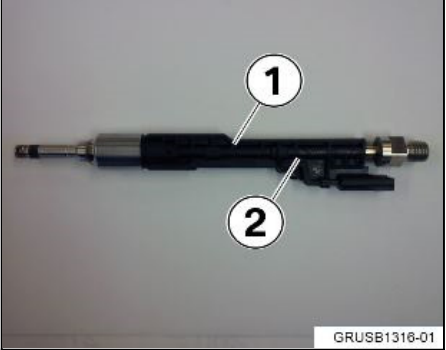
| | <p>Bosch injector with black plastic housing (1). Injector part number location (2).</p> |

1. Identify the currently installed injector part number using a borescope.
2. Enter that injector part number into Atlas and order the quantity needed to repair the vehicle. Supersessions in Atlas are correct.

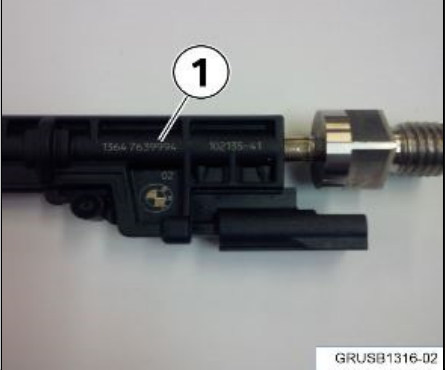
| | <p>Injector part number location (1).</p> |
