**SUBJECT****Diagnosis of Compound Brake System Complaints in M Vehicles**

**This Service Information bulletin supersedes SI 34 04 14 dated December 2014.**

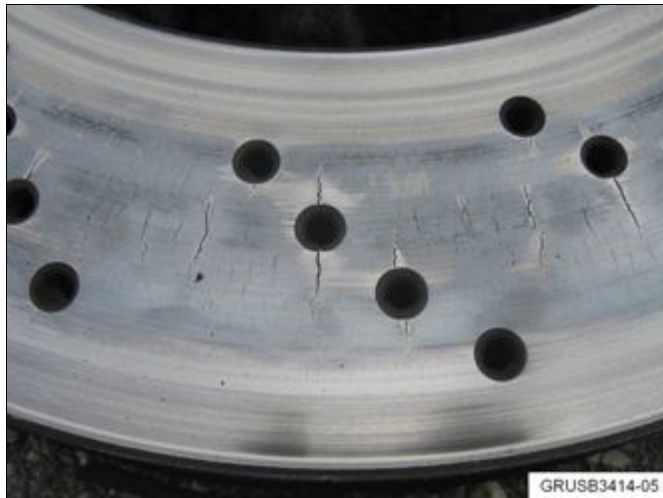
<ol style="list-style-type: none"> <li>1. Visible cracks are caused by high thermal stresses during rapid heating and cooling of the brake discs. Braking from high speed with cold brake components (less than 212 degrees F) increases the likelihood of cracks to form. These surface hairline cracks are usually spread over the entire brake disc friction area, and have no negative influence on the durability or braking performance. The rotors should not be replaced only for their appearance reasons.</li> </ol>
--	--

When performing routine service on the brake system (pad replacement due to wear), the brake discs should be replaced if surface cracks are found to be greater than 13 mm, or if the brake disc thickness is below the minimum thickness.

Always replace brake discs in pairs (per axle). Install new brake pads when replacing discs. By doing this, the service life of the friction pad surface is increased, and an even material loss is ensured.

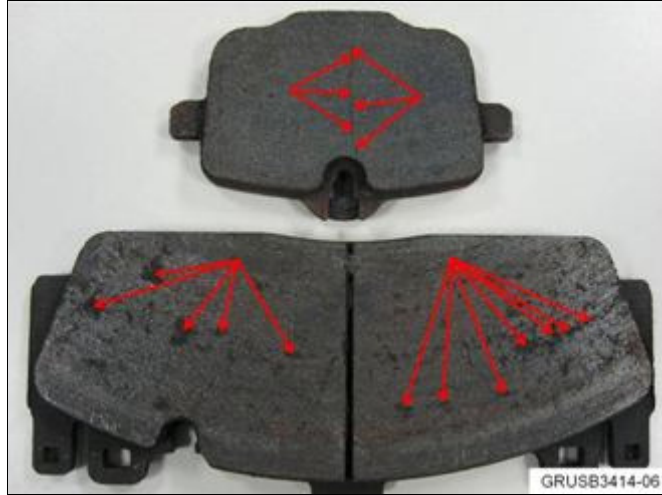
Visible surface cracks or crater-like recesses on the brake pad surface are caused by a minor difference in the material of the pad lining, which will decrease with further operation and should not be replaced due to their appearance.

These noises are reduced during normal everyday operation, due to further erosion of the brake pad friction lining.
