| Title | Inspection and Return: Brake Rotor - PN 04779884AC | | | |

Quality Inspection Request 04779884AC – Brake Rotor Correct and Suspect Part Identification

Wrong Part in the package – PN: 04779884AC

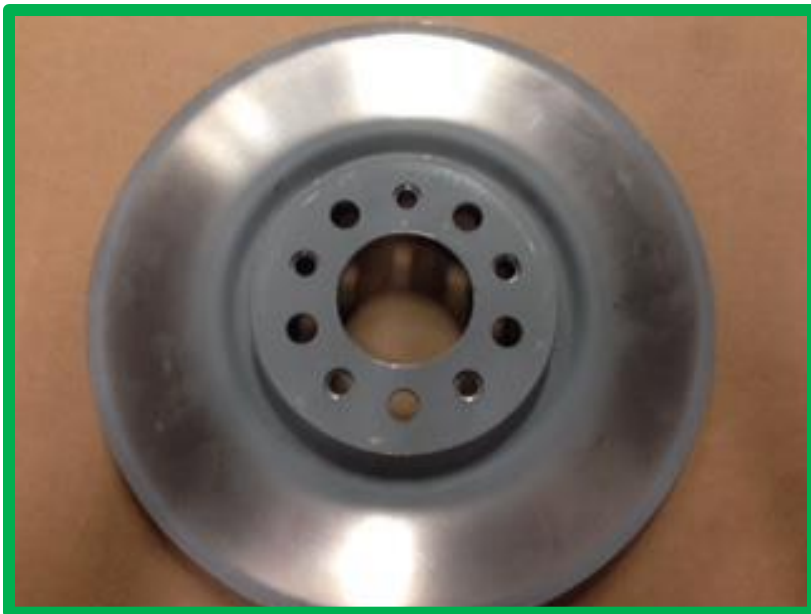
Correct Part Identification

Correct and Suspect parts can be identified by holes.

Correct part will have 10 holes.

| Message | <p>You have been identified as either having stock, or have stock in transit to your dealership.</p> <p>Reports of dealers receiving unidentified rotors packaged as 04779884AC. Suspect parts have packaging date code of 07/19/2015 to 7/26/2015.</p> <p>Correct and suspect parts can be identified visually by using pictures attached to the D-Mail.</p> <p>Please inspect stock and return suspect parts back to your facing depot using Return Code 02, before 8th September, 2015.</p> <p>Direct all questions via email to MOPARQC@fcagroup.com</p> | | | |

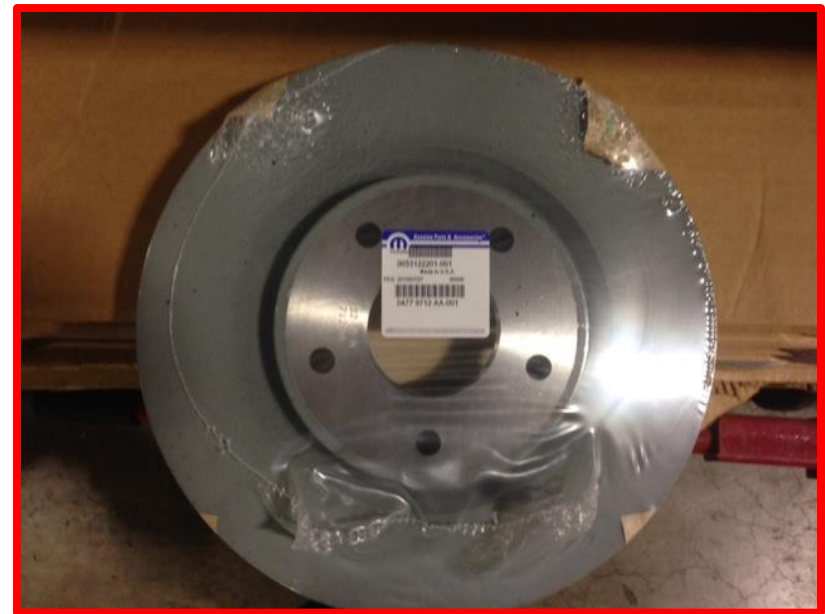
Suspect Part Identification

Suspect part will have 5 holes.
