## Quality Inspection Request 52121050AA – Brake Rotor Correct and Suspect Part Identification

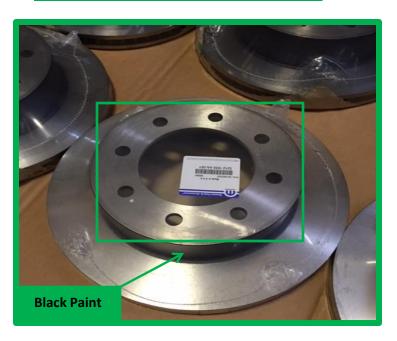
## **Correct Part Identification**

Correct part has 8 Bolted holes, black paint on top hat and vented brake plate on the rotor.

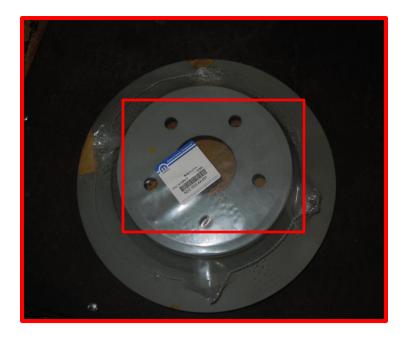
## **Suspect Part Identification**

Suspect parts have packaging date code of 2015/05/12.

Suspect part has 5 bolted holes on the rotor.
