# Technical Service Bulletin

## 90K2 UPDATE – Correction for Service Interval (NVLW)

September 8, 2018

Model(s)	Year	VIN Range	Vehicle-Specific Equipment
Q5 A4 Sedan A4 allroad A5 / S5 Coupe A5 / S5 Sportback	2016-2018	See ELSA	See ELSA

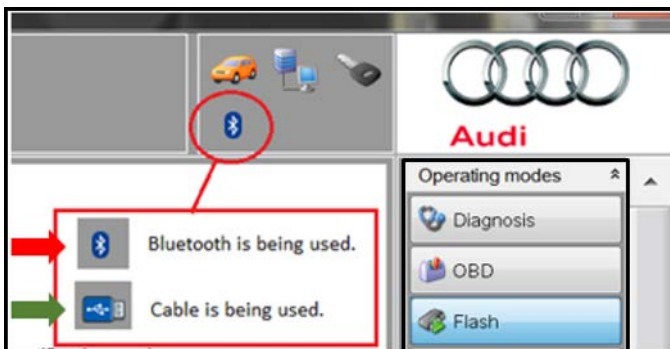
Confirm that the scan tool is communicating with the diagnostic head by USB <Green Arrow>. If the Bluetooth symbol is shown <Red Arrow> then disconnect the diagnostic head from the vehicle and then reattach the USB cable to the diagnostic head and then reattach to the vehicle.

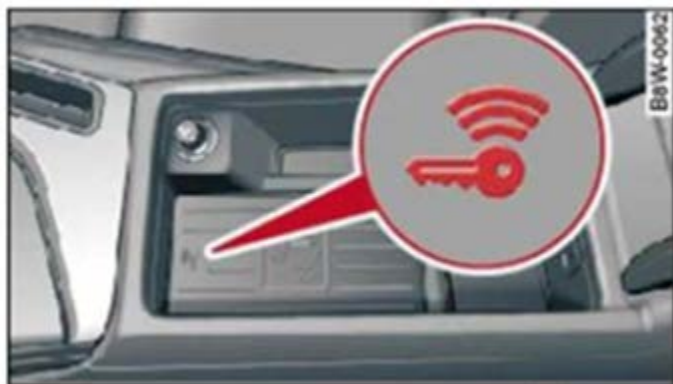
- Ensure the vehicle key is placed on the key symbol (reader coil) in the center console storage compartment and left there during the entire update process.

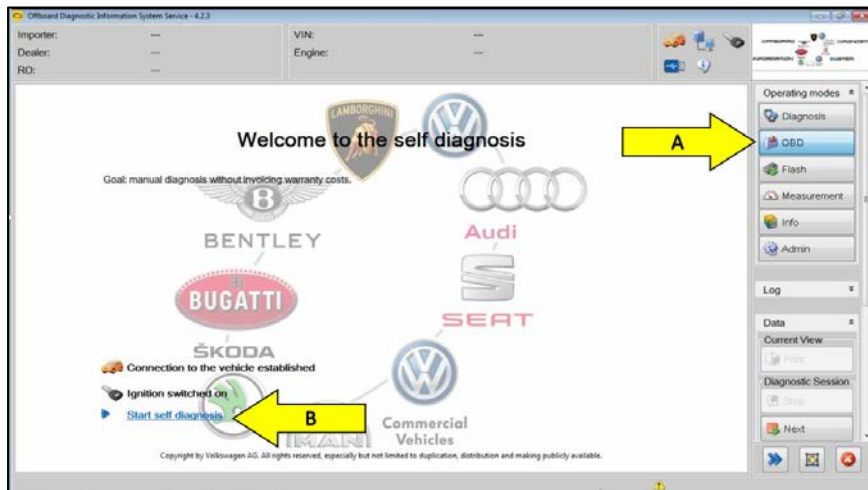
- From the ODIS home screen, highlight “OBd” <arrow A>.
- Select “Start self diagnosis” <arrow B>.
