Faded white stains on canvas

Topic number	LI77.31-P-068900
Version	1
Function group	77.31 Soft top canvas
Date	10-12-2018
Validity	E Cabrio (A238) with less than 1000 miles C Cabrio (A205) with less than 1000 miles
Reason for change	
Reason for block

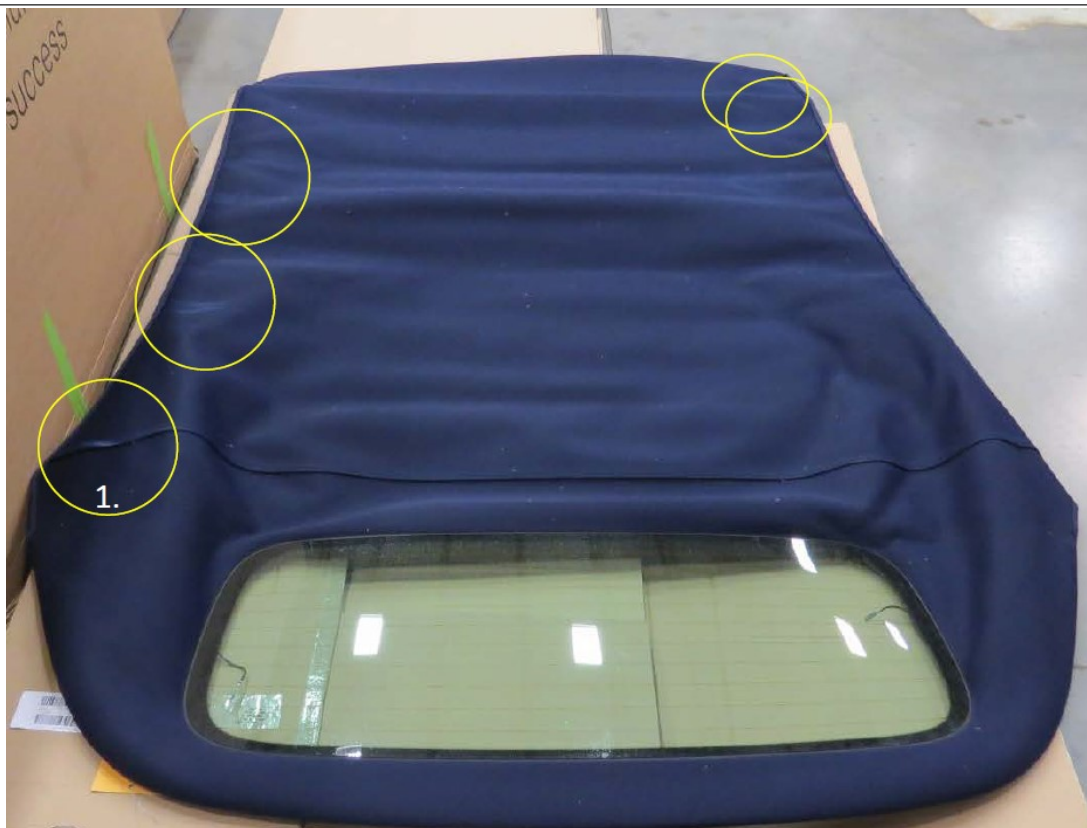
Overall view.jpg:

White faded stains located on canvas

Protective tarp used for shipping may have stained the canvas

NOTE: Stains on the canvas are typically due to external influences. Be sure that stain matches profile shown in the attachments.

1. Clean the canvas with a high pressure cleaner
2. Clean the surface with MB Canvas Cleaner (A001986337110). Use slightly warm water and brush in the direction of the fibers
3. Go through a car wash
4. Only to be performed if previous measures failed: Replace canvas
