SERVICE ACTION: CHECK CHARGING OF THE HIGH VOLTAGE BATTERY

F15 PHEV (X5)

This Service Action involves F15 PHEV (X5) vehicles produced from September 23rd, 2015 to September 30th, 2016.

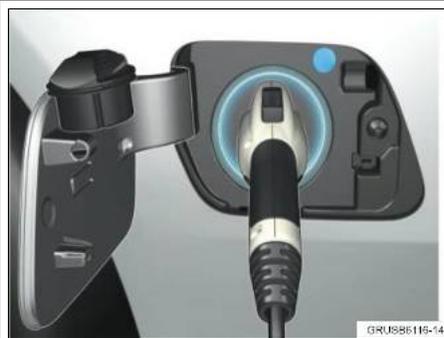
1. Connect Level 2 (220V) charging cable to the vehicle.

Wait 15 seconds until the "Charging Active" blue light is illuminated.

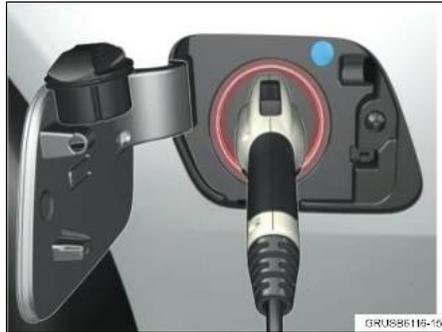
2. **Repeat this step 20 times. Was “Charging Active” indicated in every (all 20) charging cycle attempt?**

3. If the charging port indicator light flashes red (“Charging error”), connect vehicle to ISTA diagnostics and read vehicle’s fault memory.

4. The KLE charging electronics module needs to be replaced. Follow the ISTA RA61 44 502 repair instruction (Removing and installing/replacing the KLE)
