Seat belt extender toothed rack sluggish or makes noises

Topic number	LI91.45-P-066075
Version	2
Function group	91.45 Seat belt extenders
Date	07-23-2018
Validity	C205, A205, C238, A238
Reason for change	Symptom added; damage code updated
Reason for block

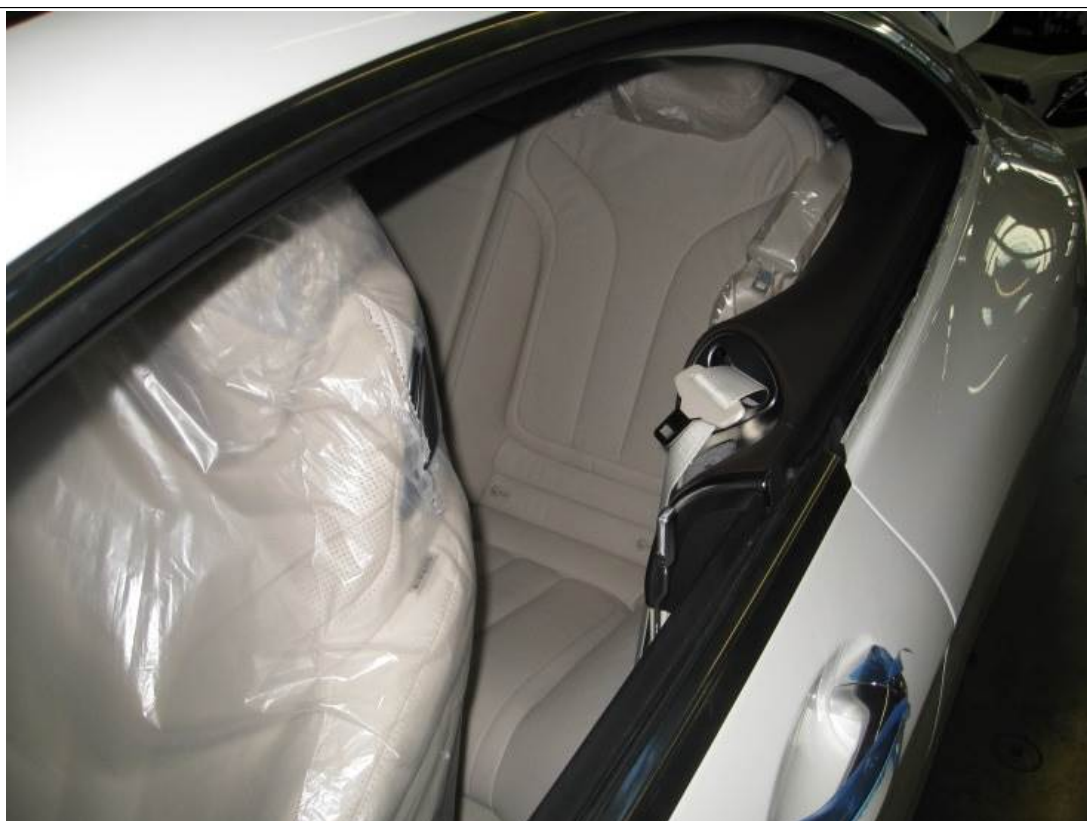
Picture 1.jpg:

Attachments	
File	Description
Picture 1.jpg	Window, door, seat
Picture 2.jpg	Remove seat belt extender
Picture 3.jpg	Retract seat belt extender
Picture 4.jpg	L/R seat belt extender

1. Completely open side window (Picture 1)
2. Extend seat belt extender toothed rack electrically or pull it out manually
3. Grip seat belt extender toothed rack and pull out (Picture 2)

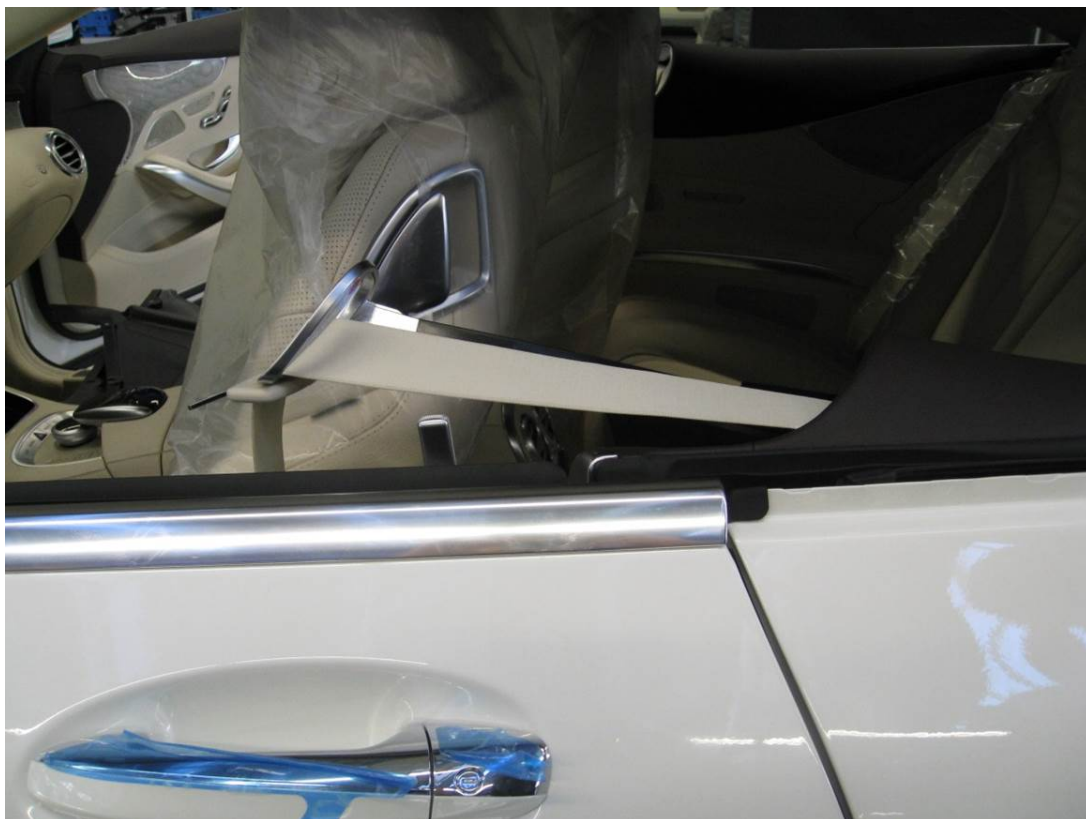
Picture 3.jpg:

When pulling out, the seat belt extender may only be gripped in the specified area (red circle in Picture 3).

4. Push in seat belt extender toothed rack carefully and without sudden movements until the first teeth mesh. The seat belt extender toothed rack can then be retracted automatically. (Picture 3)
