Warranty Extension: MIL Comes On With DTCs P0301 thru P0304

Supersedes 13-082, dated June 13, 2018, to revise the information highlighted in **yellow**.

AFFECTED VEHICLES

Year	Model	Trim	VIN Range
2009-13	Pilot	ALL	Check the iN VIN status for eligibility.

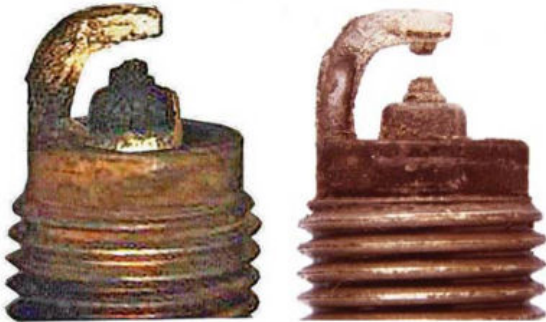
2. Remove and check the spark plug(s) on the affected cylinders (example: if P0301 is stored, check the spark plug on cylinder No. 1).

Are the spark plug(s) fouled?

GOOD

NO GOOD
