Warranty Extension: Customer Support Program For Front Passenger's Airbag Inflator for 2010-12 RL (Expires September 30, 2028)

This bulletin is a notification of a class action settlement relating to airbag inflators. American Honda is offering a Customer Support Program (Warranty Extension) to cover any manufacturing defects in the replacement front passenger's airbag inflator only.

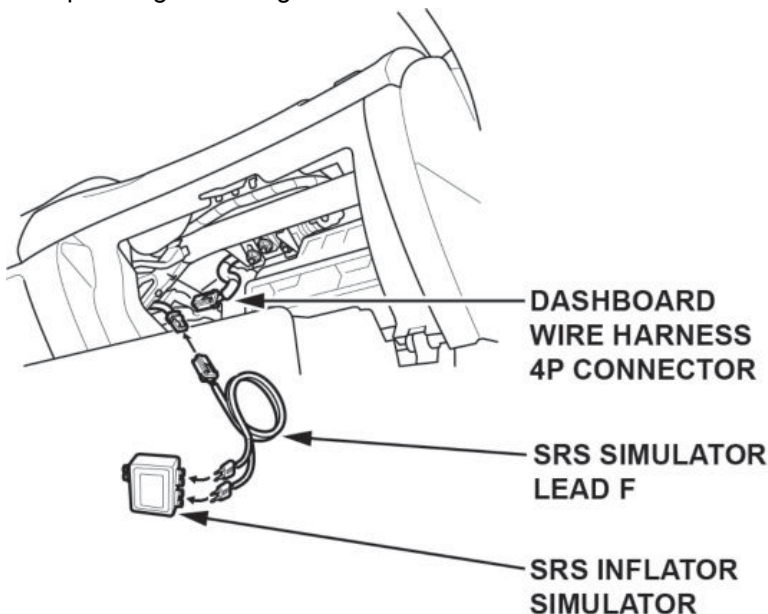
11. Access the front passenger's airbag, and disconnect the dashboard wire harness connector 4P connector from the front passenger's airbag 4P connector.

12. Connect the terminals of SRS simulator lead F to the SRS inflator simulator (2 Ω connectors), then connect SRS simulator lead F to the 4P connector as shown.
13. Reconnect the negative battery cable.
14. Turn the ignition to ON, not ACC, and wait 10 seconds.
15. Check if the SRS DTC listed in step 8 returns.

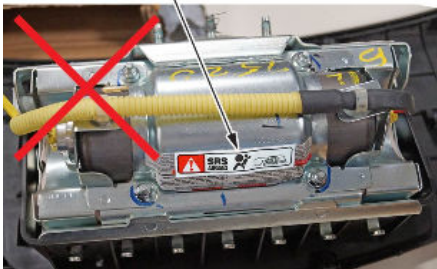
NON-STANDARD SAFETY LABEL

- If there are any unusual markings, like an incorrect label or a model year written in marker, the airbag module and inflator may not be the correct airbag module and/or inflator for the vehicle or it may be a counterfeit part. For more information about counterfeit airbags, you can refer to *safercar.gov*, enter keywords **MANAGING COUNTERFEIT**, and select **Recommended Dealer Guidance for Managing Counterfeit Air Bags** from the list. **If you suspect that the airbag module or inflator is counterfeit, do not continue this procedure.** Contact your DPSM for assistance.

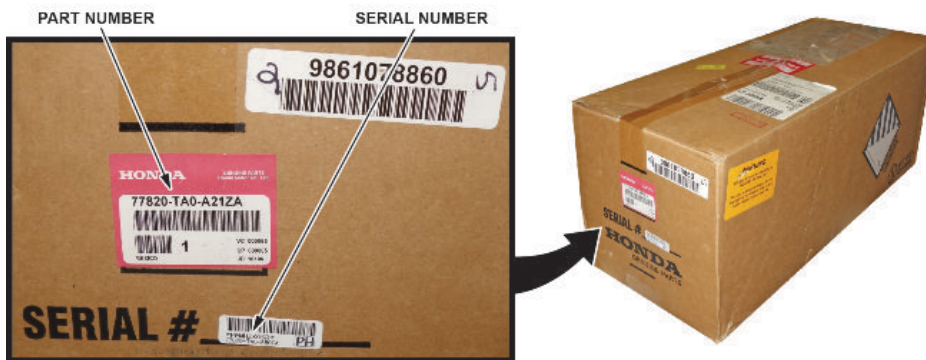
6. Write the serial number and part number from the outside of the airbag module box on the RO.

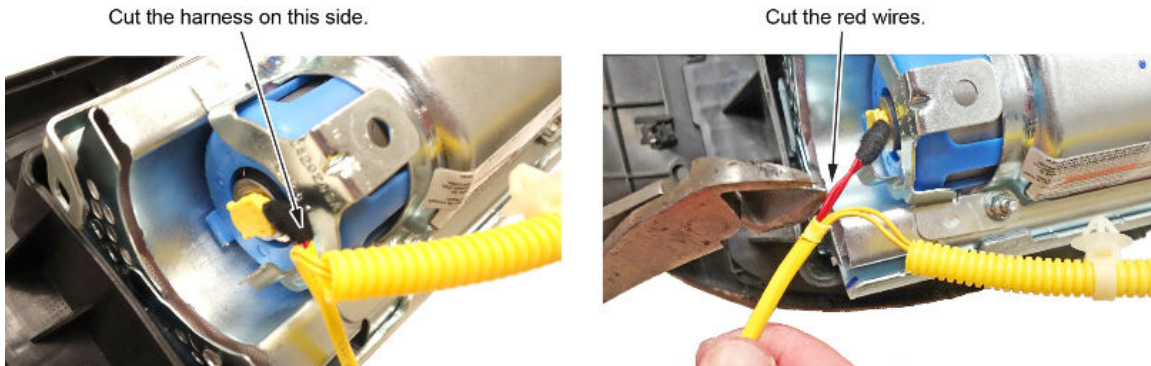
- 3.1. Cut the red wires about 2 inches from the inflator.

There may be some protective tube covering the wires that needs to be cut away to access the wires.

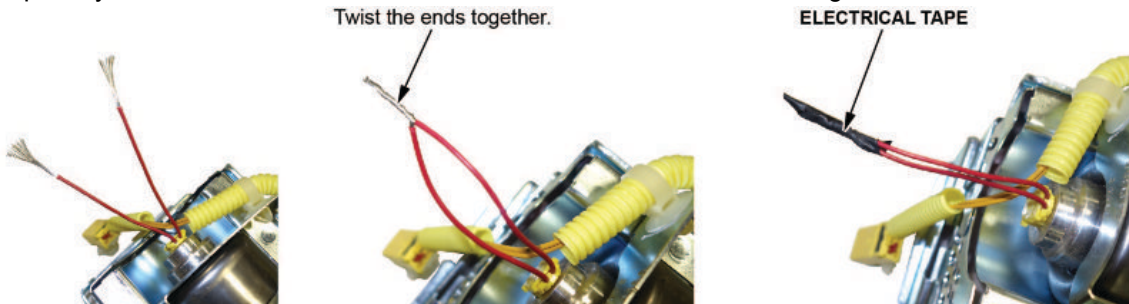
- 3.2. Strip away about 1 inch of the red wire insulation, then twist the wires together.

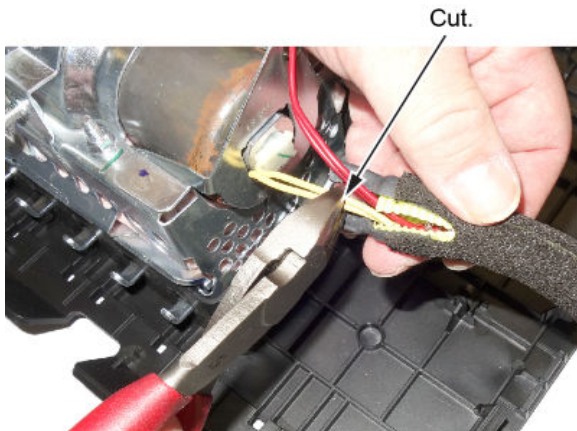
- 3.3. Tape the twisted ends with electrical tape.
- 3.4. Cut the yellow wires about 2 inches from the inflator.

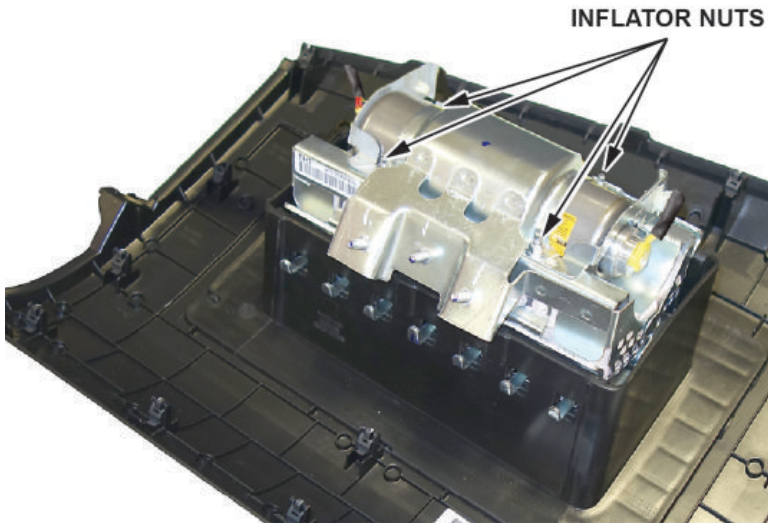
3.7. Remove the four inflator nuts.

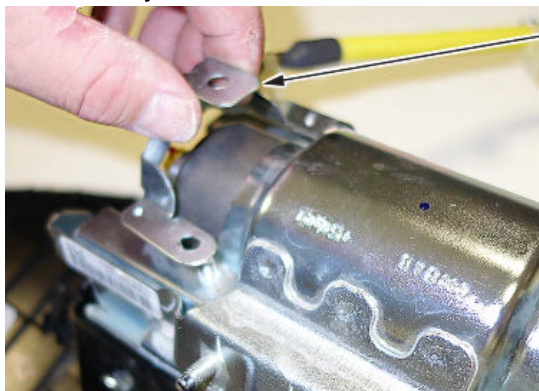
4. Remove the inflator bracket.

You can only remove one of the brackets, as the other is welded to the airbag housing.

INFLATOR BRACKET
Do not reuse.

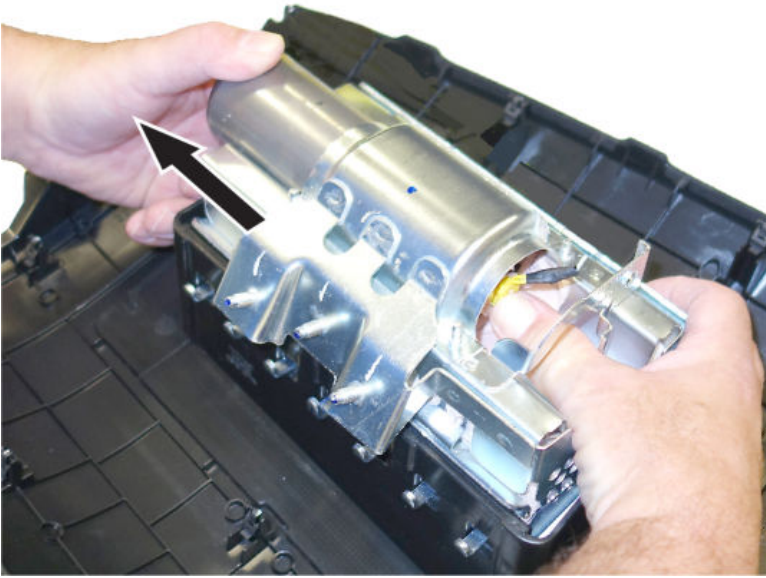
5. Remove the inflator by pulling it out.
