January 18, 2019

## Warranty Extension: Customer Support Program For Front Passenger's Airbag Inflator for 2010-14 TSX, 2011-14 TSX Sport Wagon, and 2010-13 ZDX (Expires September 30, 2028)

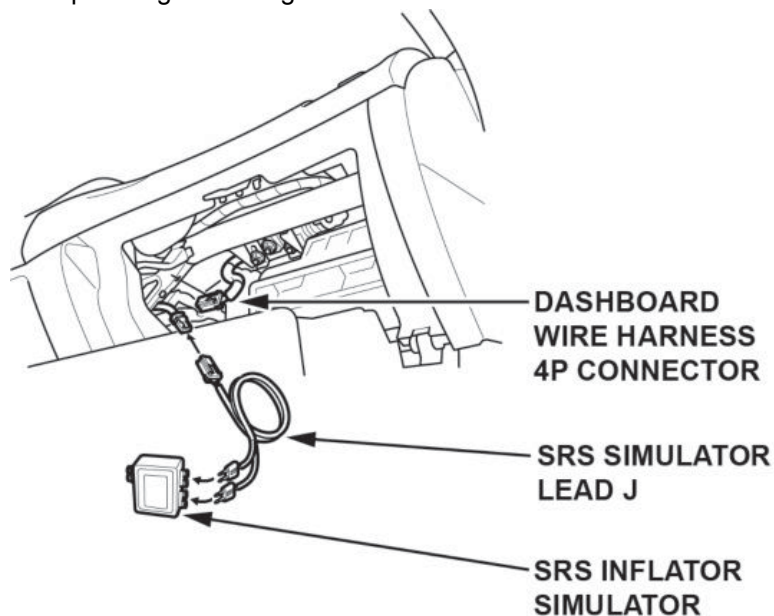
- Access the front passenger's airbag, and disconnect the dashboard wire harness connector 4P connector from the front passenger's airbag 4P connector.

- Connect the terminals of SRS simulator lead J to the SRS inflator simulator (2  $\Omega$  connectors), then connect SRS simulator lead J to the 4P connector as shown.
- Reconnect the negative battery cable.
- Turn the ignition to ON, not ACC, and wait 10 seconds.
- Check if the SRS DTC listed in step 8 returns.
  - If the same SRS DTC returned, the inflator is OK. The Customer Support Program does not apply. Continue with normal troubleshooting.
  - If the same SRS DTC **did not** return, go to the REPAIR PROCEDURE.

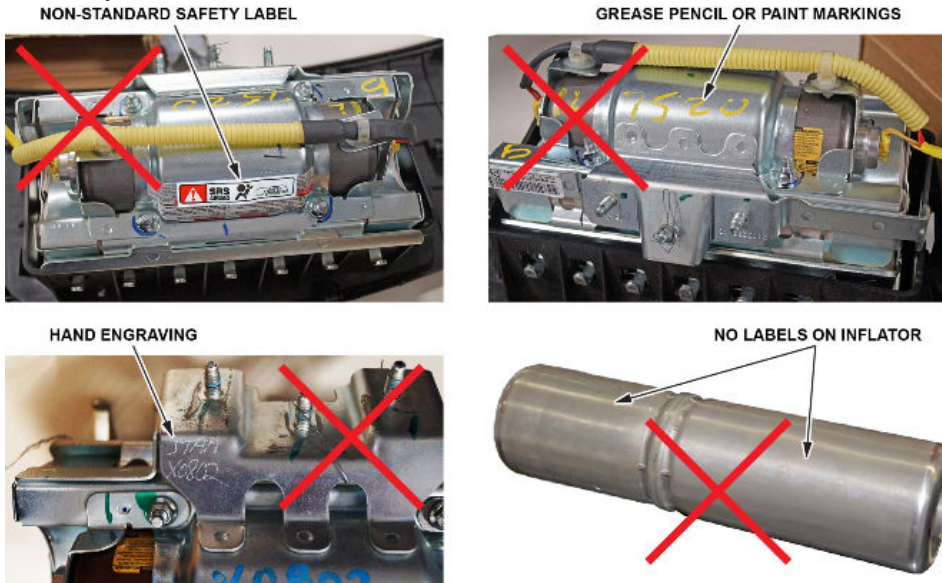
- If there are any unusual markings, like an incorrect label or a model year written in marker, the airbag module and inflator may not be the correct airbag module and/or inflator for the vehicle or it may be a counterfeit part. For more information about counterfeit airbags, you can refer to [safercar.gov](http://safercar.gov), enter keywords **MANAGING COUNTERFEIT**, and select **Recommended Dealer Guidance for Managing Counterfeit Air Bags** from the list. **If you suspect that the airbag module or inflator is counterfeit, do not continue this procedure.** Contact your DPSM for assistance.

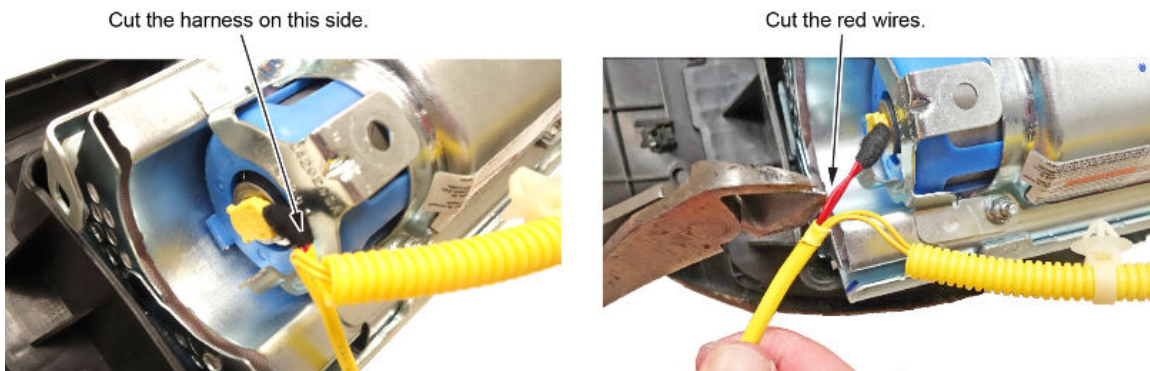
- 3.1. Cut the red wires about 2 inches from the inflator.

There may be some protective tube covering the wires that needs to be cut away to access the wires.

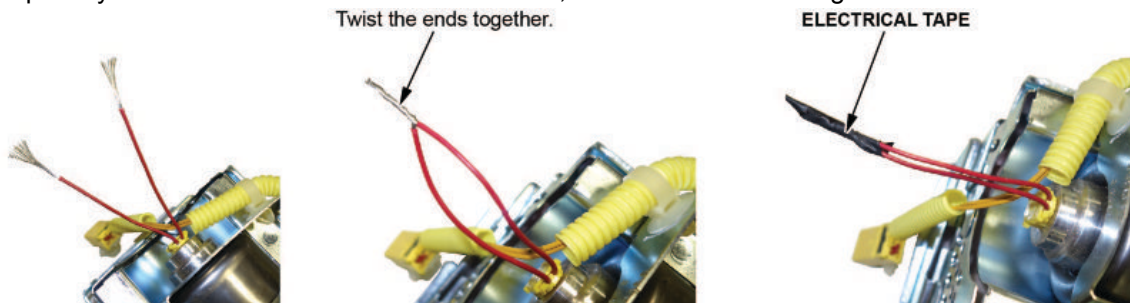
- 3.2. Strip away about 1 inch of the red wire insulation, then twist the wires together.

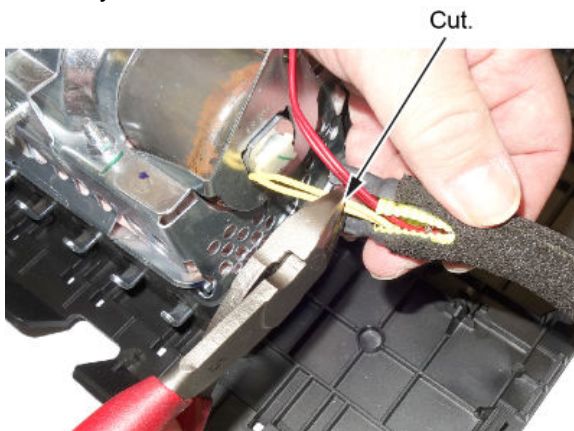
- 3.3. Tape the twisted ends with electrical tape.
- 3.4. Cut the yellow wires about 2 inches from the inflator.

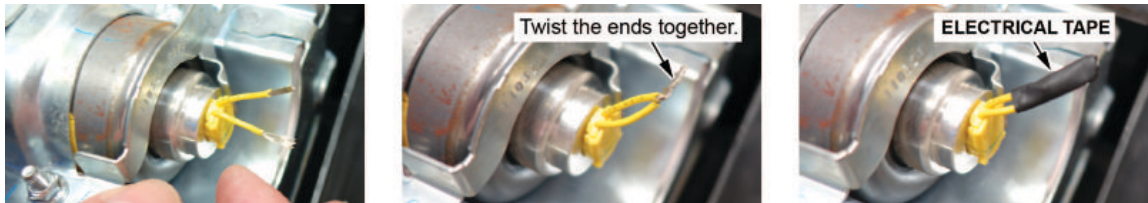
3.5. Strip away about 1 inch of the yellow wire insulation, then twist the wires together.

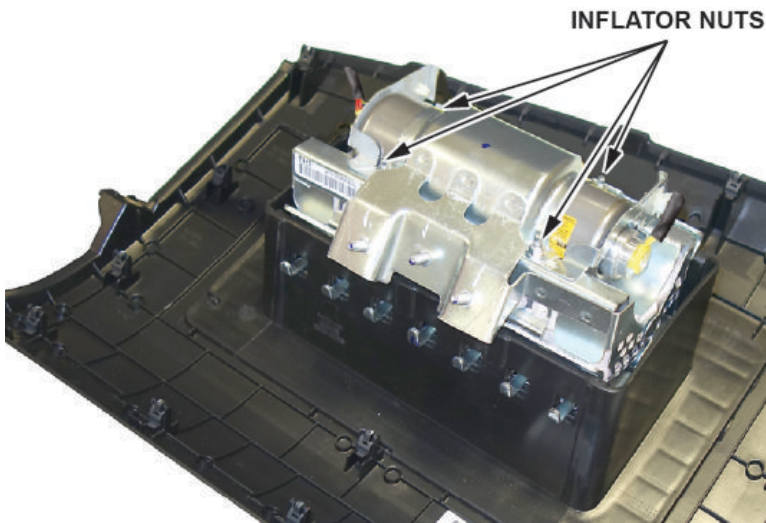
3.7. Remove the four inflator nuts.

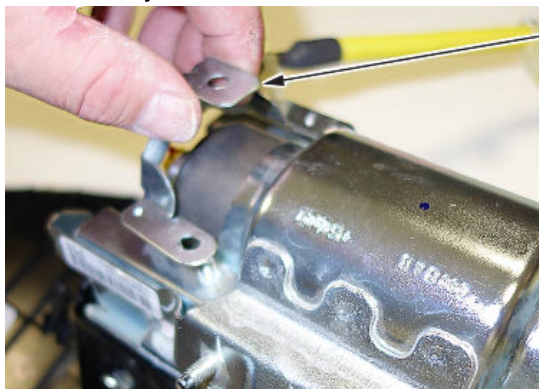
**INFLATOR BRACKET**  
Do not reuse.

4. Remove the inflator bracket.

You can only remove one of the brackets, as the other is welded to the airbag housing.

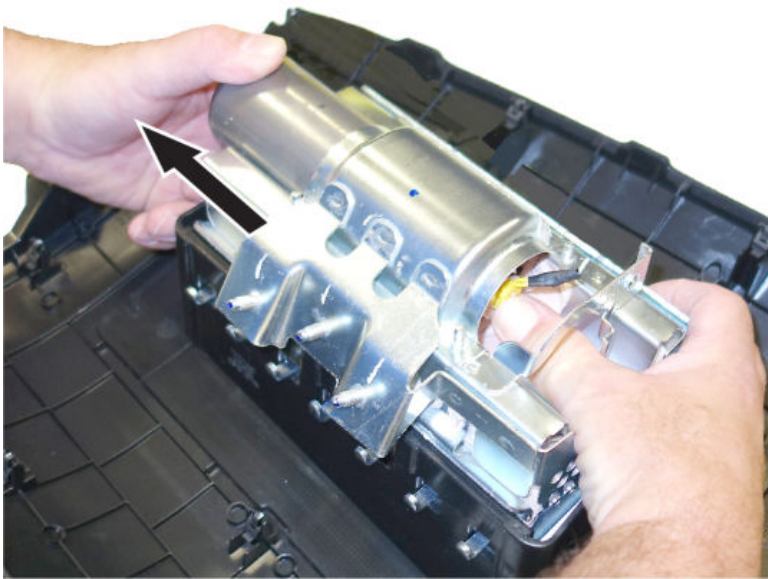
5. Remove the inflator by pulling it out.
