GROUP  
Fuel

MODEL  
2017MY~  
Sportage (QL)

NUMBER  
PS532 (Rev 1, 12/05/2018)

SUBJECT: DTC P0449 VENT VALVE/SOLENOID CIRCUIT &  
P2422 VENT VALVE STUCK CLOSED

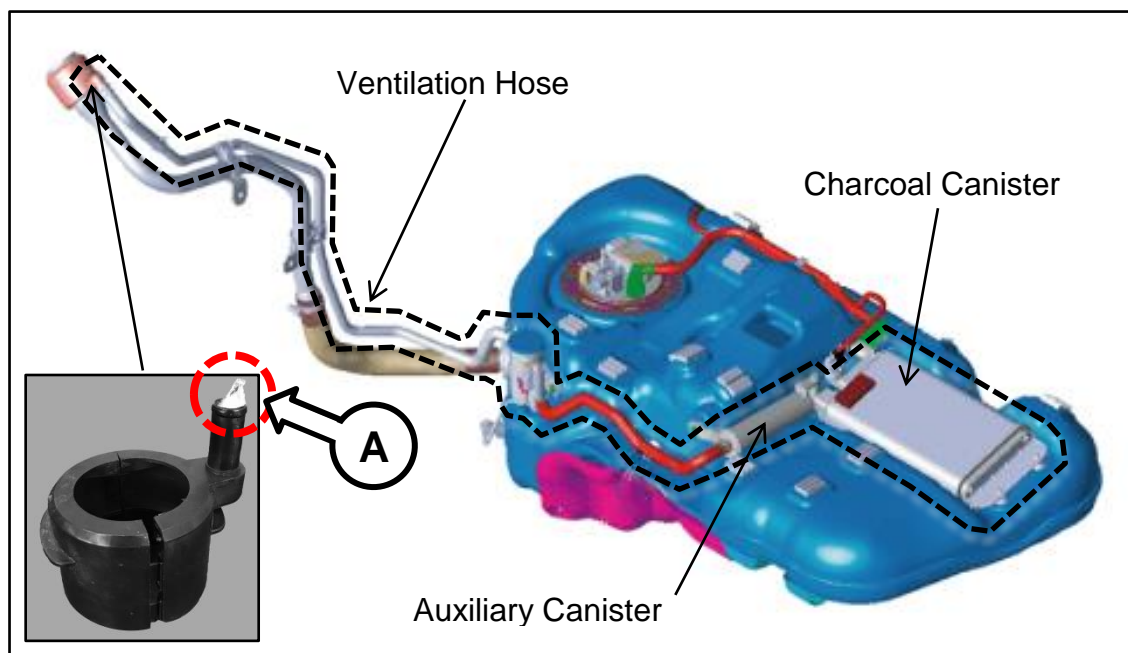
Fuel Tank Evaporative System (QL)

If a foreign object is found anywhere from the filler neck to the main charcoal canister, such as a spider nest (A), the object will need to be removed with a pipe cleaner. Trying to clear the hose with compressed air has proven to be ineffective and should not be done. The most common area of spider nest presence is located at the filler neck.
