Latest Vehicle Concern Fixes

Roof Opening Panel – Lower Level Service Repair	F-PACE
<p><u>Customer Voice:</u></p> <ul style="list-style-type: none">• Customers may report that the roof opening panel mechanism has become jammed or does not tilt up properly. <p><u>Technical Description:</u></p> <ul style="list-style-type: none">• This may be caused by wear or damage to the opening panel guide rails. <p><u>Status:</u></p> <ul style="list-style-type: none">• Lower level service parts have been made available to replace the guide rails without the need to replace the complete panoramic roof assembly.• Procedures for replacing the guide rails has been added to the Workshop Manual. Please refer to Topix, section 501-17 Roof Opening Panel, Removal and Installation - Roof Opening Panel Guide Rails• Jaguar F-Pace Service Part Numbers:<ul style="list-style-type: none">• Left Hand Guide Rail = T4A33021• Right Hand Guide Rail = T4A33020

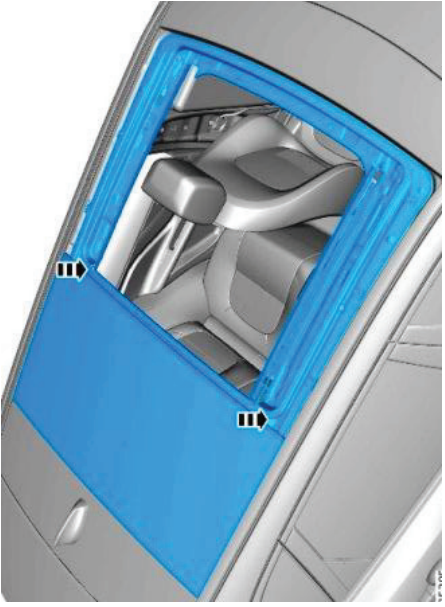
A technical diagram showing the interior of a vehicle with the roof opening panel highlighted in blue. Two arrows point to the guide rails on either side of the panel's track.
