# Technical Service Bulletin

## 35 Oil leak from transmission input shaft

35 18 36 2051719/3 December 17, 2018. Supersedes Technical Service Bulletin Group 35 number 18-35 dated August 23, 2018 for reasons listed below.

| Model(s) | Year | VIN Range | Vehicle-Specific Equipment |
|---|---|---|---|
| A3 | 2016 - 2018 | All | e-tron |

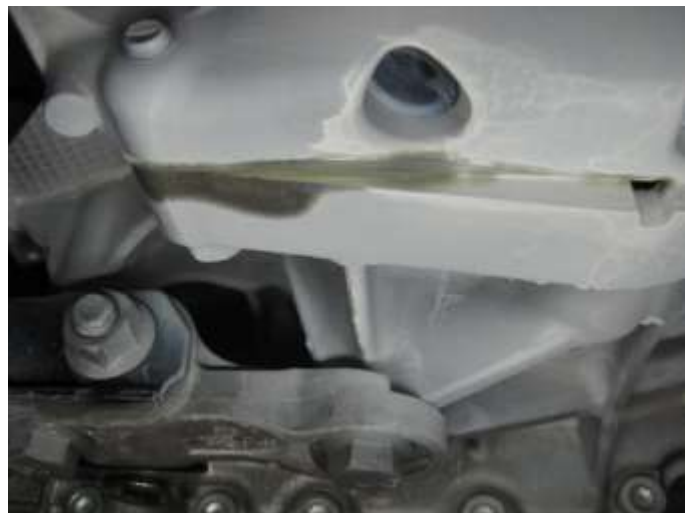
- The customer concern can be duplicated. The oil leak can be traced to the transmission at the bellhousing (Figure 1) and the input shaft (Figure 2).

**Figure 1.** Oil leaking from the bellhousing.

1. Document the leak with photos and keep them with the vehicle records.
2. Replace the oil seal according to the repair manual. Located in ELSA under *Drivetrain* >> *6-Speed S tronic Transmission 0DD* >> *30 Clutch* >> *Input Shaft Seal, Replacing* (Figure 3)

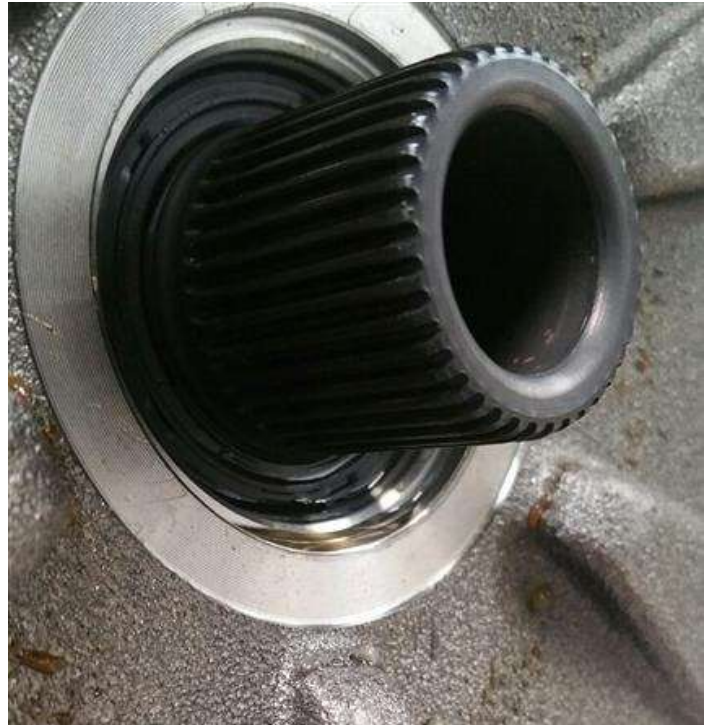
*Figure 2. Oil leak at the input shaft.*

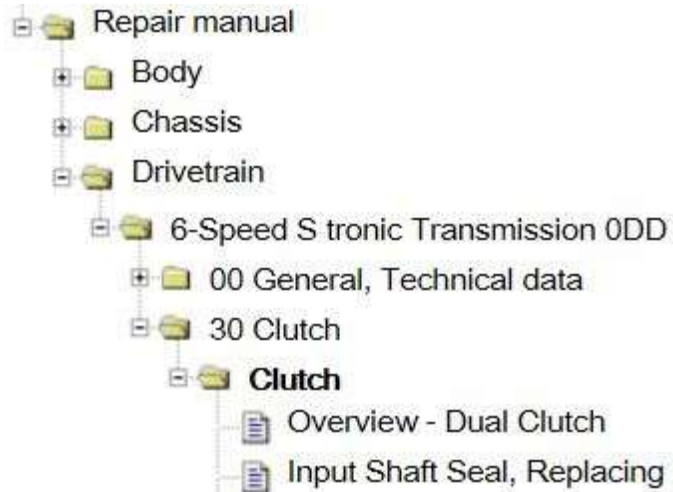
Figure 3. Location of repair manual directions.
