March 5, 2019

Version 9

## Product Update: 2016-18 Civic: Software and A/C Control Unit Update; DTC P0300, P0301, P0302, P0303, P0304, or P0172

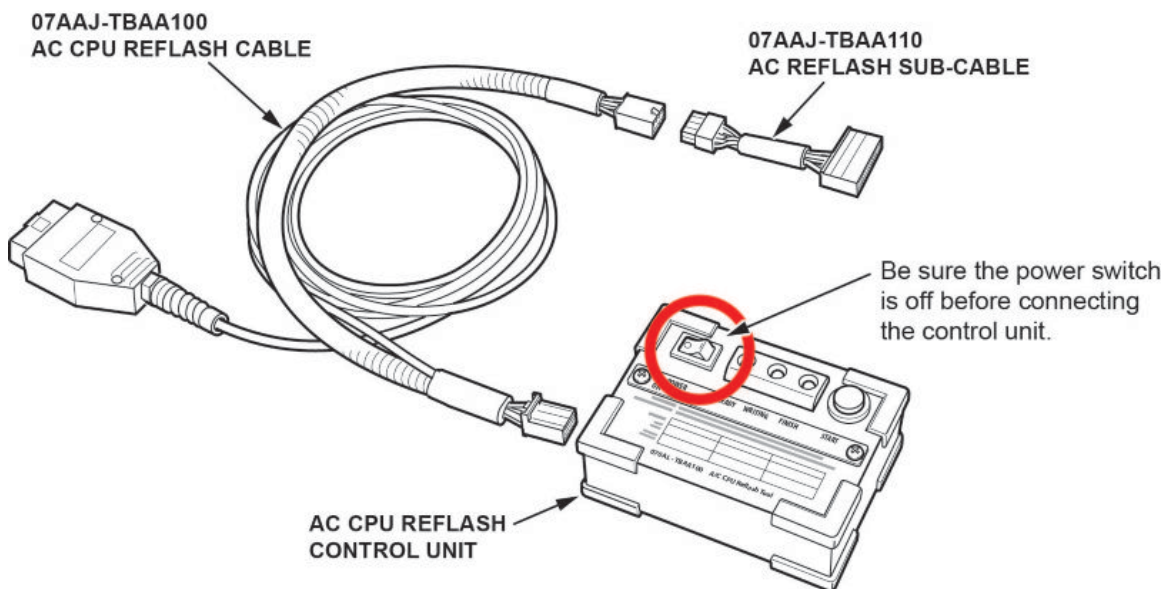
5.1. Empty the glove box and lower it to expose the A/C control unit on the right-hand side.

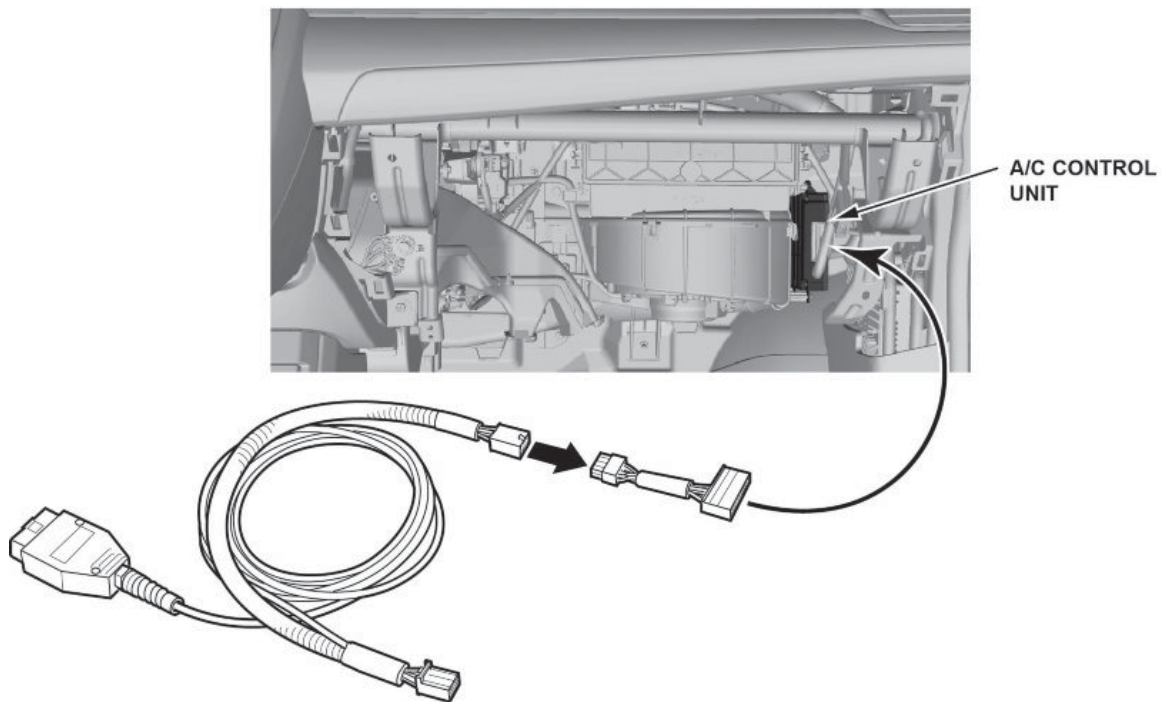
5.3. Plug the A/C refresh sub cable to the A/C CPU refresh cable.

5.4. Plug the A/C CPU refresh cable to the tool.

5.5. Connect the A/C CPU reflash cable to the OBD2 connector to supply power to the tool.

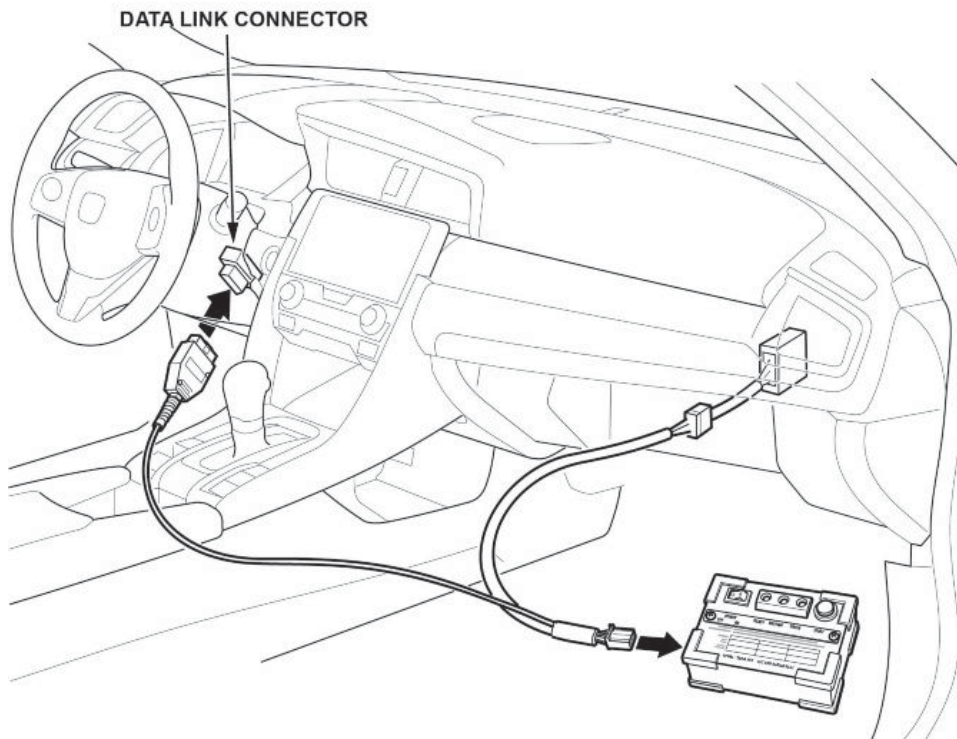
5.6. Turn the power switch to **ON**. A solid green LED should come on.

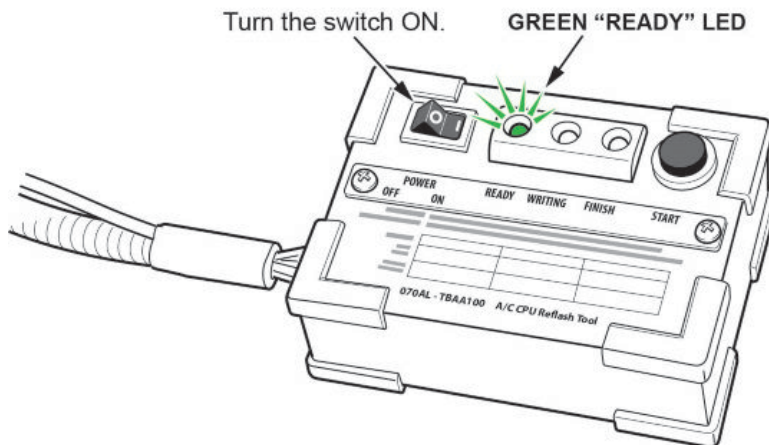
5.7. Once the solid green LED is on, press the black "start" button on the right-hand side to start the rewriting process.

5.8. A solid yellow LED should appear, which means that the tool is rewriting the A/C control unit.

If the green LED starts flashing, there might be an issue with the tool. Use a different or known good cable or tool as needed and try again.

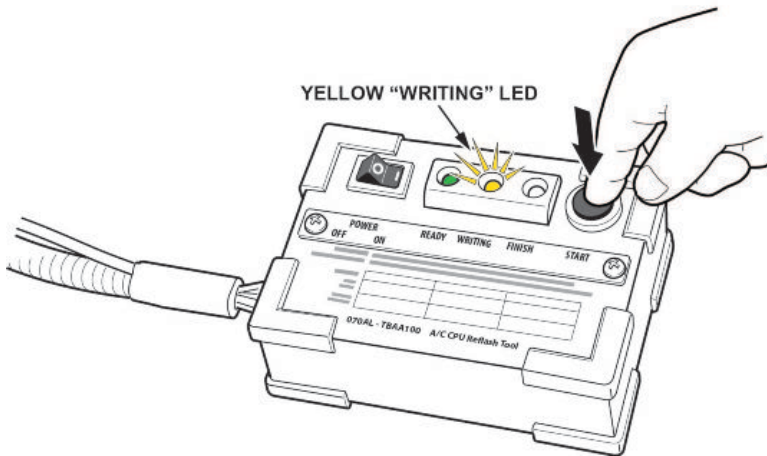
5.9. Once reprogramming is complete, a solid blue LED should come on.

If the yellow LED is flashing, the vehicle may have been repaired previously or is ineligible for the repair, or the sub cable is worn out. If the sub cable is worn out, replace it and try again. The 32 pin connector on the sub cable is expected to last about 50 connections. **If the yellow LED is still flashing after replacement of the sub cable, refer to S/B 19-027, 2016-18 Civic 1.5L: Software Update with A/C Control Unit Replacement; DTC P0300, P0301, P0302, P0303, P0304, or P0172 for further instructions.**

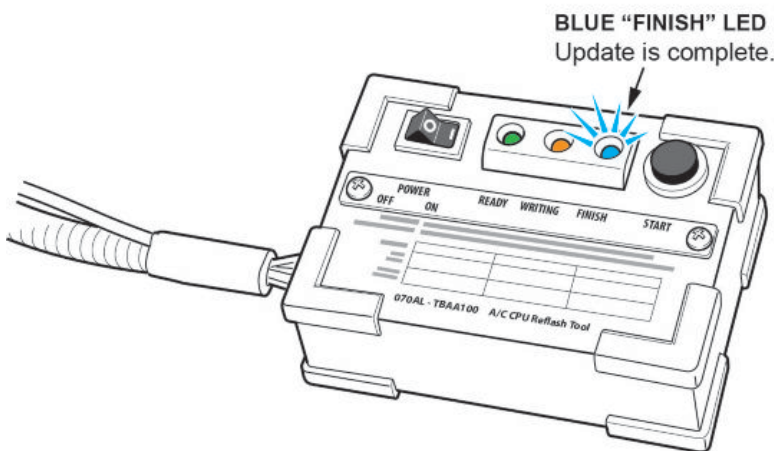
If the blue LED is flashing, the update has failed. Power off the tool and repeat the procedure again. If the error is consistent, replace the sub cable and try again. The 32 pin connector on the sub cable is expected to last about 50 connections..

5.10. Turn the tool **OFF**, disconnect it from the vehicle, connect the factory harness to the A/C control unit, and install the glove box.
