## **T8 P0EA773 Auxiliary Cooling System Performance**

REF NO: TJ 34123.1.3			CAR MARKET: United States and Canada		
10 04120.110	Teomineal Gervice	Omitou otatot	- and Ganada		
	PARTNER:	ISSUE DATE:	STATUS DATE:		
3 US 7	510 Volvo Car USA	2018-10-23	2018-10-31		
FUNC GROUP:	FUNC DESC:				
2647	Heater, thermostat	Page	1 of 3

## **Technical Journal 34123.1.3**

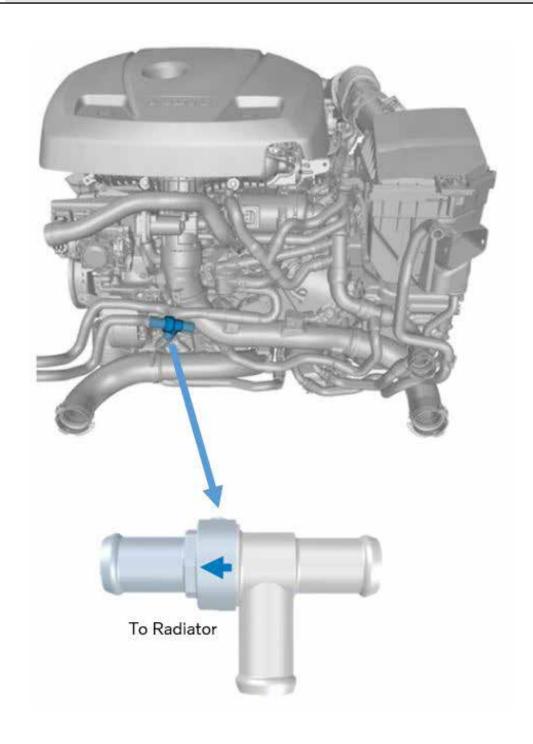
File Name	File Size		
US34123_Orientation_Illustration.JPG	0.0363 MB

Note: Orientation of the component is critical to correct operation. See attached photo US34123\_ Orientation Illustration.jpg

A new component is now available for replacement and the old thermostat part number has been blocked. Do not install old stock on shelves.

Please order and install component 32139082.
