Technical Service Bulletin

91 Wireless charging does not work

91 19 34 2053536/1 February 5, 2019.

Model(s)	Year	VIN Range	Vehicle-Specific Equipment
A5, A6, A7, A8, and Q8	2019 - 2020	All	With wireless charging

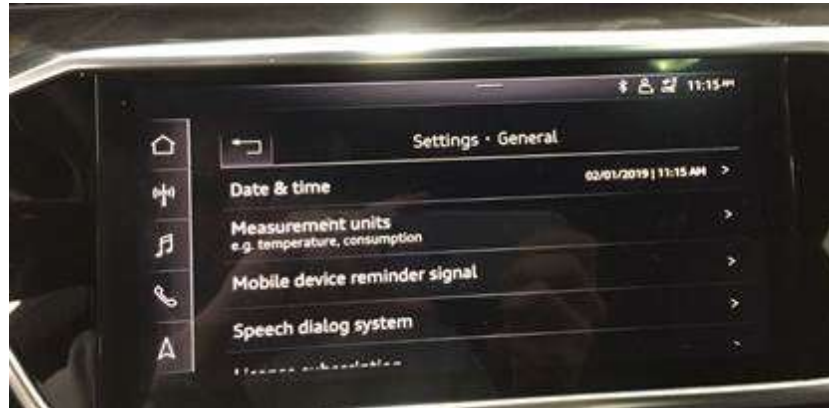
Figure 1. Mobile device reminder signal.

1. Check whether wireless charging works in a comparable vehicle.
2. Make sure that wireless charging is turned on in the MMI. Switch on the ignition and in the MMI select *Home >> Settings >> General >> Mobile device reminder signal >> Wireless charging*. Make sure the slide control is set to on (Figure 1-2).

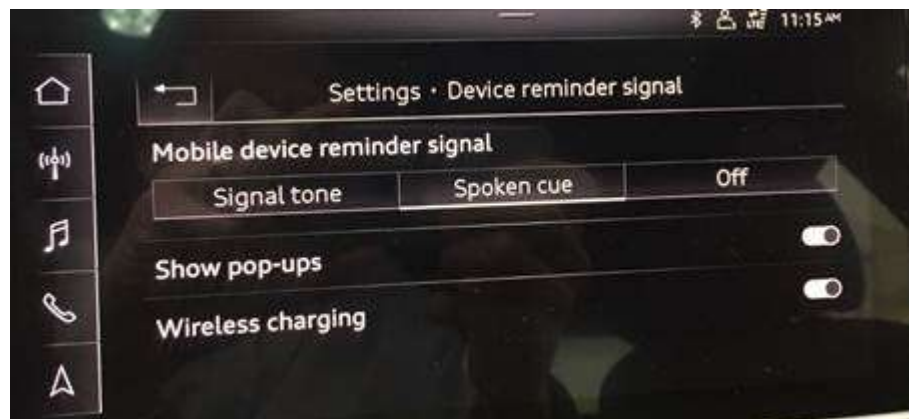
Figure 2. Mobile device reminder signal menu.
