# Technical Bulletin

**26 19 01** February 7, 2019 **2039436** Supersedes Technical Bulletin 26-18-02 (V261802) dated April 2, 2018 to update Front Reductant Agent Supply Line Remove + Install labor operation number according to Saga/Elsa updates.

### AdBlue® Warning and or MIL ON – AdBlue® Leakage at Reductant Injector

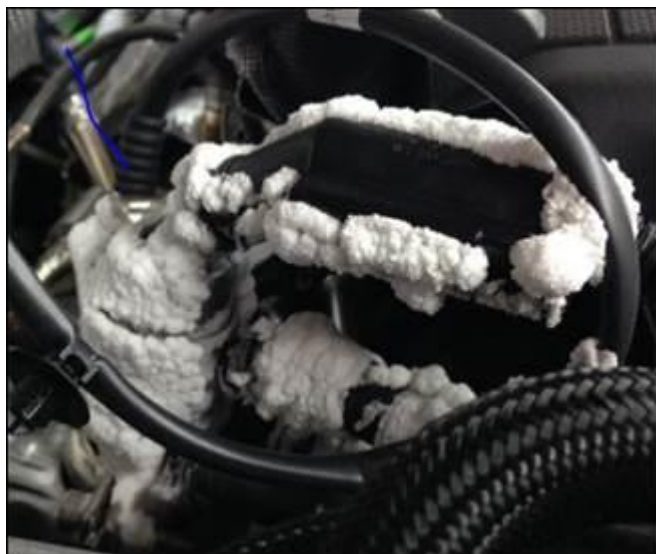
Welding process issues of the reductant line connector to the supply line may cause AdBlue® leakage at the reductant injector.

Inspect the connection of the reductant supply line connector at the reductant injector in the engine compartment. If white crystalized (dried) AdBlue® is found at the reductant injector (see Figure 1 & 2), it will be necessary to replace the reductant supply line.

- Thoroughly clean the area of the reductant supply line connection with water to remove the crystalized AdBlue®.
- Replace the reductant supply line.
- Refill reductant agent as required per part table quantity.

It is not necessary to replace the reductant injector.
