# Preliminary Information

## PIC6305 Buzz Noise Heard At Idle

Brand:	Model:	Model Years:	VIN:		Engine:	Transmissions:
			from	to		
Chevrolet	Cruze	2018	J710002	J7102070	LE2	All
Involved Region or Country	North America					
Condition	A customer may comment of a buzz type noise heard at idle. The noise can be turned on and off by activating and deactivating the canister purge solenoid using the scan tool.					
Cause	Mass dampeners may be missing from the evaporative emission purge valve line.

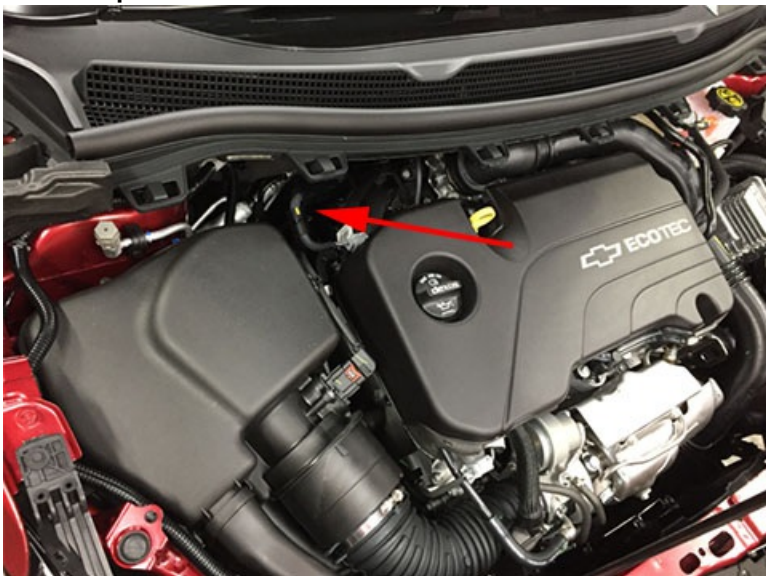
Figure 1

Inspect evap purge line underhood (figure 1) to see if mass dampeners were installed (figure 2).

If mass dampeners are present, proceed with SI diagnostics.

If mass dampeners are not present, contact TAC to get a mass dampener kit.

Install kit per included instructions – re-evaluate noise.
