Juddering/shuddering at the front axle brakes

Topic number	LI42.10-P-064899
Version	7
Function group	42.10 Service brake
Date	08-16-2017
Validity	All vehicles of model series 222/217 without AMG
Reason for change	Remedy updated
Reason for block

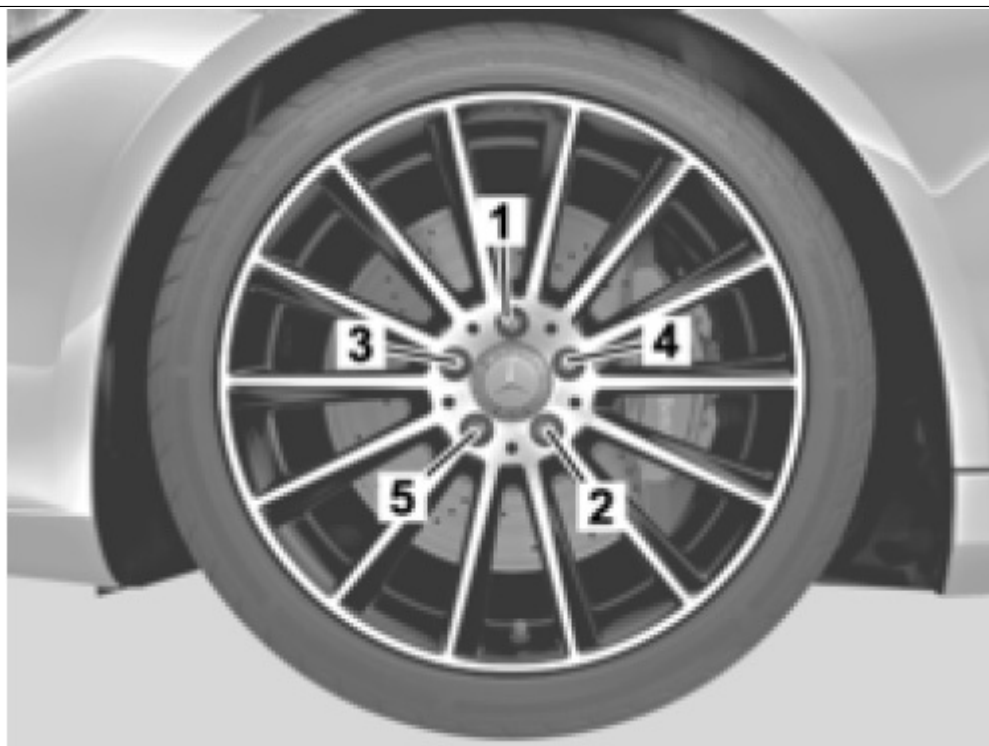
Anzugreihenfolge Radverschraubung.jpg:

Attachments	
File	Description
Anzugreihenfolge Radverschraubung.jpg	Wheel bolts are to be tightened in the 1-2-3-4-5 sequence shown in the picture

6.2 Mount wheel bolts crosswise by hand with max. 20 Nm (see picture in attachment "Wheel threaded connection tightening sequence").

6.3 First tighten wheel bolts crosswise with a torque wrench up to max. 70 Nm (see picture in attachment "Wheel threaded connection tightening sequence").

6.5 Tighten wheel bolts crosswise with a torque wrench to the prescribed vehicle-specific tightening torque (see picture in attachment "Wheel threaded connection tightening sequence").
