# Technical Service Bulletin

<b>Topic</b>	Bentayga - Touch Screen Remote (TSR) - Not ejecting from the cradle
<b>Market area</b>	Bentley: worldwide (2WBE),Hongkong-Macau (5HK)
<b>Brand</b>	Bentley
<b>Transaction No.</b>	2050603/2
<b>Level</b>	EH
<b>Status</b>	Released for publishing
<b>Release date</b>	May 20, 2019

Touch screen remote (TSR) is not ejecting from the cradle

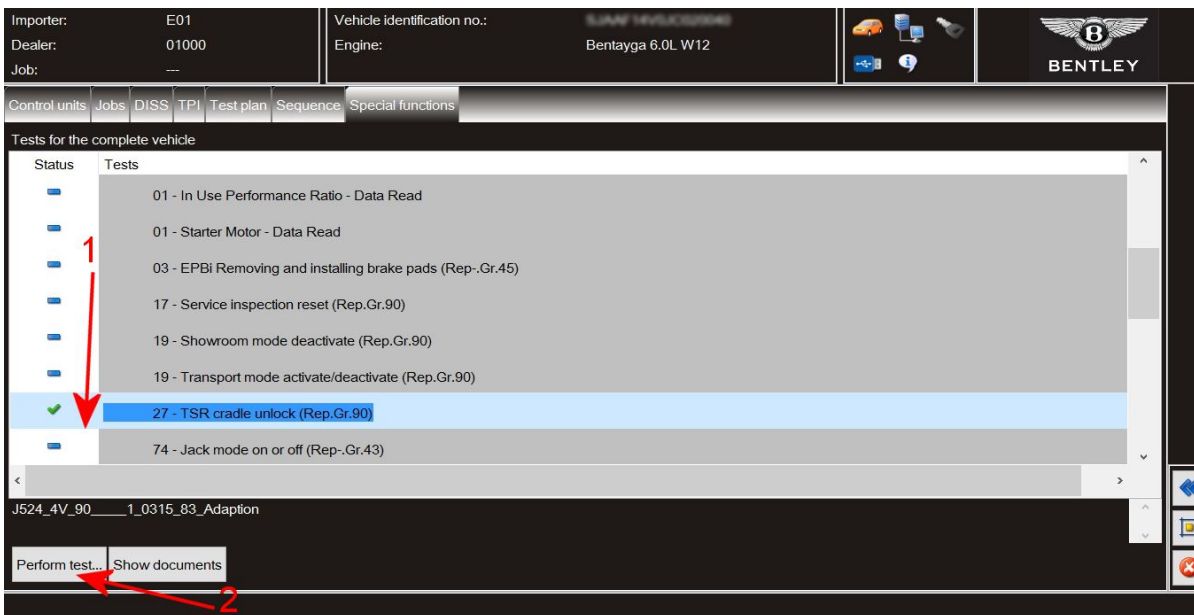
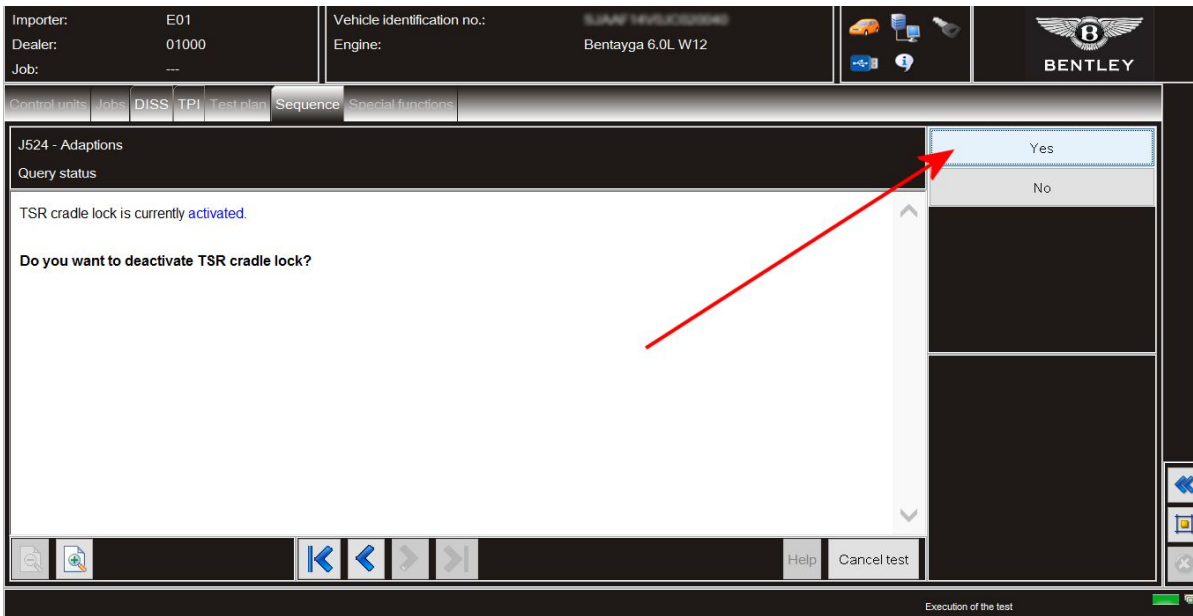
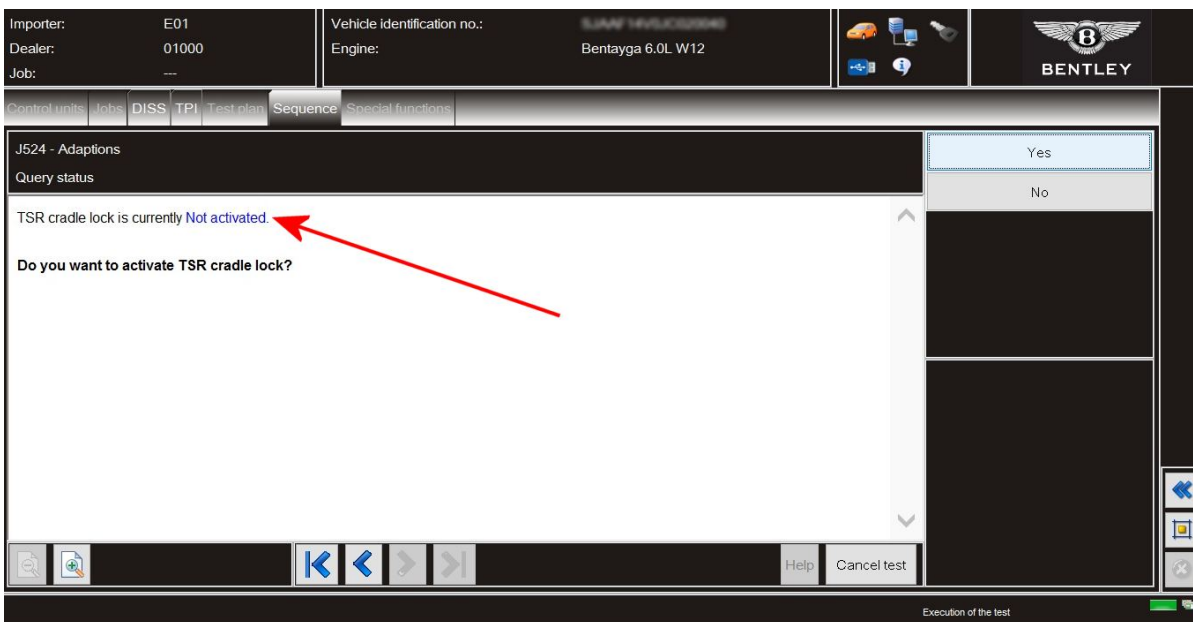
- From the diagnostic tool main desktop select Off board Diagnostic Information System
  - Select – Start diagnosis
  - Adopt the correct vehicle identification and allow guided fault finding of all control modules to complete
  - Once Guided fault finding has completed go to the Special Functions page and select (Point 1) 27 – TSR cradle unlock (Rep.Gr.90)
  - Select Perform test (Point 2) and follow on screen prompts until at the relevant screen regarding TSR activated/Not activated status
- Figure 2 shows the TSR cradle lock is currently activated, (Locked), select Yes and follow the remaining prompts to deactivate the TSR cradle lock
- Figure 3 shows the TSR cradle lock is currently Not activated (unlocked) this is the correct status to ensure the TSR can be ejected from the cradle

**In the event the TSR cradle lock status is not activated and the TSR will not eject, please raise a DISS query include within the query that this TPI was conducted previously and an issue with TSR ejection is still evident although the status shown is Not activated**
