## **Service Bulletin**

Bulletin No.: 16-NA-383

Information on Rough Idle, Crank No Start, Extended Crank or Misfire Due to Excessive Carbon on Top of the Valves or Sticking Valves, Malfunction Indicator Light (MIL) Illuminated - DTC P0300, P0301, P0302, P0303, P0304, P0305, P0306, P0307, P0308 Set

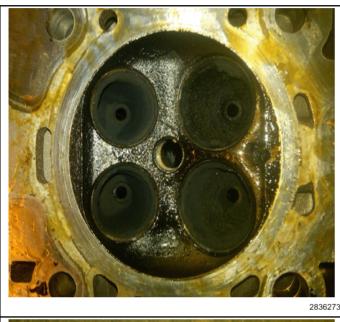
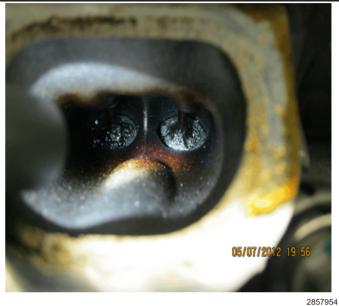
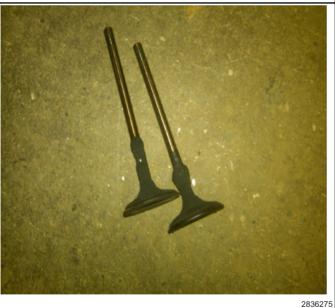
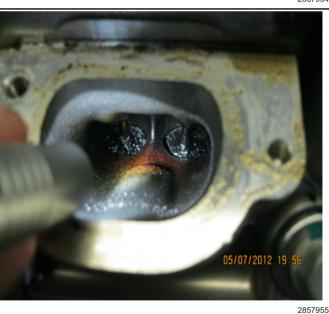
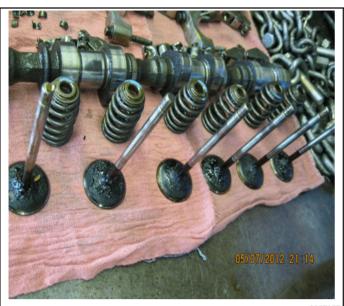
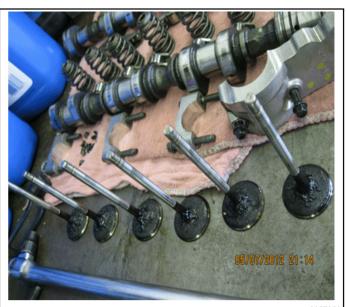
| Involved Region or Country | North America and N.A. Export Regions | | |
|---|--|--|--|
| Cause | This condition may be caused by major carbon build up on the intake and/or exhaust valves due to fuel contamination or incomplete burning of the fuel as shown below, so the misfires should not have appeared until accumulating at least 8,000 km (5,000 mi) or more. | | |

The graphics below may show typical carbon build-up during engine disassembly and inspection of the cylinder heads:

- If there is no sign of valve damage or cam followers that are out of place, perform the following procedure to free up sticking valves and to remove carbon from the valves and pistons.
- If valve damage is present or if there are cam followers that are out of place, perform engine mechanical repairs as necessary to correct the concern and then perform the procedure below to prevent the concern from returning.

- Perform an upper engine and valve cleaning procedure.
- Below are examples of valves that have gone through a Top Engine cleaning procedure.

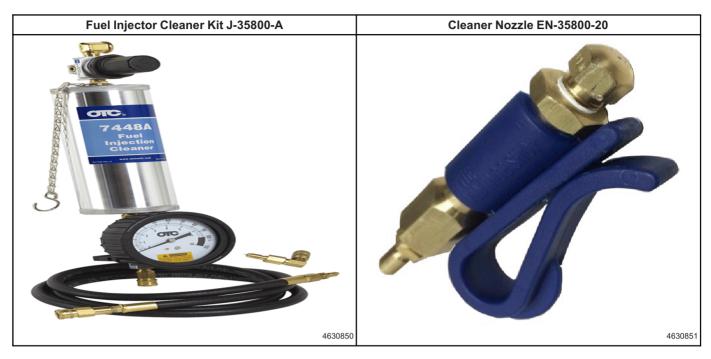
- In a well-ventilated area with the engine at operating temperature, slowly/carefully induce the Top Engine Cleaner into the engine, which should take approximately 3 minutes.
  - ⇒ For best results, it is suggested to induce the cleaner through the throttle body with Fuel Injector Cleaner Kit J-35800-A or equivalent and NEW Cleaner Nozzle EN-35800-20, which has been developed to help atomize the cleaner.

Important: Extreme care must be taken not to hydro-lock the engine when inducing the cleaner, especially if it is induced without Fuel Injector Cleaner Kit J-35800-A or equivalent. If too much cleaner is induced at too low of an RPM, or if you force the engine to stall by inducing too much cleaner at once, the engine may hydro-lock and bend a connecting rod(s).

- Fill Cleaner Kit J-35800-A with Top Engine Cleaner, approximately 473 ml (16 oz), and close the cap of the tool tightly. Set the air pressure to 260 kPa (40 psi) at the service tool.
- Using GDS 2 or Scan Tool, command engine idle to 2000 rpm to prevent the engine from stalling. Typically 2,000 rpm will be sufficient.
