Field Service Bulletin Trucks

Leveling Valve, Leak Test VN, VAH, VHD, VT

FSB 728-005, Leveling Valve, Leak Test

(May 2019)

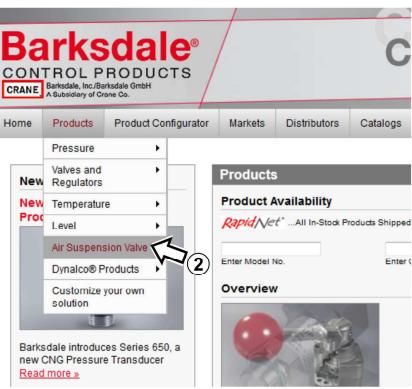
W7146913

- 1 Use the link in this body of text which goes to troubleshooting video (on YouTube). In order to access the link, please go to www.barksdale.com (1).
- 2 Click on the **Air Suspension Valve** option from the products menu as shown in the image below (2).

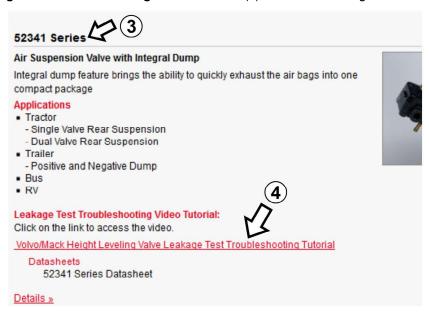
W7146914

- 3 (3) Once the air suspension valve page opens, scroll down to the section titled "52341 Series Air Suspension Valve with Integral Dump."
- 4 In that section you will see a link to the leveling valve leak test video under the description "Leakage Test Troubleshooting Video Tutorial" (4) as shown in the figure below.

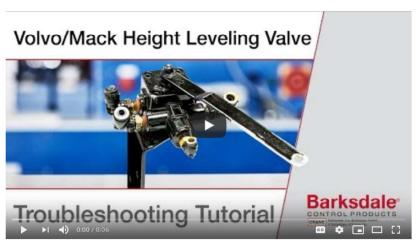
5 The link will connect to the YouTube video below.
