Latest Vehicle Concern Fixes

Restricted Performance & Dynamic Stability Control Message	19MY I-PACE
<p>Customer Voice:</p> <ul style="list-style-type: none">• Restricted Performance with or without Dynamic Stability Control message on Instrument Cluster. <p>Technical Description:</p> <ul style="list-style-type: none">• This message may be paired with P0A2A, P0A2B, or P0A2D for Drive Motor “A” Temperature Sensor Circuit stored in either both or either EPIC B or C. <p>Status:</p> <ul style="list-style-type: none">• Under investigation• Follow TOPIx & Pathfinder Guided Diagnostics.• Inspect all the connectors at the EPIC and the EDU including the HV Cables. Inspect connectors for damaged & check to confirm there isn’t any coolant in the HV 3 phase connector at the EDU. Check Fuse 32 for rear inverter & Fuse 17 for front inverter.• Should parts be replaced, please raise an EPQR with the parts manager information

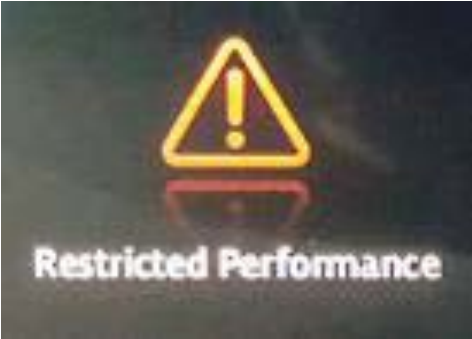
<p>The image shows a yellow warning triangle with an exclamation mark inside, set against a dark background. Below the triangle, the text "Restricted Performance" is displayed in white.</p>
