Technical Service Bulletin

01 MIL on, DTC P045600 and/or P044200, P04EF00, P04ED00 stored in the ECM

01 19 18 2055592/1 July 15, 2019.

Model(s)	Year	VIN Range	Vehicle-Specific Equipment
A3 e-tron	2015 - 2018	All	e-tron

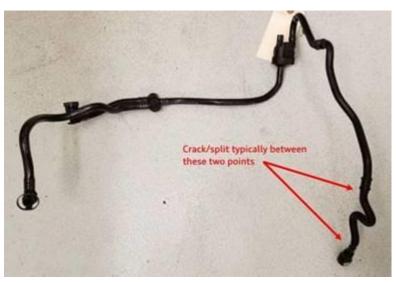
1. Check the N80 valve with the hose for leak/cracking.

Figure 1. Potential locations of the crack.

2. If confirmed, replace the N80 assembly.
