# Latest Vehicle Concern Fixes

Restricted Performance & Dynamic Stability Control Message	19MY I-PACE
<p><b><u>Customer Voice:</u></b></p> <ul style="list-style-type: none"><li>• Restricted Performance with or without Dynamic Stability Control message on Instrument Cluster</li></ul> <p><b><u>Technical Description:</u></b></p> <ul style="list-style-type: none"><li>• This message may be paired with P0A2A, P0A2B, or P0A2D for Drive Motor “A” Temperature Sensor Circuit stored in either both or either EPIC B or C</li></ul> <p><b><u>Status:</u></b></p> <ul style="list-style-type: none"><li>• Under investigation</li><li>• Follow TOPIx &amp; Pathfinder Guided Diagnostics.</li><li>• Inspect all the connectors at the EPIC and the EDU including the HV Cables. Inspect connectors for damaged &amp; check to confirm there isn’t any coolant in the HV 3 phase connector at the EDU. Check Fuse 32 for rear inverter &amp; Fuse 17 for front inverter.</li><li>• Should parts be replaced, please raise an EPQR with the parts manager information</li></ul>

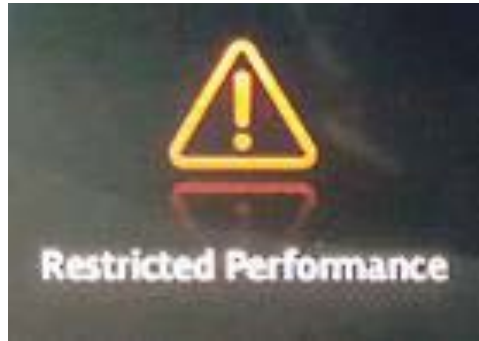
<p>The image shows a yellow warning triangle with an exclamation mark inside, set against a dark background. Below the triangle, the text "Restricted Performance" is displayed in white.</p>
