REFERENCE:	Nova Bus Manuals
SECTION:	11: Fuel Tank & Accessories
RS N°:	MQR 7621-1850
EFFECTIVE IN PROD.:	LC32-052

APPLICATION DEADLINE: 2020NO1
CLAIM REFERENCE NUMBER: WB-4629

SUBJECT:	Fuel tank
JUSTIFICATION:	Possibility of fuel leakage

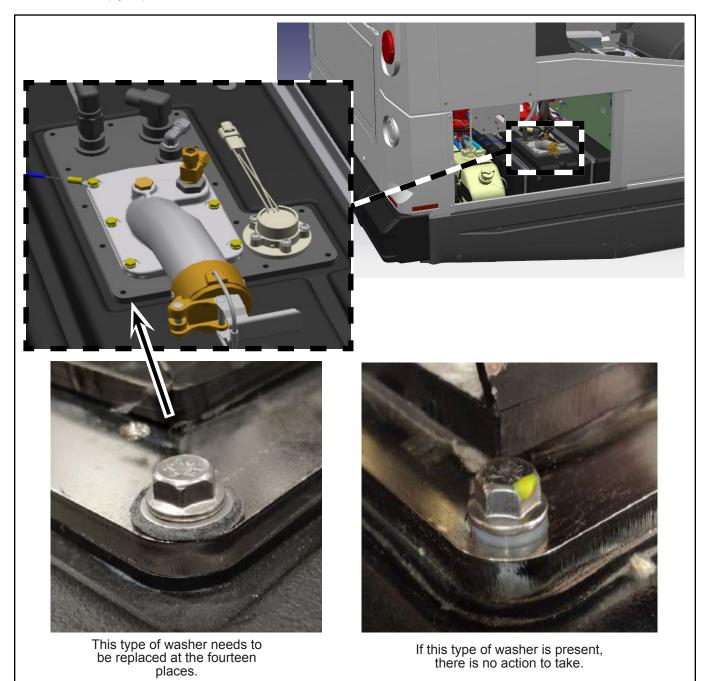
1.1. Check the fuel tank for the type of washers installed. Check only one washer and not each one. If the washer is white (nylon), there is no action to take.

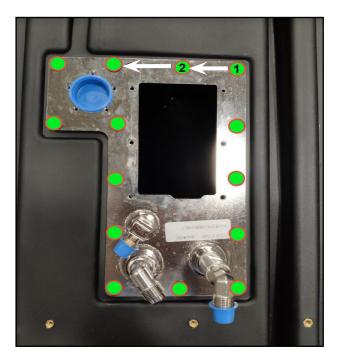
Figure 1 - Replace One Washer at a Time

1.2. To replace the washers: remove one bolt at a time, replace the washer by a 10568958, apply a thread adhesive such as Loctite 242 or equivalent (# 9985283) before tightening to 5.1 lb-ft (7 N•m) and apply a torque marker.
