Noises from lock of valuables/stowage compartment or from gap cover between seat and center tunnel

Topic number	LI91.10-P-059389
Version	1
Design group	91.10 Front seats
Date	07-12-2014
Validity	Model series 221
Reason for change	Damage code updated
Reason for block

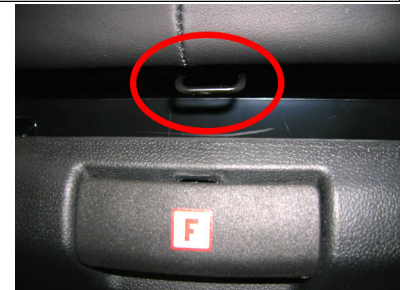
DSCN3496.JPG:

- a) Noises due to relative movement between lock and striker (picture 1).
- b) Contact surfaces between the side seat bolsters of the front seats and the center tunnel.

Attachments	
File	Description
DSCN3496.JPG	(1) Striker

- a) Please treat the striker with Krytox lubricant.
 - b) Please treat the leather surface of the center tunnel in the affected area with Mercedes-Benz leather care foam.
- Important note: Also perform this action when carrying out other work on the seat, even when the customer does not complain of noise at the time. Preventive performance of this work is intended to avoid follow-up repairs in the future.
