Partially electric seat adjustment switch broken

Topic number	LI91.29-P-050932
Version	2
Design group	91.29 Seats - electrical system
Date	07-10-2014
Validity	Model: 211/219 as of 1.7.04 except code (275) Memory package (driver seat, steering column, mirrors) except code (242) Electrically adjustable front passenger seat with memory Procedure depends on the VIN end number For model series 211 up to WDB211 020 1B 038 511 For model series 219 up to WDB219 322 1A 093 640
Reason for change	WIS reference added
Reason for block

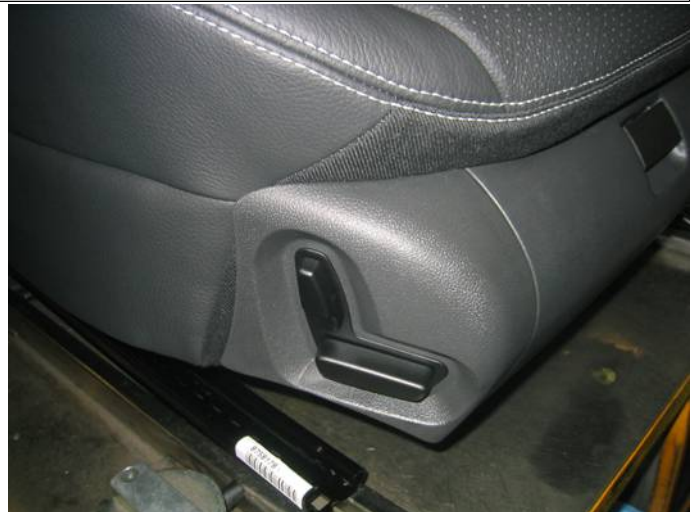
bild 1.jpg:

The controls on the partially electric seat adjustment switch stick or are loose or broken.

Attachments	
File	Description
bild 1.jpg	Partially electric seat adjustment switch

Excessive force application, broken by force

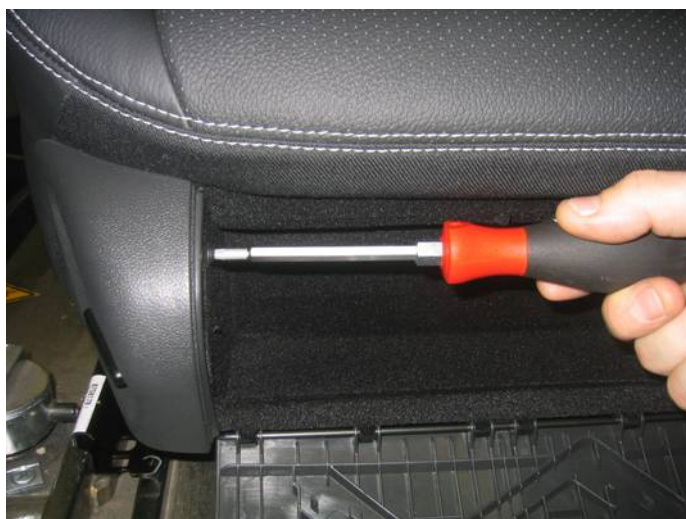
bild 2.jpg:

Attachments	
File	Description
bild 2.jpg	Loosen bolts T 20
bild 3.jpg	Loosen covering and detach connectors. Caution - Catch tabs!
bild 4.jpg	Loosen bolts on switch and replace switch.
bild 5.jpg	Push on replacement part
bild 6.jpg	Replace switch unit.

- Open stowage compartment flap
- Loosen bolt T20
- Tilt covering forwards and disconnect connector for partially electric seat adjustment switch.
