Technical Service Bulletin

44 Wheel alignment

44 19 70 2056386/1 October 21, 2019.

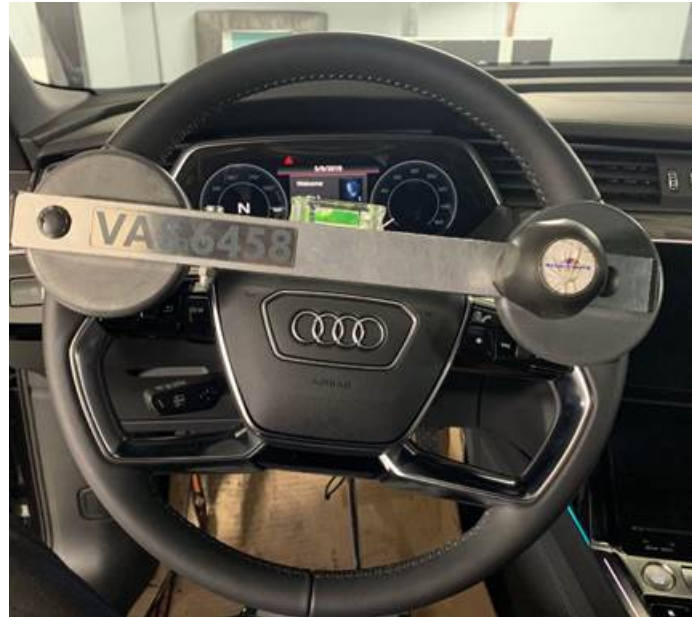
5. If the concern was “steering wheel crooked”, upload a picture of the steering wheel with VAS 1978 installed (Figure 1).

Figure 1. VAS 6458 installed with steering wheel off-center.

1. Test drive the vehicle to reproduce the concern.
2. Review Elsa at Repair Manual, *Chassis >> Suspension, Wheels, Steering >> 44 Wheels, Tires, Wheel Alignment*.
3. Make sure that the software of the wheel alignment equipment is up-to-date.
4. Upload the alignment protocol before and after the repair to DOC-IT.
