SERVICE BULLETIN

PATHFINDER, ALTIMA, MAXIMA, MURANO AND QUEST; CVT JUDDER AND DTC P17F0 OR P17F1 STORED

NTB17-039h

AT16-020h

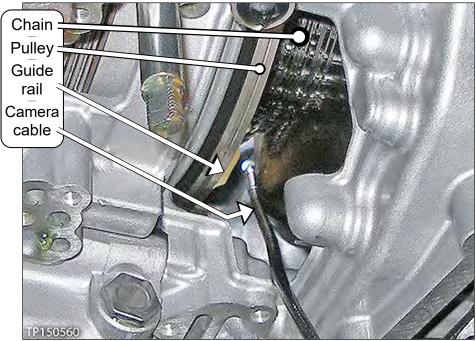
• Figure 11 shows where to insert the camera lens on the <u>driver side</u> of the chain.

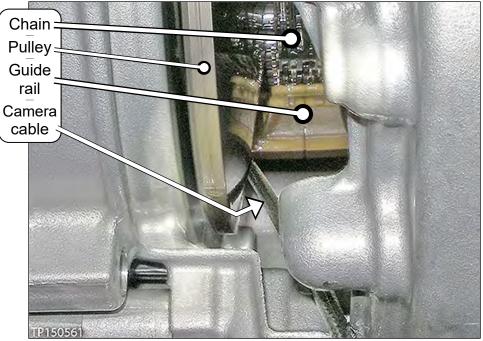
• Figure 12 shows where to insert the camera lens on the <u>passenger side</u> of the chain.

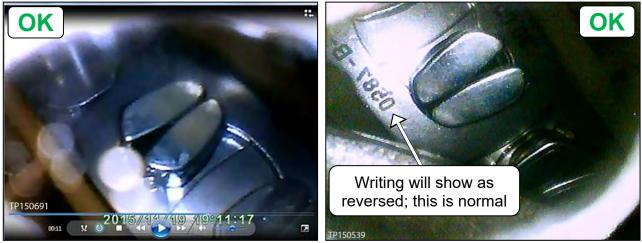
Pictures in Figure 19 and Figure 20 were taken with borescope J-51951.

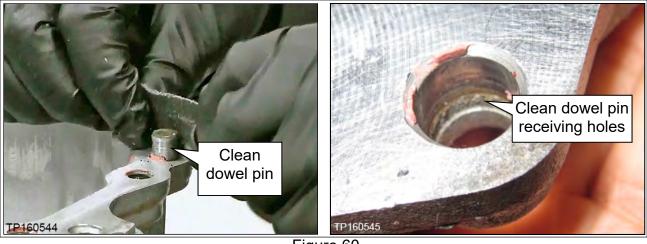
Figure 60

- <u>DO NOT</u> use sanding discs, similar abrasive tools, or metal blades.
- Use brake spray or equivalent solvent and lint-free towels only.
- Make sure brake spray or solvents used are compatible with local regulations.
- Avoid debris entering into the inside of the CVT.
- Make sure rust and debris have been cleaned off of dowel pins and receiving holes (Figure 60).
- 35. Clean the dowel pins and dowel pin receiving holes of any rust or debris with emery cloth (Figure 60).

NOTE: Use small wire brush or similar tool at the inside surface of dowel pin holes. DO NOT SCRAPE CVT CASE mating surfaces.

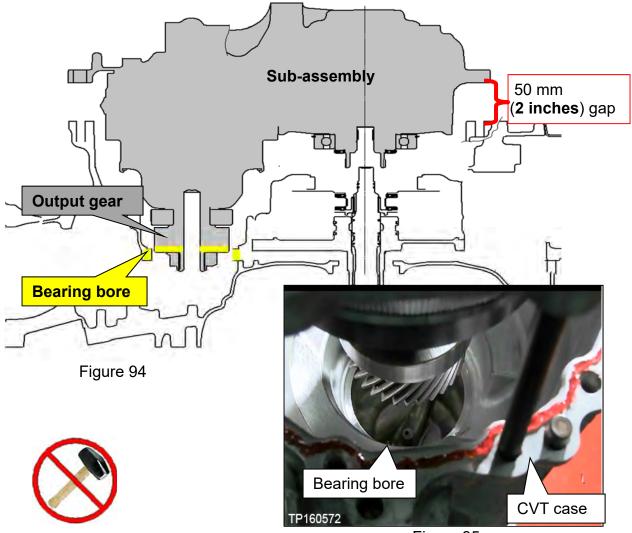
Interference is present between the output gear and bearing bore and are highlighted with yellow in Figure 94 and Figure 95.

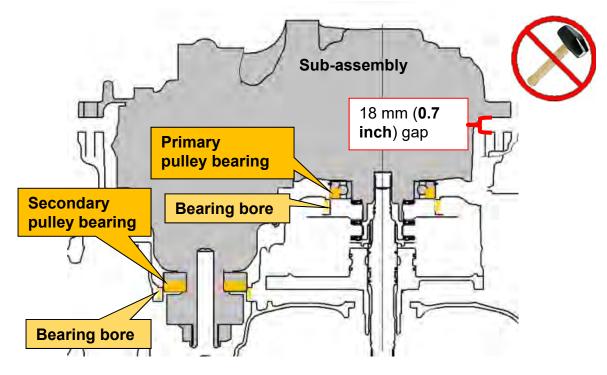
Figure 99

- 71. Continue to slowly lower the sub-assembly into the CVT case.
 - If the primary and the secondary pulley bearings do not align properly with their bores (Figure 99) or are at an angle, a **gap of 18 mm (0.7 inch**) may be present.
 - Possible areas of interference are highlighted with orange and tan in Figure 99.
 - As needed, level the sub-assembly as it is lowered into the CVT case to help the primary and the secondary pulley bearings align in their bores.
 - MINOR LEVELING ADJUSTMENTS with limited weight on the sub-assembly will help the installation. <u>Vertical force is not needed.</u>
 - Once the sub-assembly is LEVEL the primary and the secondary pulley bearings will smoothly align while lowering.

- If this occurs <u>Do NOT force sub-assembly into case.</u>
 - a. Raise the sub-assembly slightly.
 - b. Level the sub-assembly (visually check the gap between case and subassembly side cover and confirm that it is even all around).
 - c. Gently lower the sub-assembly.
 - d. Gently shake the sub-assembly horizontally, lower, raise and repeat as needed to help align.
 - e. Lower to 6 mm (0.25 inch) to clear the dowel pins.

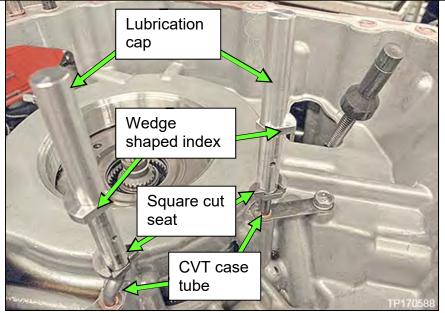
Figure 106 shows the pulleys and chain removed to illustrate how the lubrication caps attach to the CVT case tubes and is for reference only.

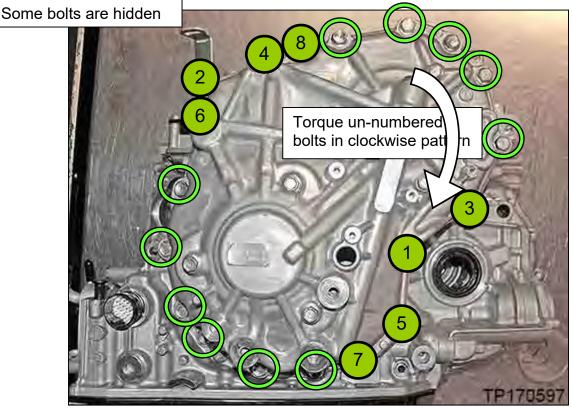
- Torque the first eight (8) bolts marked as \bigcirc in the sequence numbered in Figure 121 below, and then torque the rest of the bolts in a clockwise manner.
 - > Bolt torque: 45 N•m (4.6 kg-m, **33 ft-lb**) 19 pieces.

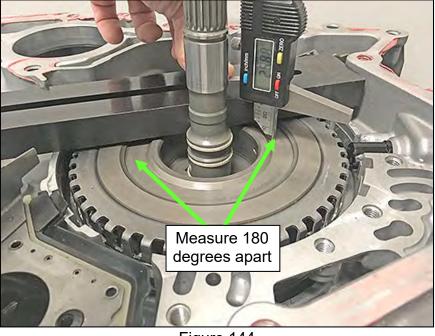
Figure 144

d. Carefully slide the gauge down until it bottoms out on the upper surface of the clutch drum where thrust bearing seats, where shown in Figure 144. Write this measurement as **D1** (use millimeters).

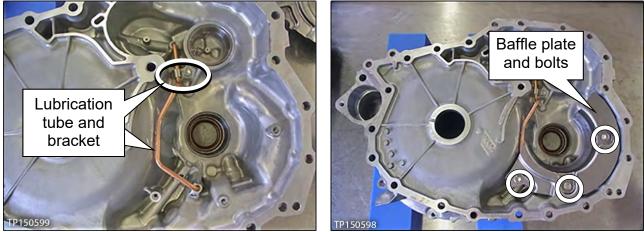
Figure 156

- 126. Install the lubrication tube and bracket, and then the baffle plate with three bolts (Figure 156).
 - Bolt torque: 5.9 N•m (0.6 kg-m, 52 in-lb.)

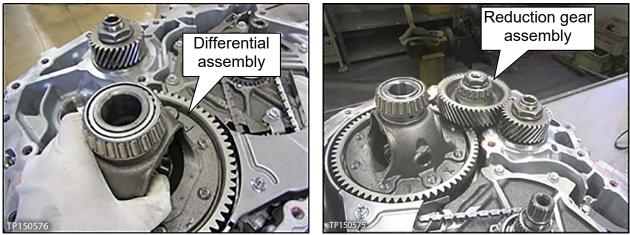
Figure 169

- 138. Install the differential assembly and the reduction gear assembly into the CVT case (Figure 169).
 - Thoroughly clean each assembly before installing.
 - Oil the bearings and gear teeth with CVT fluid before installing.

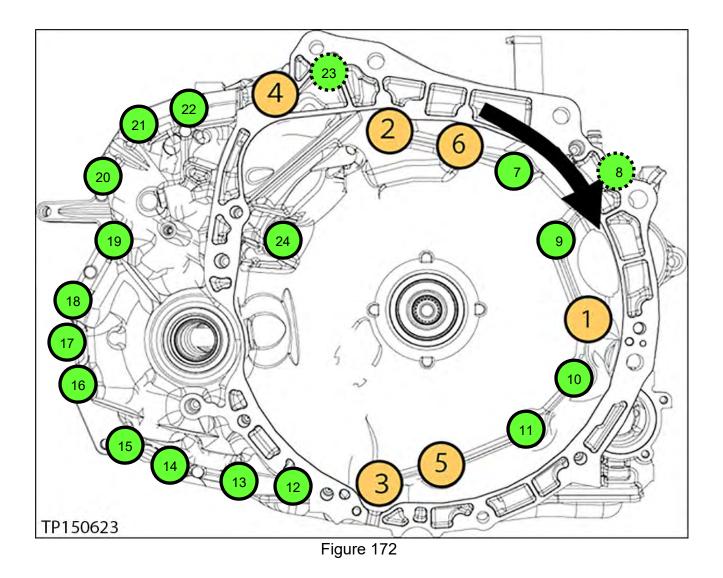
- 141. Install the torque converter housing onto the CVT case (see Figure 172 for torque sequence):
 - Install new bolts (24).
 - a. Torque the first six (6) bolts with symbol O in numbered sequence (see below).
 - b. Torque the remaining bolts with symbol O in numbered sequence (see below).
 - All bolts are 30 mm (**1.2 inches**) in length.
 - Bolt torque: 45.0 N•m (4.6 kg-m, 33.2 ft-lb.)

IMPORTANT: Make sure to torque the bolts in the sequence shown (Figure 172).

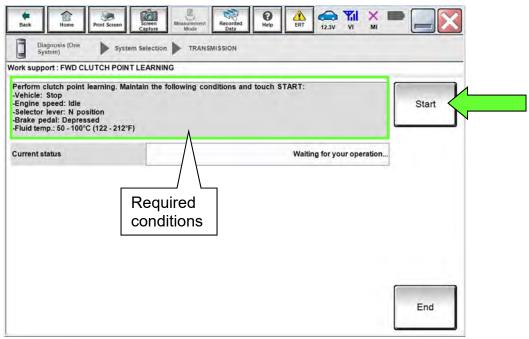
- 188. With the engine still running and at idle, depress the brake pedal and shift the CVT into neutral (**N**).
 - Confirm that all of the required conditions indicated in Figure 200 are being met.
- 189. Select Start.

190. While maintaining <u>all conditions</u> shown in Figure 200 and the "Current status" indicates "EXECUTING", shift the CVT into **D** and then wait until the "Current status" indicates "COMPLETED".
