# Steering wheel vibrations in vehicle speed range between 70 - 80 mph

Topic number LI40.10-N-070401

Function group 40.10 Wheels, tires

Date 10-11-2019 Validity Model 906

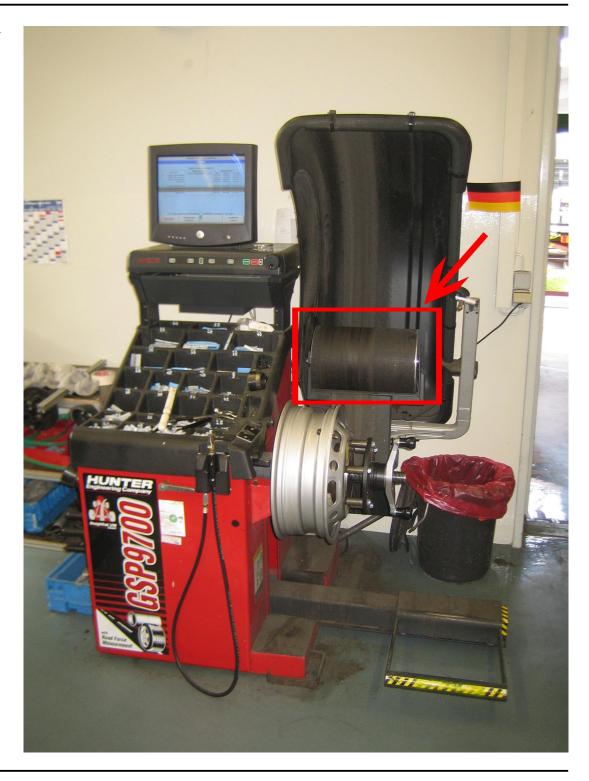
Maschine zur Bestimmung der RKS.jpg:

Attachments	
File	Description
Maschine zur Bestimmung der RKS.jpg	Example of a machine for determining RFV

- 1) Check wheels for damage and tire inflation pressure. Replace any damaged, unusable wheels. Correct the tire inflation pressure. Perform a test drive if the deviations are greater than 0.5 bar.
- 2) Check radial force variation (RFV) of the front wheels on a suitable machine (see attachment for example) (target: RFV < 90N), file measurements in a tamperproof manner. Match the wheels if this value is exceeded.
- 3) Balance wheels on wheel balancing machine.
- 4) Mount the wheels. Ensure that they are seated centrally and tighten the wheel studs/wheel nuts finger-tight in a crosswise pattern, then tighten to the required tightening torque.
- 5) Perform test drive. If the problem is still present, continue with step 6).
- 6) Check whether the specified steering gear is installed, replace if necessary.
- 7) Perform test drive.
