# **TECHNICAL INSTRUCTIONS**

# **CUSTOMER SUPPORT PROGRAM ZKA**

# **CERTAIN 2011 THROUGH 2015 MODEL YEAR TACOMA**

# COVERAGE FOR VEHICLE FRAME CORROSION PERFORATION

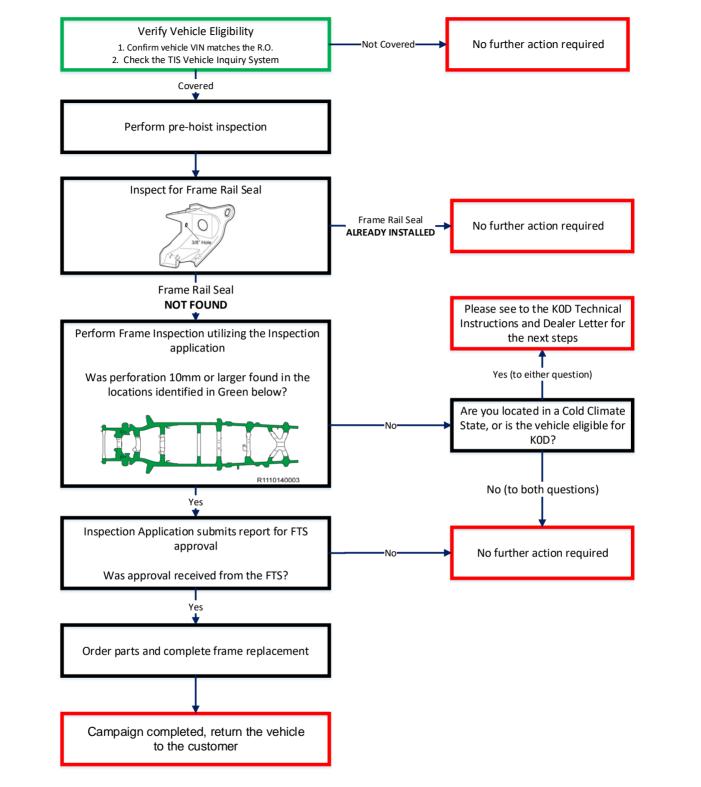
# I. OPERATION FLOWCHART

Cold Climate States Include - CT, DE, IL, IN, KY, MA, MD, ME, MI, MN, NH, NJ, NY, OH, PA, RI, VA, VT, WI, WV and District of Columbia

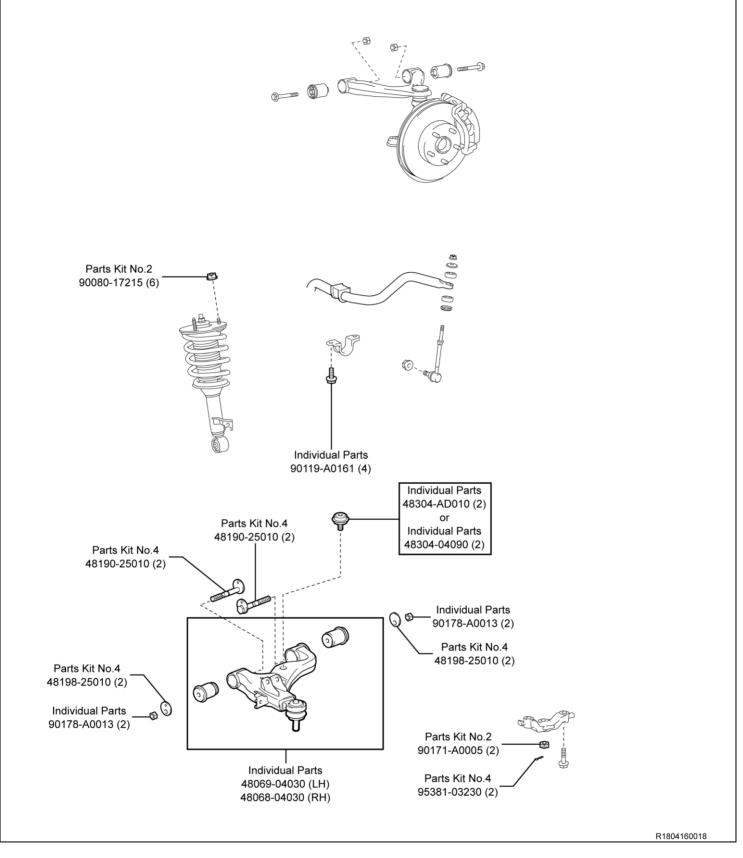
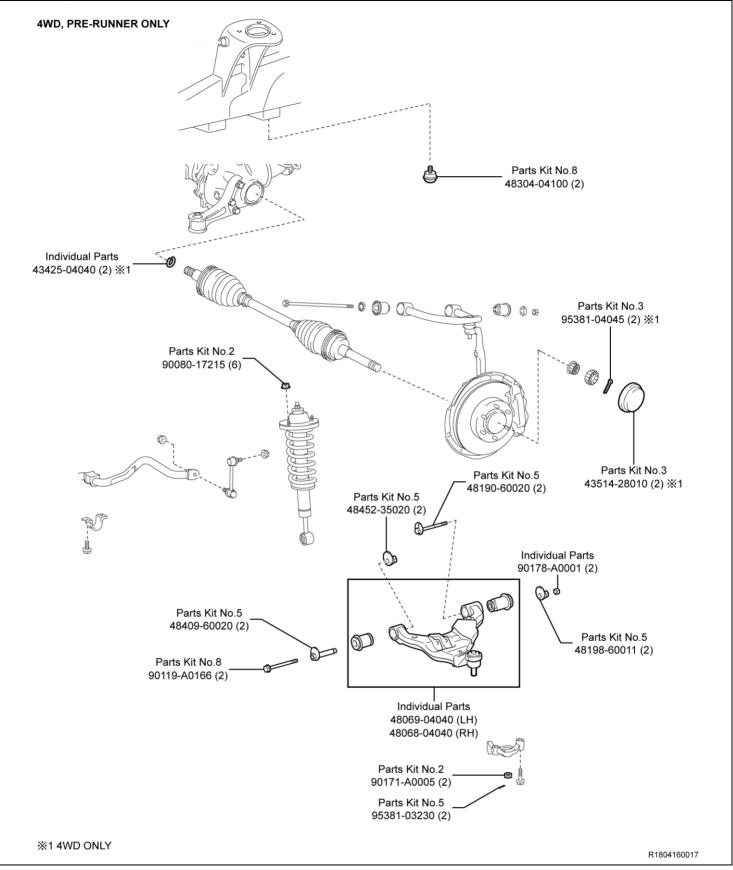
#### **Front Suspension**

2WD ONLY

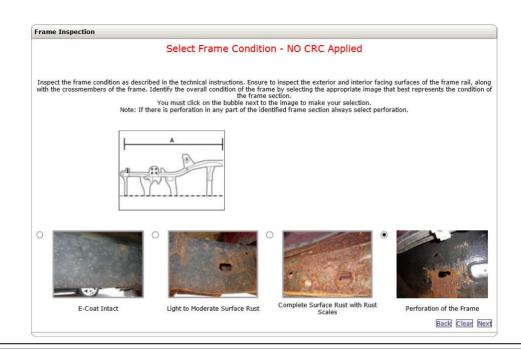
c. Inspect the frame section and inspect all surfaces of the frame rail and crossmember. Select the photo that best represents the frame condition. If perforation of 10mm or larger is identified select "Perforation of the Frame".

Note: You must click the bubble next to the image to select the condition.

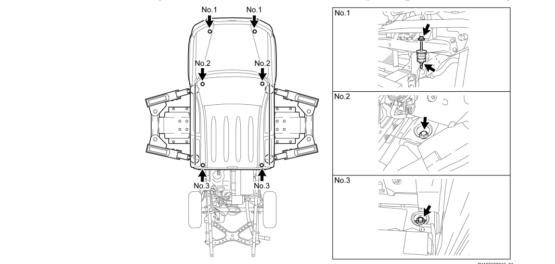
# 40. REMOVE THE CAB BODY ASSY USING AN ABOVE GROUND LIFT

- Center the cab assy weight on the lift arms so that it does not slant/tilt to one side.
- Raise the cab assy slightly off the frame and verify that it is held securely by the lift arms.
- The center of gravity of the cab body may become nose heavy depending on placement of the lift arm which could cause the cab to fall when lifted. To prevent this, use weights to establish a balance and secure the cab body to the lift arm using ratchet tie down belts.
- DO NOT work directly underneath the vehicle when pulling the frame assy out from under.

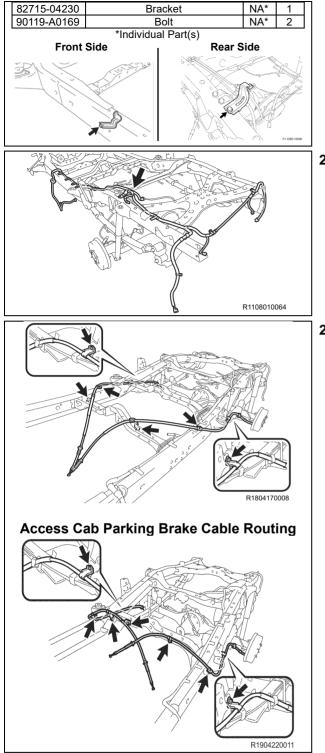
## 23. INSTALL THE NEW HARNESS BRACKETS

a) Install the 2 *NEW* brackets with the 2 *NEW* bolts and torque to spec.

### Torque Spec: 14 N·m (143 kgf·cm, 10 ft·lbf)
