Technical Service Bulletin

Topic	Running gear - Noise identification
Market area	Bentley: worldwide (2WBE),Hongkong-Macau (5HK)
Brand	Bentley
Transaction No.	2056407/2
Level	EH
Status	Released for publishing
Release date	Dec 16, 2019

Object of complaint	Complaint type	Position
chassis -> level control system, pitch and roll compensation	noises, vibrations	
chassis -> steering	noises, vibrations	
chassis -> steering, steering assist	noises, vibrations	
chassis -> damping\suspension regulation	noises, vibrations

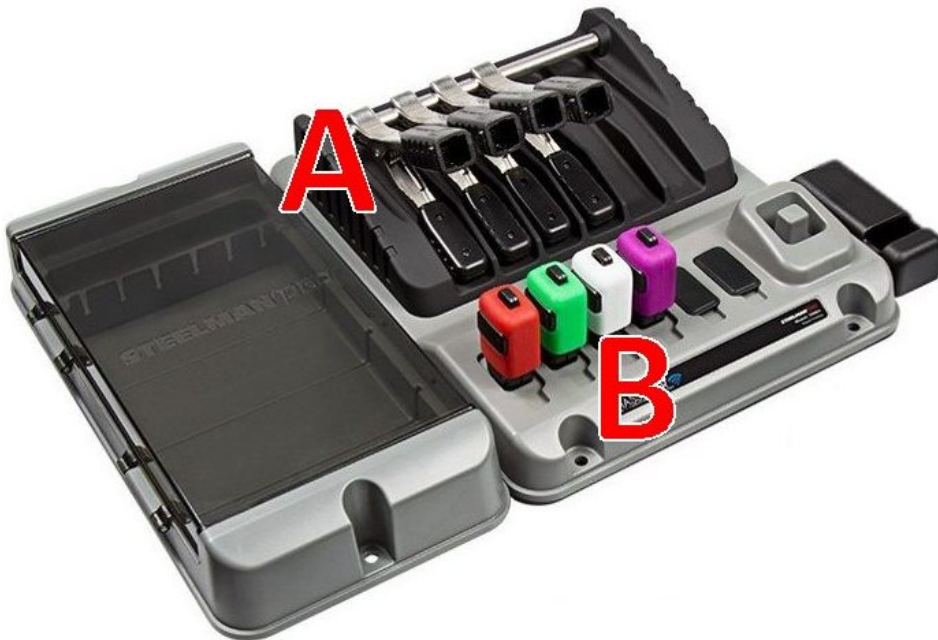
3) Referring to Figure 1 - Using the sensor clamp/s (Point A) and Bluetooth module/s (Point B) provided in the kit - Record the noise

TIP: In order to locate the noise it could be necessary to use multiple clamp and module assemblies, the operative must refer to the appropriate user instructions

NOTE: If the noise is only evident during a road test, the clamp and module assembly must be positioned outside of the cabin for the best results, please be aware that recordings from outside of the vehicle may not help identify the issue at higher speeds or noisy geographical locations, therefore a recording from inside the cabin will also be required
