EC19-027a

MIL ON WITH DTC P0087, P0101, P0448, OR P2008, VEHICLES REGISTERED OUTSIDE OF CALIFORNIA

APPLIED VEHICLES: 2016 – 2019 Q50 (V37)
2017 – 2019 Q60 (CV37)
2015 – 2019 QX60 (L50)

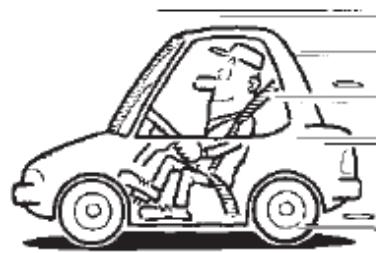
Figure 1

- If you are not familiar with the reprogramming procedure, [click here](#). This will link you to the "CONSULT- III plus (C-III plus) ECM Reprogramming" general procedure.
- Take the vehicle for a 10 minute drive in order to meet the following Idle Air Volume Learn (IAVL) conditions:
 - Engine coolant temperature: 70 -100°C (158 - 212°F)
 - Battery voltage: More than 12.9V (At idle)
 - Transmission: Warmed up
- After reprogramming is complete, you will be required to perform Throttle Valve Closed Position, Idle Air Volume Learn, Accelerator Closed Position, and DTC erase.
