**Raise Fuel Fill Bezel to ensure proper flow of fuel into tank  
Fix as Reported**

<b>Bulletin Type:</b>	Standard Repair Publication SRP	<b>Publication Date:</b>	February 2020
<b>Bulletin #:</b>	20-004	<b>Make:</b>	Jayco Entegra
<b>Job Code:</b>	**	<b>Model:</b>	Greyhawk Prestige Greyhawk Red Hawk Esteem and Odyssey
<b>Flat Rate:</b>	**	<b>Model Year:</b>	ALL

<b>Incident:</b>	Fuel fill bezel is too low, restricting fuel flow into tank.	
<b>Affected Units:</b>	Greyhawk Prestige: 1BF, 1BX, 1BU Greyhawk: 1MF, 1MX, 1MU Red Hawk: 1XF Esteem: 3BF, 3BX, 3BU Odyssey: 3EF	
<b>Parts</b>	1 - Cover, Gas Fill 3.00 x 6.63 x 2.25 (0347509) 4 - Screw, RW QD 8.00 x 1" DT TYP 17 ZC (0059335) 2 - Screw, RW QD #8 x 1-1/2" .67 TWFST NW (0072887) 2 - Screw, FL QD 8.00 X 4.00 .67 TWFST PL (0017682)	
<b>Misc. Tools &amp; Supplies:</b>	<ul style="list-style-type: none"> <li>Air saw</li> <li>Screw gun with #2 sq. drive bit</li> <li>Utility Knife</li> <li>Reciprocating saw</li> <li>Flat screwdriver</li> <li>Creeper</li> <li>2 ft Putty tape</li> <li>1 Tube white silicone caulking</li> <li>1 can undercoating spray</li> </ul>

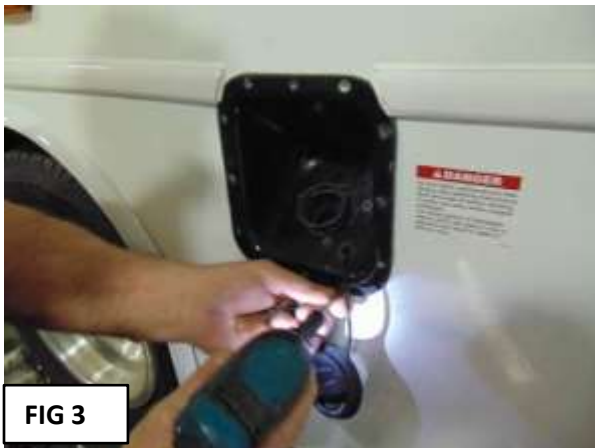
**FIG 3:**

- Remove the 12 screws holding the bezel to the sidewall. Save the screws to reinstall at end of repair.

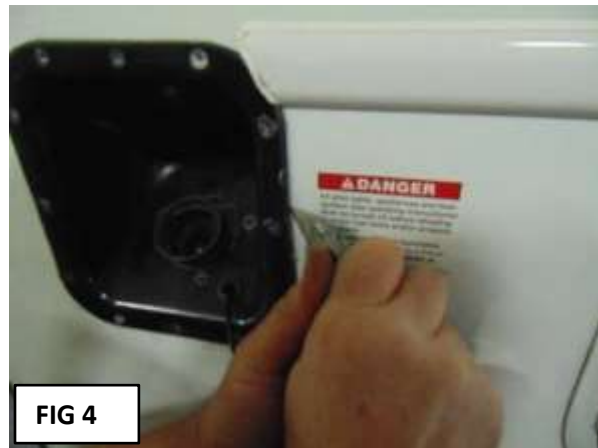
**FIG 4:**

- Carefully, cut the seal around the bezel with a utility knife.

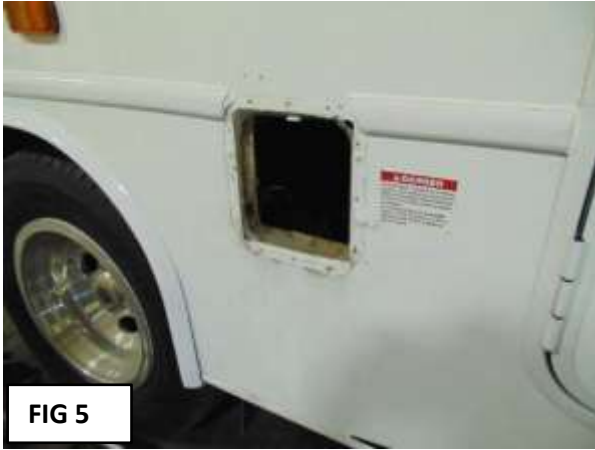
**FIG 5:**

- Remove fuel fill bezel and push the filler neck down toward the ground inside the opening.

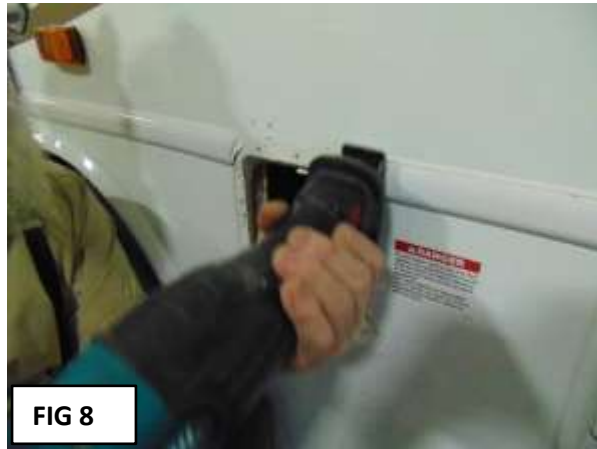
**FIG 8:**

- Enlarge the fuel bezel opening by 1 inch with a reciprocating saw.

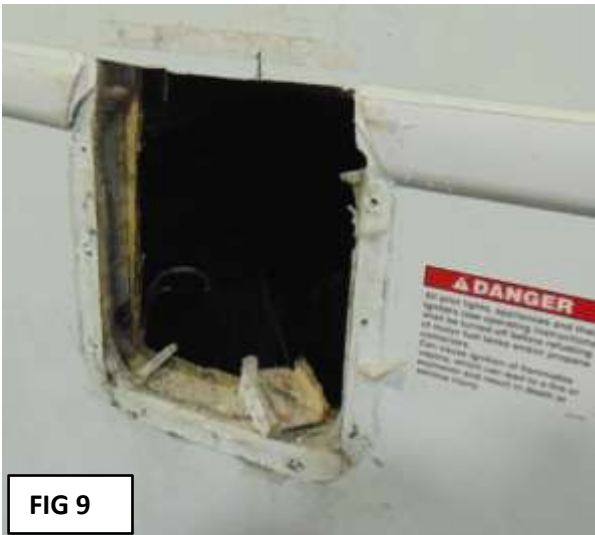
**FIG 9:**

- The fuel fill bezel hole enlarged by 1 inch.

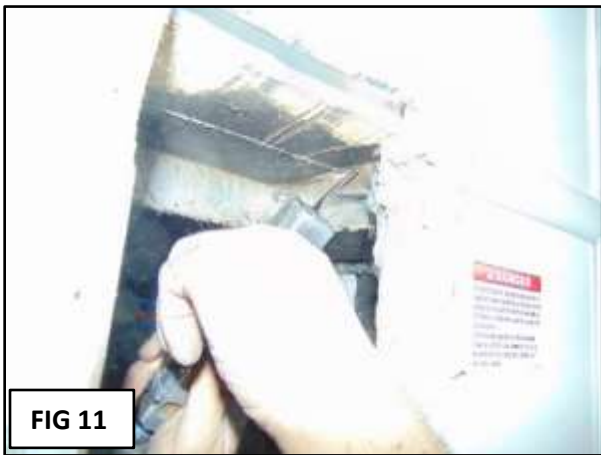
**FIG 11:**

- Cutting the 3" x 7" hole into the floor with the air saw.

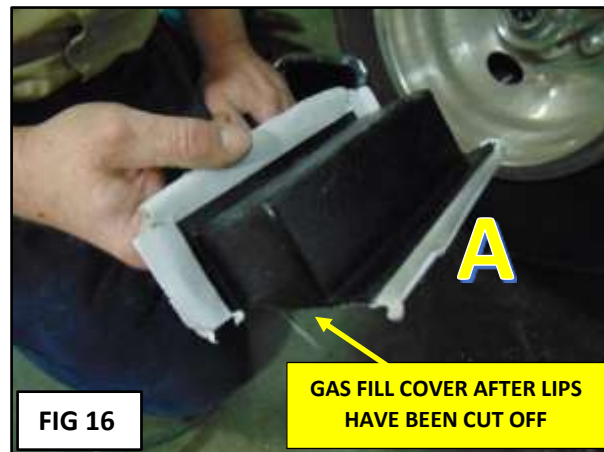
**FIG 16:**

- Gas fill cover after trimming off only the flanges on each end of the cover.
- Flange A shown to reference the top of the cover.

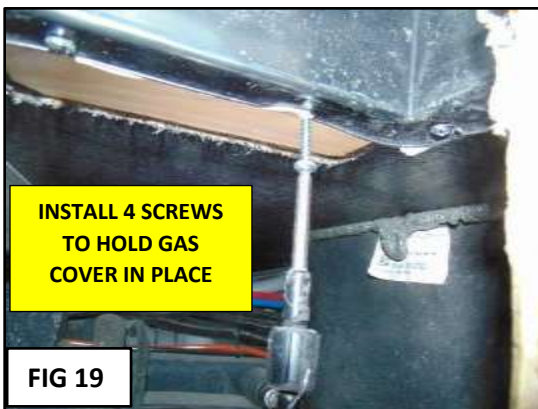
**FIG 19:**

- Install 4 screws to secure the cover to the wood block.

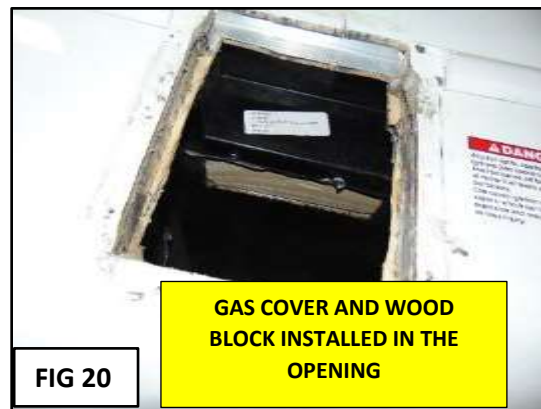
**FIG 20:**

GAS COVER AND WOOD BLOCK INSTALLED IN THE OPENING

- Shows the gas cover installed in the gas fill bezel opening.

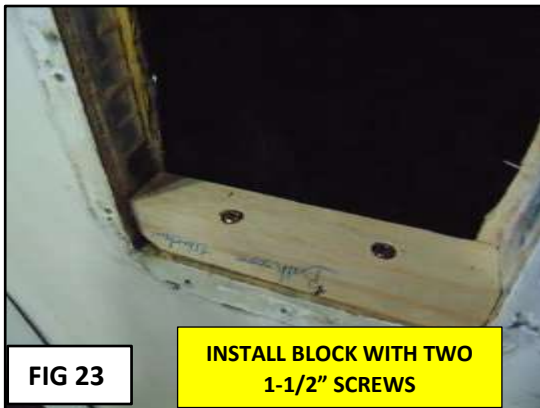
**FIG 23:**

- When the block sits flush in the opening, secure it in place using the two 1-1/2" screws.

At this point, the lower 1" area where this block is located will need to be glassed in as this will show when the fuel fill bezel is reinstalled 1 inch higher up on the wall.

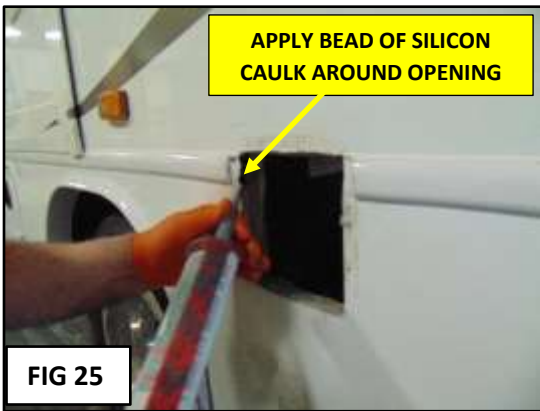
**FIG 25:**

- Apply a bead of white silicon caulk around the perimeter of the opening.

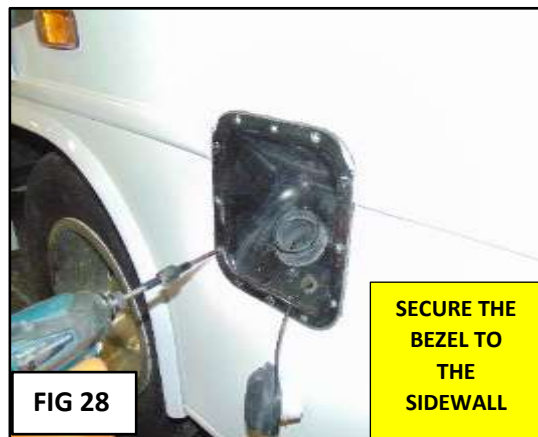
**FIG 28:**

- Secure the fuel bezel (removed previously) to the sidewall using the 12 screws removed previously.

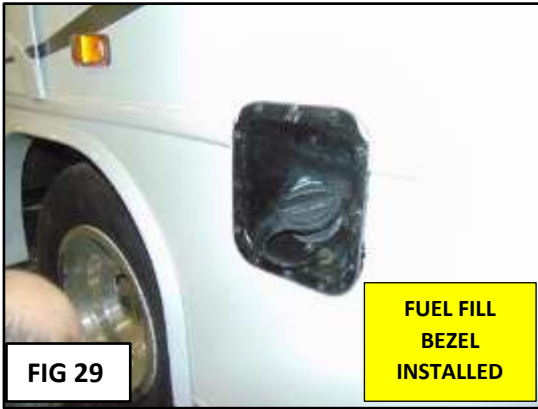
**FIG 29:**

- Fuel fill bezel installed on the sidewall.

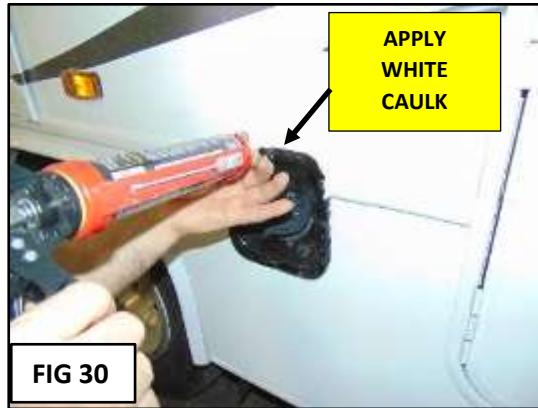
**FIG 30:**

- Apply white silicon caulk around the top of the bezel, and around each side to the skirt trim molding.
- Fill in the area between the bezel and the trim pieces on each side with white caulking.
