# **Preliminary Information**

# PIP5704A Only 11 Digit PUN (Part Unique Number) Found On Service Solenoid Body Assembly GF9 9T45/50/60/65

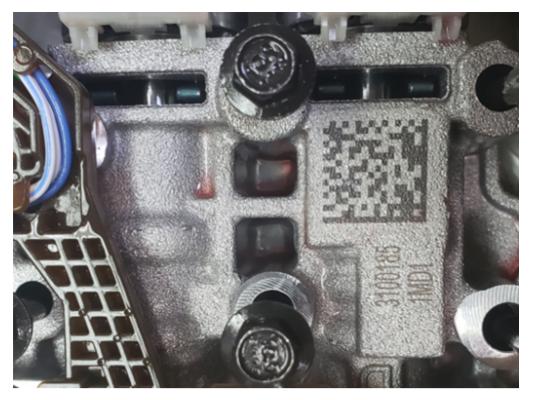
Involved Region or Country	North America and NA Exports.
	Un-able to perform the shift characterization when installing replacement Solenoid
Condition	Body Assembly due to only 11 digit PUN (Part Unique Number) found on the Service
	Solenoid Body Assembly.
Cause	Service Solenoid Body Assembly may not have the 16 digit PUN (Part Unique
Cause	Number) printed on the assembly.

Example using above picture should be "WL0Y931001851MD1" as this part was manufactured in the Calendar Year 2019.

The complete 16 digit PUN (Part Unique Number) can be found on the back side of the instruction sheet that came with the service solenoid body assembly.

If the number is not found on the instruction sheet, use a QR scan code reader to obtain the full 16 digit PUN (Part Unique Number).

If 16 digit PUN (Part Unique Number) is not read when scanned, can try information listed below as the first 5 digits to use in front of the 11 digits printed on the Solenoid Body Assembly.

First five digits are dependent as to where the part was manufactured as well as Calendar Year built, can try WL0Y9, WL0Y0, WL4P9, or WL4P0.

If still un-able to complete the shift characterization with the 16 digit PUN, verify the digits being used are not transposed, and ensure "0" is being used and not "O".
