TF16-002a ITB17-001a March 25, 2020

# FLUID LEAK CAUSED BY TRANSFER ASSEMBLY RIGHT SIDE DRIVE SHAFT SEAL

**APPLIED VEHICLES:** 2014-2020 QX60 (L50)

2019-2020 QX50 (J55)

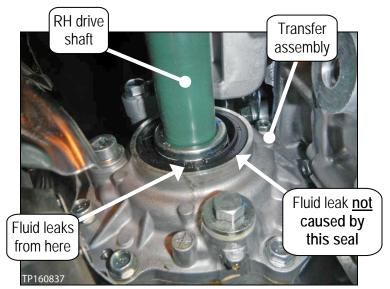
Figure 1

Fluid is leaking from the right side of the transfer assembly (see Figure 1).

**NOTE**: The fluid leak is not caused by the seal shown in Figure 1.

- 1. **DO NOT REPLACE** the transfer assembly.
- 2. Reseal the transfer assembly.
  - Refer to the Electronic Service Manual (ESM), section DLN Driveline or TRANSMISSION & DRIVELINE > DRIVELINE > TRANSFER: TY21C - UNIT REMOVAL AND INSTALLATION > **TRANSFER ASSEMBLY** for transfer assembly removal, reseal, and installation information.
  - Refer to page 2 and 3 for additional information.

**CAUTION**: Be careful not to damage the transfer assembly right side drive shaft seal when reinstalling the drive shaft.

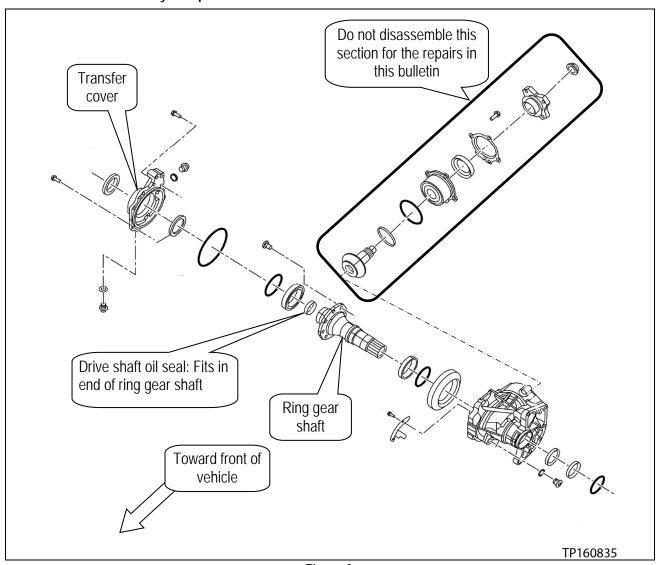
Figure 2

TY21C Transfer Assembly - Exploded View
