SERVICE BULLETIN

Classification: AT19-002c	Reference: NTB19-040c	Date: April 13, 2020
------------------------------	--------------------------	-------------------------

MIL ON WITH DTC P0741, P0744, P0746, P0776, P0841, P0965, P2857, P2858, P2859, AND/OR P285A STORED, AND MAY HAVE HESITATION AND/OR REDUCED POWER

APPLIED VEHICLES: 2018-2020 Kicks (P15)
2020 Versa Sedan (N18)

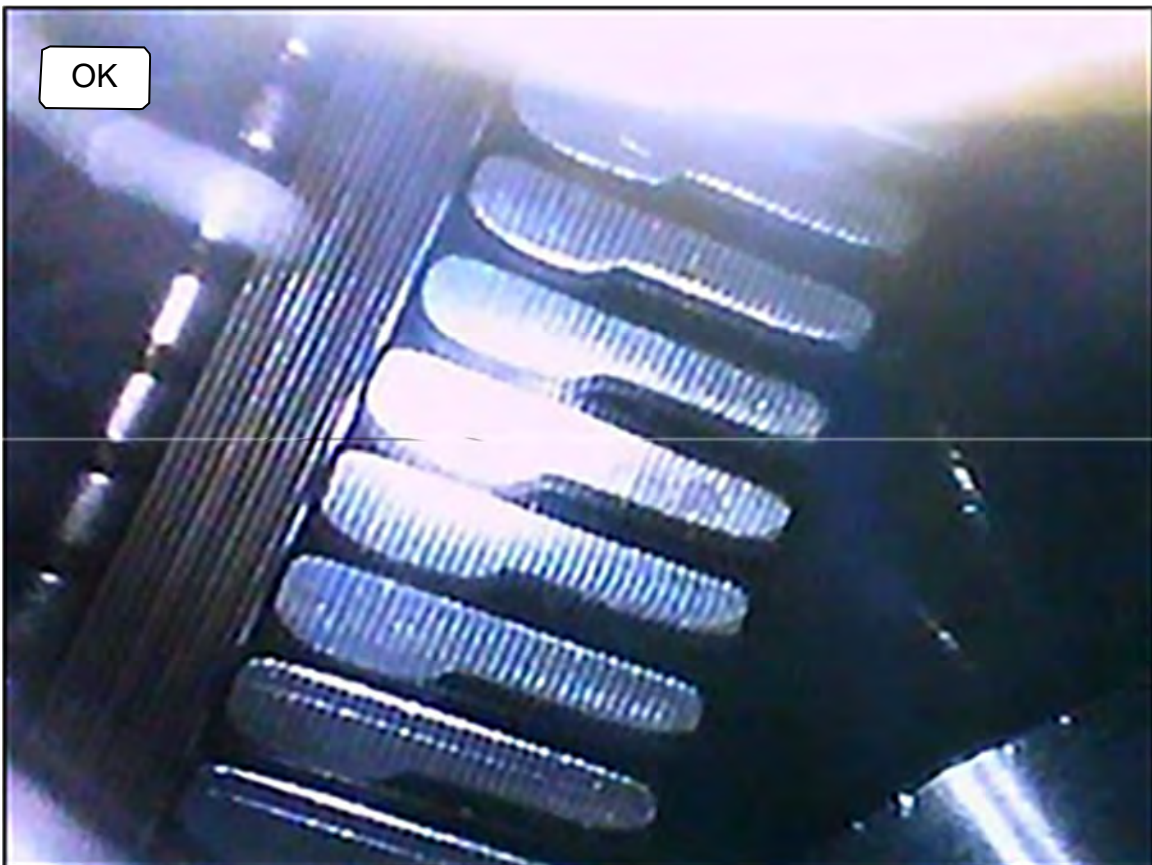
Pictures in Figure 16 and Figure 17 were taken with borescope J-51951.

- If no evidence of belt slip is found, proceed to step 19 on page 11.
- If evidence of belt slip is identified as shown on pages 13-16, skip to step 22 on page 17.
- If the belt does not move when rotating the front left tire, return to step 17 on page 8.

- Look for evidence of belt slip as shown on pages 13-16.

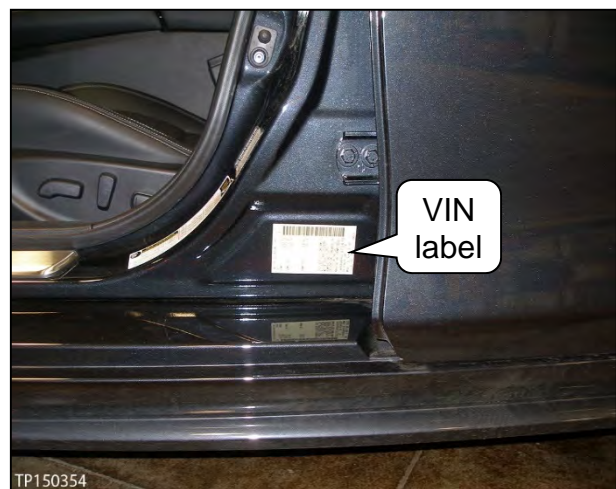
Figure 23

24. If CVT replacement is required based on the inspection results from steps 18 and 19, use borescope J-51951 to record a continuous video, 15 seconds or less, of the most severe evidence of belt slip and the VIN on the F.M.V.S.S. certification label (VIN label). See Figure 23.
