LATEST VEHICLE CONCERN FIXES

Blower motor inoperative due to a blown / melted fuse 5E

2017- Onwards Range Rover ,
Range Rover Sport and Discovery

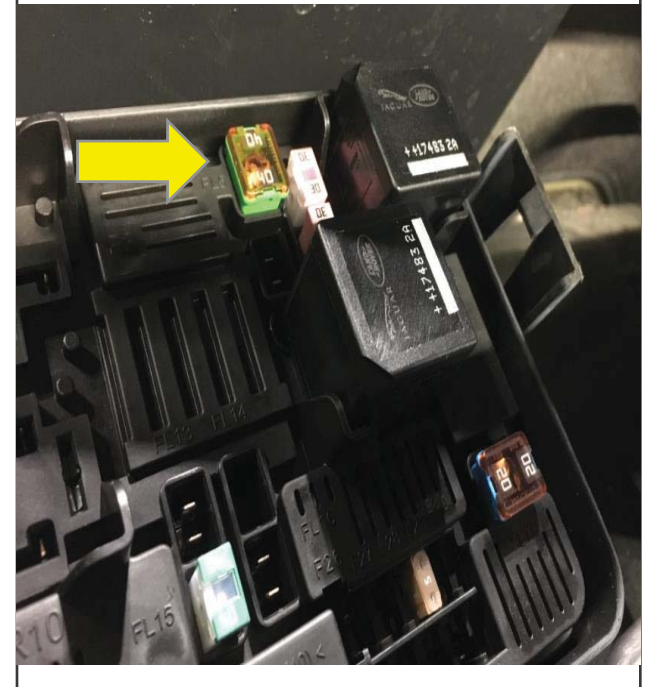
- Fuse 5E in the EJB is found blown/melted.

- This is currently under investigation.
- Before any parts are replaced, please take pictures from different angles of the fuse in the EJB.
- If the fuse is found blown, replace the fuse and check the current draw of the blower motor.
- Verify the manner in which the HVAC is normally operated.
 - HVAC is operated in manual or auto mode?
 - What is the temperature setting normally used?
 - Is the vehicle driven with A/C on and the windows open?
- Submit an EPQR with the pictures, customer usage and contact details for the parts return of the fuse and blower motor.
