Technical Service Bulletin

40 Noises from front suspension's buffer stops

40 20 06 2059474/1 May 13, 2020.

Model(s)	Year	VIN Range	Vehicle-Specific Equipment
All except Audi e-tron quattro	2018 - 2021	All	Not Applicable

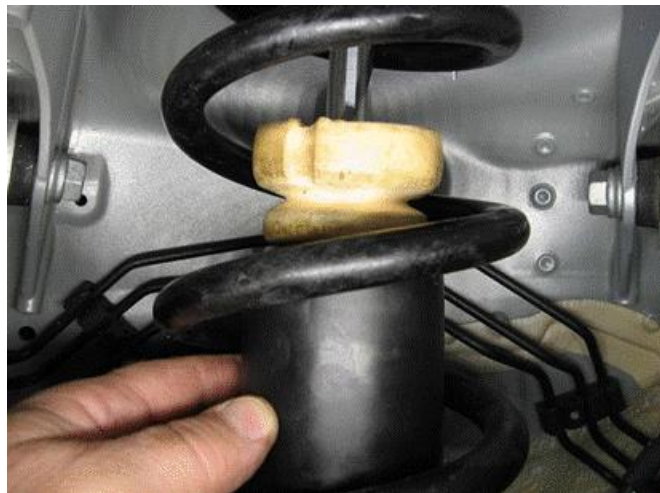
- The buffer stops of the shock absorbers are identified as the source of the noise, because they do not sit correctly in the shock absorber mounting (Figure 1).

Figure 1. The shock absorbers are sitting incorrectly.

With the new improvements in suspension design, the material in the buffer stop changed to increased hardness. As a result, it has become harder to press them into the mountings.

1. Secure the buffer stops correctly. A tire assembly paste can be used as an aid. The buffer stops must be completely pressed in.
2. If the buffer stops were deformed during the vehicle transport, try to shape them correctly by warming them up slightly. If this is not possible, replace the affected components.
