STAR ONLINE PUBLICATION

Case Number: S2021000002

Symptom/Vehicle Issue: Valve Body Pressure Testing Plug Inspection

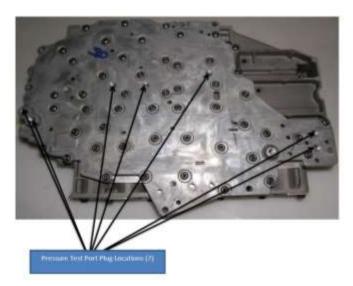
Instruction Sheet K6856070

CAUTION BEFORE INSTALLING THIS VALVE BODY

You must Install the 7 supplied plugs and torque to 45 Inch Pounds (5 NM) before valve body installation.

Technician: OEM RFE valve body testing and or replacement, verify the required seven (7) Part #06030035 plugs are installed and torqued to 45 in-lb (5Nm).
