SRS Message Displayed in Instrument Cluster

Topic number	LI54.21-P-070658
Version	4
Function group	54.21 Control units / basic modules
Date	06-04-2020
Validity	A-Class (177) CLA-Class (118) GLB-Class (247)
Reason for change	Updated Remedy, Validity and Part Number
Reason for block

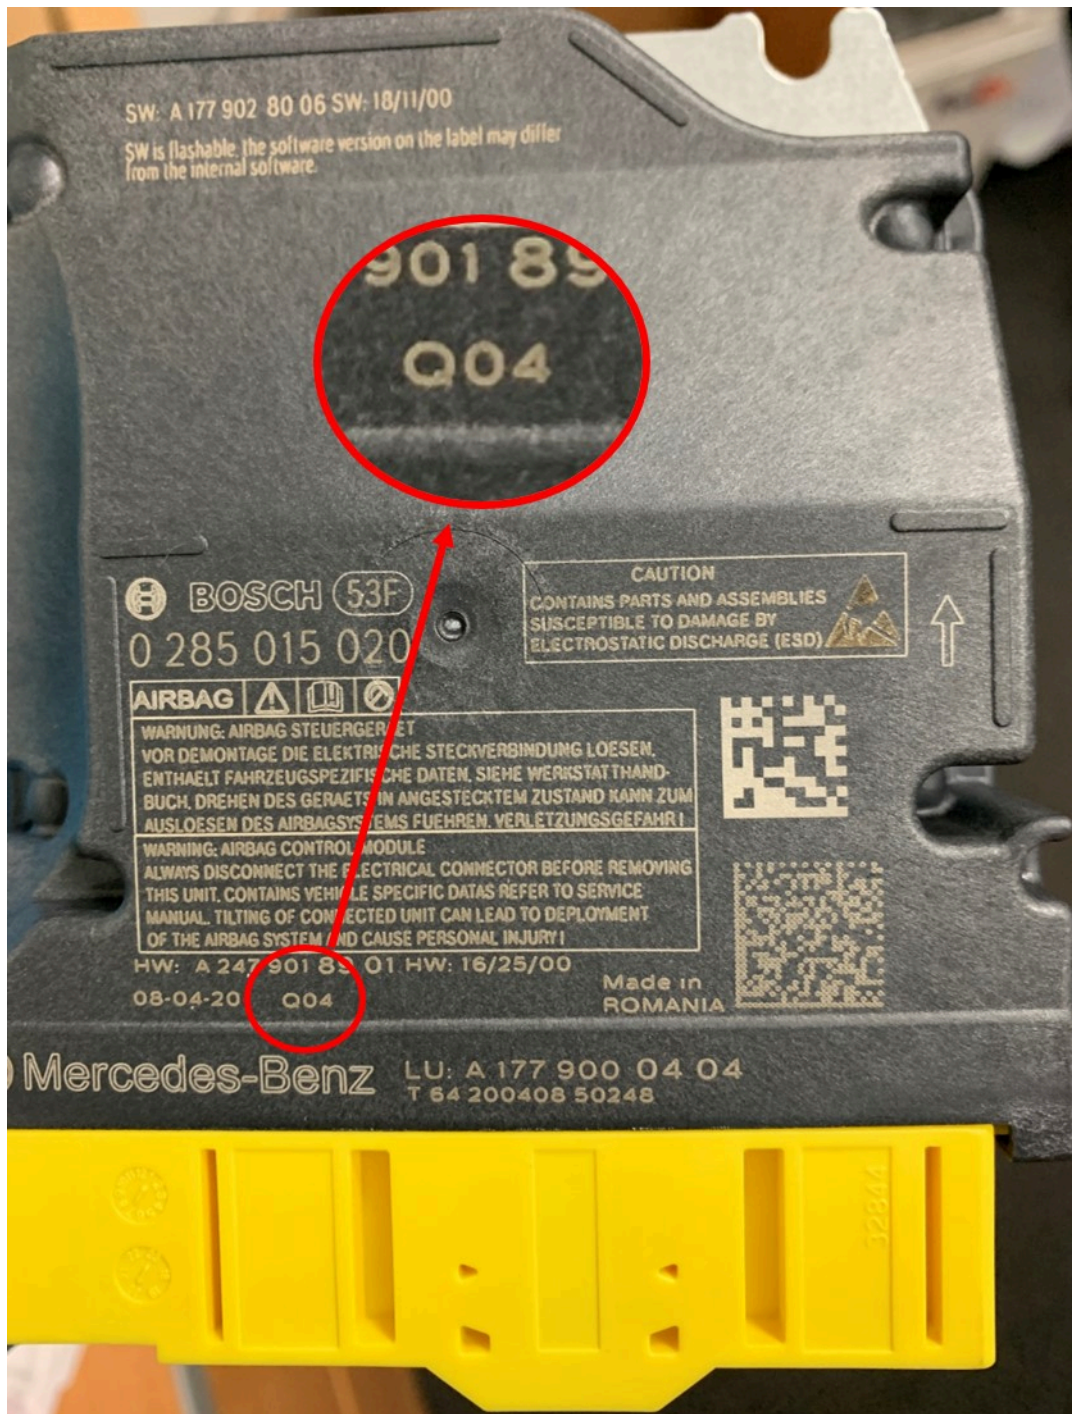
Q4 SRS Example.jpg:

Attachments	
File	Description
Q4 SRS Example.jpg	Location of Q Level on SRS Control Unit

If the fault occurs again, or if this is a reoccurrence of the same problem, replace the SRS control unit. Ensure the new control unit is Q4 level or higher.
